TECHNICAL MEMOIR FOR ENVIRONMENT PERMIT ISSUANCE

The ISPA EUROPEAID/122137/D/SV/RO - "Technical assistance for improvement of conditions for navigation on the Common Romanian - Bulgarian Danube sector and further studies".

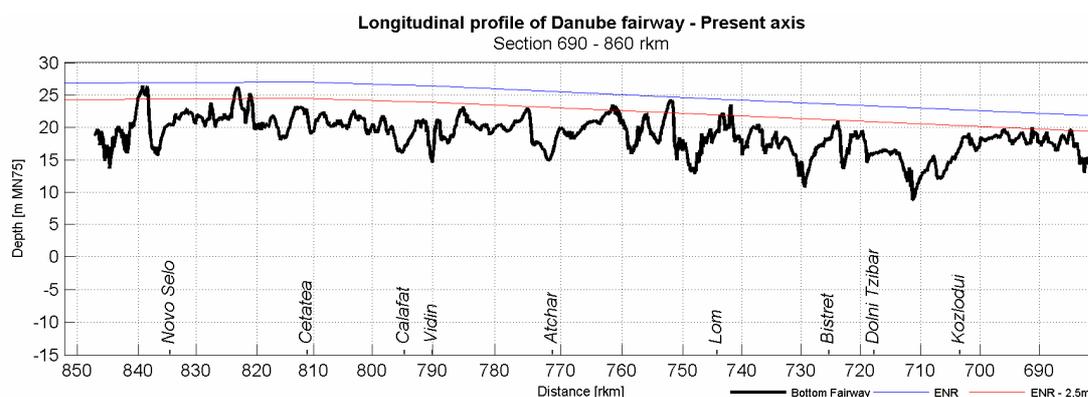
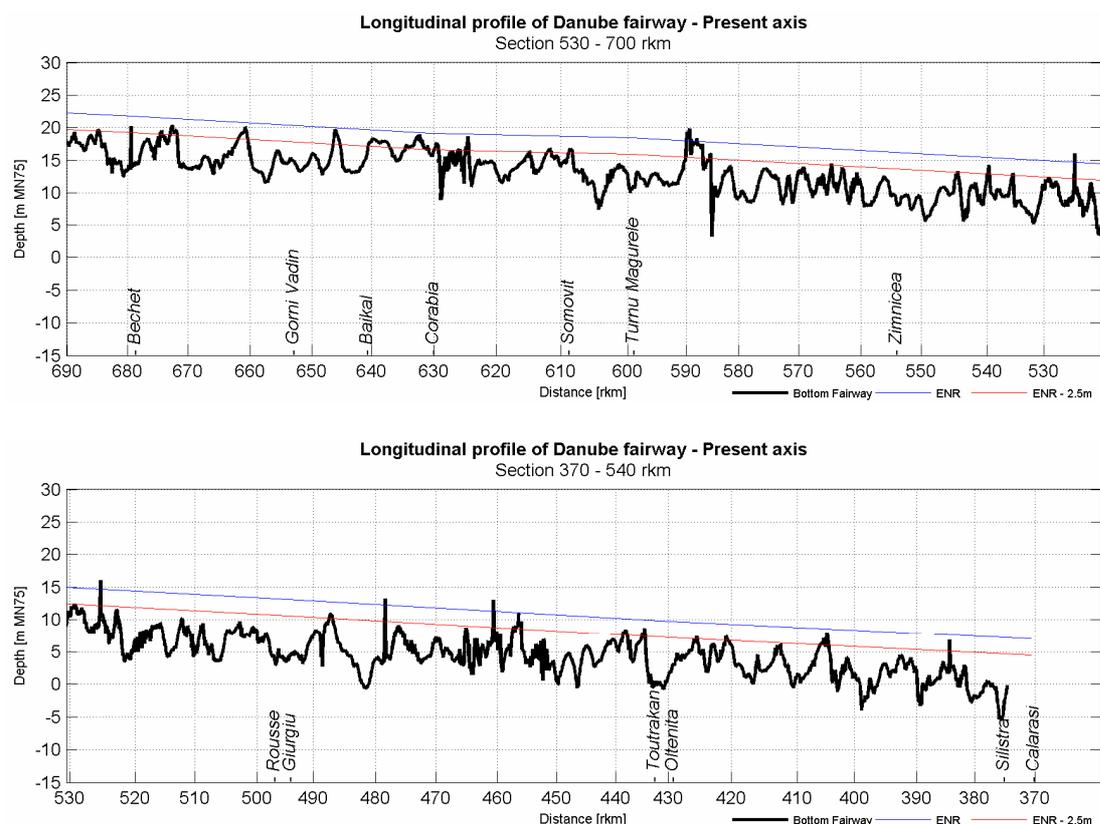
Figure III-1: Longitudinal profile along the current navigation channel rkm863-375

Figure III-1 shows the longitudinal profile along the present navigation channel between rkm863 and rkm375 and based on the collected bathymetry data. As can be seen, the river bottom is at some locations higher than the minimum required level for navigation of ENR-2.5m, either because there is not enough depth for navigation or the river has moved its banks and the original alignment of the navigation channel is outside the present riverbanks.

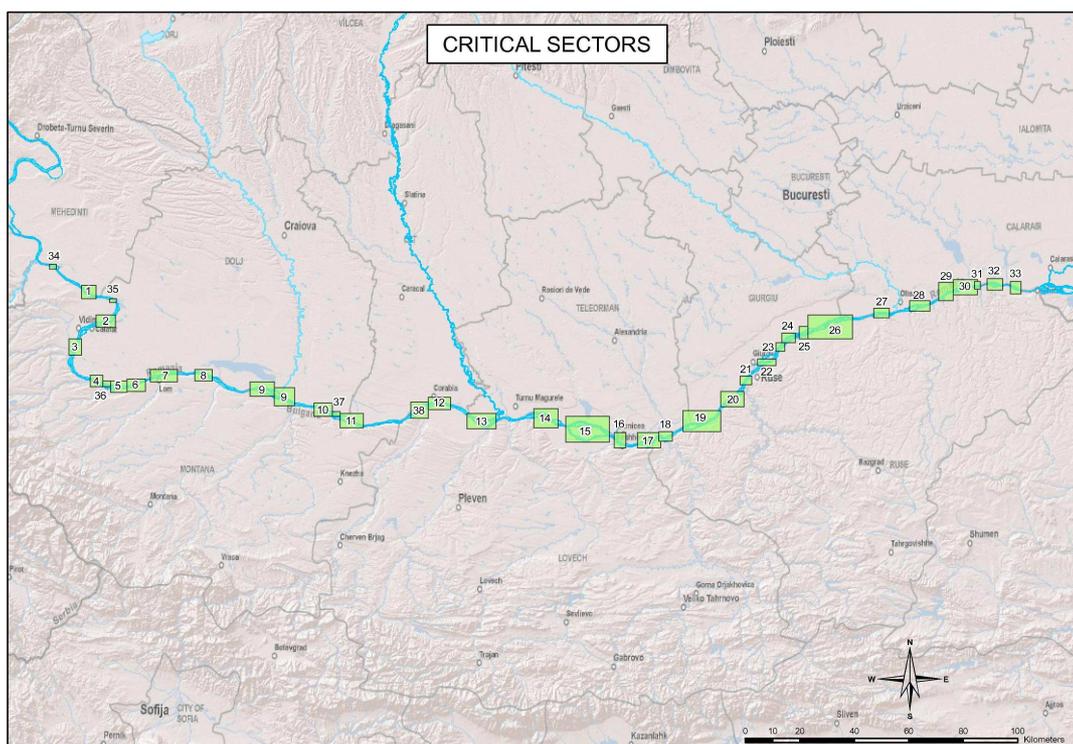
Figure II-10: Critical Sectors for Navigation on the Danube between rkm863 and rkm375

- Abscissa of the fairway, rkm;
- Navigation channel;
- Contour line at ENR;
- Contour line at ENR-2.5m: bathymetry above this line in the fairway hampers navigation;

- Dredging areas ($> -2.50\text{m ENR}$);
- Measures: bottom sills, groins, bank protection;
- Sturgeon spawning sites;
- Natura 2000 areas (RAMSAR, SPA, SCI);
- Depth with respect to the ENR line [m].

The critical sectors found by the Consultant are listed in TableIII-6 and shown in Figure II-10. It is important to point out that the list of critical sectors corresponds to an exhaustive inventory of sectors reported by the Client and institutions in charge of the navigation to be studied by the Consultant. However, there are several sectors in this list that are not critical at present based on the most updated field data and engineering measures are not needed. On the other hand, the sectors at: rkm840-838, rkm813-811, rkm763-761, rkm671-669 and rkm641-634, correspond to areas with required capital dredging after the realignment of the navigation channel proposed by the Consultant.

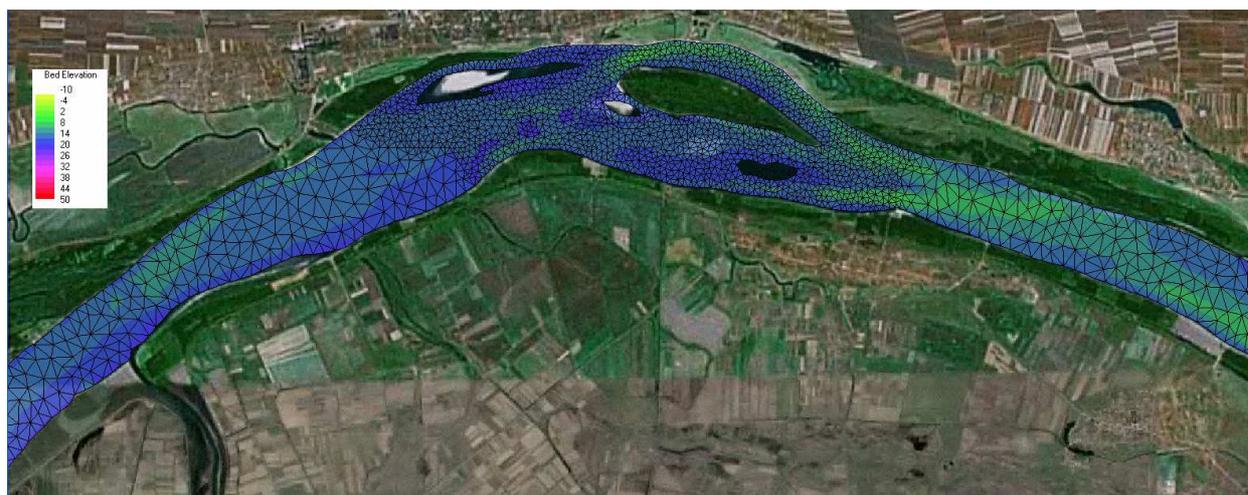
Figure III-10: Model grid and bathymetry at rkm630-620 (Aerial picture from Google.com).

The numerical model is the keystone for the analysis of the hydrodynamics and sediment transport of the river. Figure III-10 shows a plan view of the model grid at one of the critical sectors.

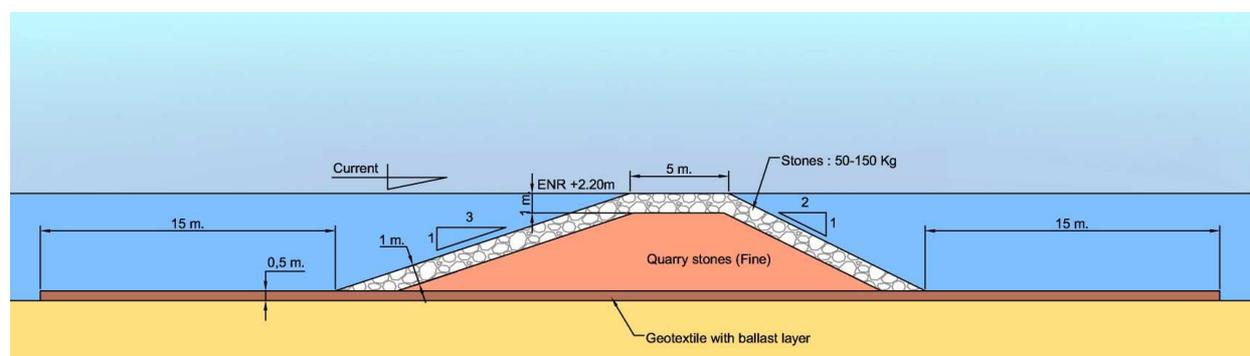
Figure II-12: Schematisation of a groin

Design of parallel guiding walls is similar to the groin structures. Differences result from the absence of an up- and downstream side of the structure and consequent symmetrical design of slopes on both sides of the structures.

Ice loads on the structures should be included in the cross-section design, while the groins are usually inclined in downstream direction, to facilitate ice-discharge by the river.

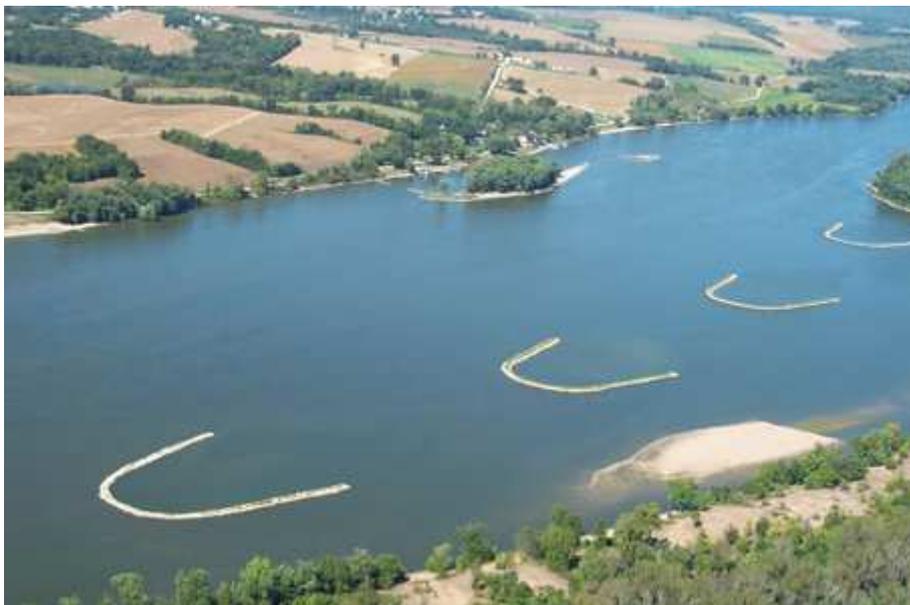
Figure II-13: Example of Chevrons (Source: US Army Corps of Engineers, 2008)

A special type of wall structures is the called "Chevrans". They are arch-shaped structures placed in a river, off the bank. The open end of the arch faces downstream, with its crown

or arch facing upstream against the river's flow. They may be visible at lower river stages but are submerged at higher stages. In addition to direction flow and energy to either side to improve navigation, they also create a wide range of aquatic habitats. They are particularly useful for reducing point sedimentation and thus, requirements for dredging (US Army Corps of Engineers, 2008).

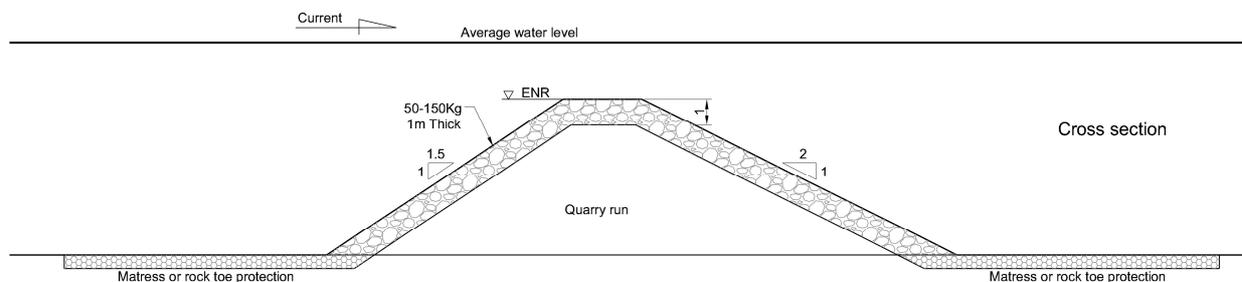
Figure II-14: Schematisation of a bottom sill (cross and longitudinal sections)

Bottom sills are submerged structures at secondary river branches that consist of a core of quarry run and a protective layer of stones. The aim of the bottom sills is to divert the river discharge to the main branch where the navigation channel is located. The crest level of these sills will be ENR so that the flow redistribution occurs mainly only during low water periods. The sills usually have culverts, pipes or a level crest reduction at the center in order to refresh continuously the water in the side branch.

A typical cross section of a bottom sill is shown in Figure II-14. At both sides of the bottom sill is required bottom protection to prevent scour around the sills, especially important on the downstream side, where strong currents may create large scour holes in absence of bottom protection.

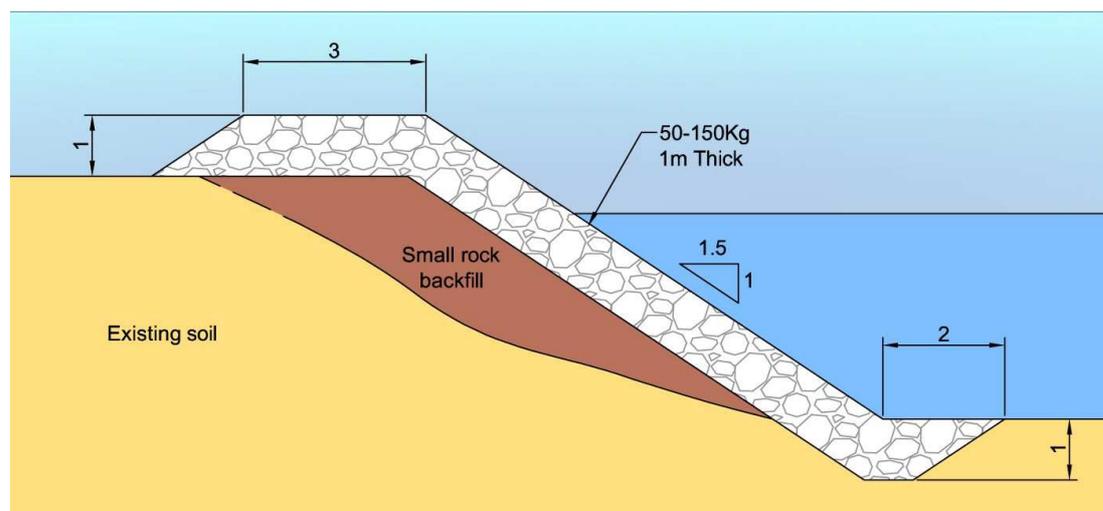
Figure III-11: Schematisation of a bank protection

Bank protection structures are used to control bank erosion due to the water flow. They can be made of rock and concrete, or with natural materials such as wood or vegetation. These structures do not affect the flow conditions, but help to reduce the amount of sediment entering the river and its morphological changes. A typical bank protection is shown in Figure III-11.

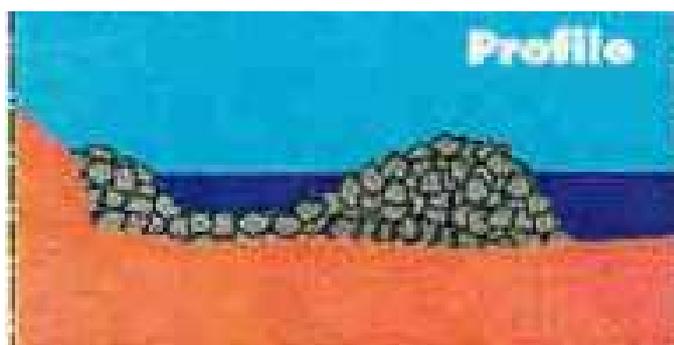
Figure 5.11: Alternative groins with poor connection with the riverbank

- Open guiding wall or groins at river bank: groin or guiding wall has poor or no connection with river bank in order to allow water to flow between groin and bank. The height of groins and guiding walls influences the visibility of structural measures and should be therefore kept as low as possible (see Figure 5.11).

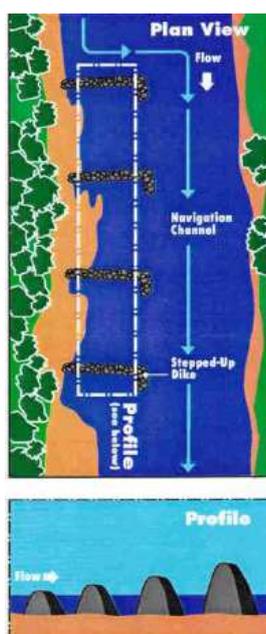
Figure 5.12: Alternative L-shaped groins
(source: US Corps of Engineers, 2008)

- Less groins but with wing: L-shaped groins instead of perpendicular straight groins. Groins change river morphology by decreasing the channel width and the surface area of the waterway. The accelerated flows at groin head develop a scour hole immediately downstream of the dike subsequently with submerged bar forming. Therefore, habitat diversity is increased, providing macroinvertebrate habitat and therefore fish foraging and nursery ground (see Figure 5.12).

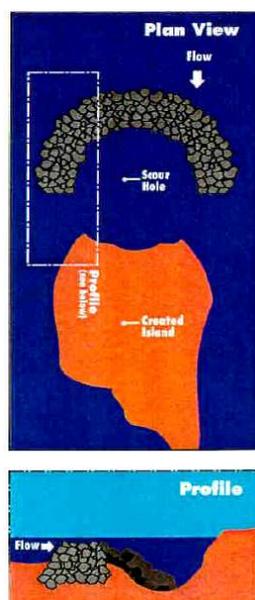
Figure 5.13: Chevrons (source:US Corps of Engineers, 2008)

Chevrons instead of groins and guiding walls: chevrons are considered to be more environmentally friendly as they can significantly increase habitat diversity. Dredging material can be deposited behind the chevron dike, forming small islands that encourage the development of primary river ecosystem habitats. Various microorganisms tend to grow and live on these structures, providing a food source for fish and other organisms (see Figure 5.13).

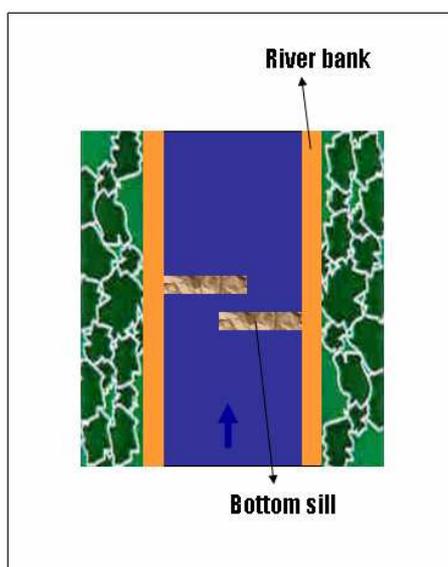
Figure 5.14: Two partial bottom sills (source:US Corps of Engineers, 2008)

Two partial bottom sills: instead of one bottom sill, two partial bottom sills are created with an opening in between, thus allowing fish migration and water passage during low run-off periods. A major point of attention is the water velocity through the opening that needs to be adapted to the swimming capacity of fish. Other adapted bottom sill configurations can be designed. An alternative can be to use large cubic structures in the river channel to obstruct water passage (see Figure 5.14).

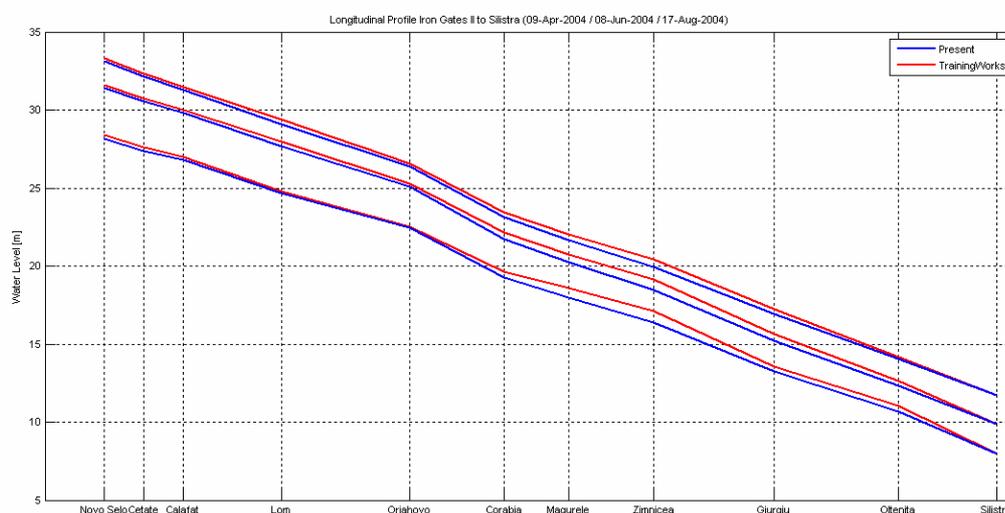
Figure III.17: Water level for scenarios: SA and SLH (TWS)

redistributing the flow between the river branches. The strategy of the TWS is to realign the fairway, dredge where needed, propose measures to reduce the river morphological changes and slightly increase the water levels mainly during low water periods. Figure 6.1 shows model results of a longitudinal profile of a river with water levels for the present conditions (AS, blue line) and after the construction of the structures (TWS, red line) for minimum, average and maximum discharges. As can be seen, water levels are increased due the training works during low flow discharges between Corabia (km 630) and Giurgiu (km 493) with the maximum difference of around cm (maximum near Zimnicea km 554). The effect of the training works is less during average discharge and even less during high flows. Upstream Corabia and downstream Giurgiu the effect of training works is much less significant.

The results of the numeric model highlight the fact that the water level for this scenario is high in certain areas for the average flow period and also that there is a decrease of the sediment deposition in the navigation channel, as compared to SB.

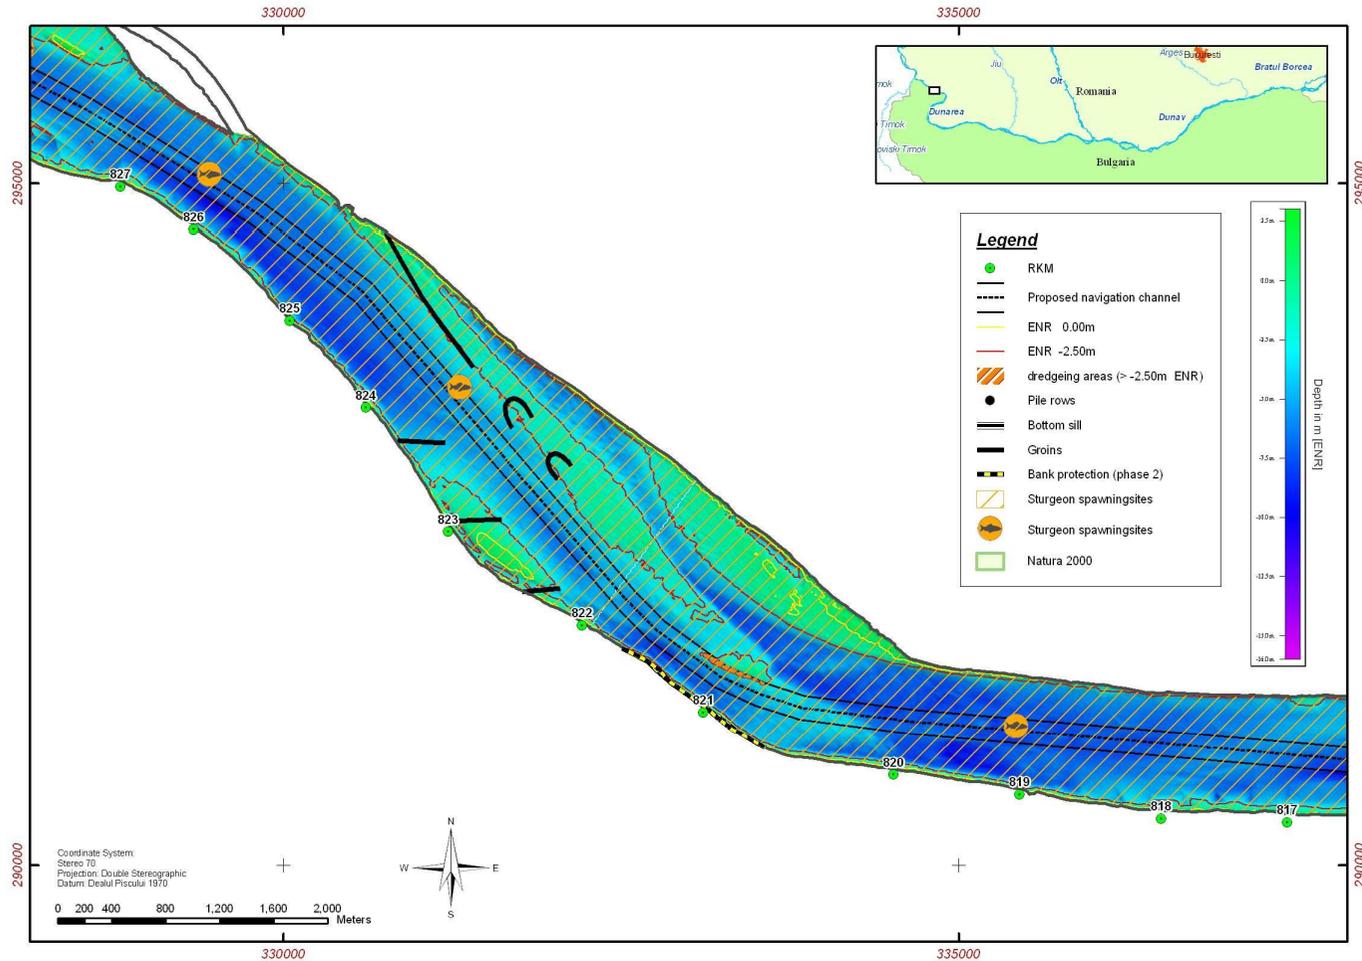
Figure 27: Salcia. Alternative Development Strategy

- Phasing of dredging to take into account fish spawning/migration;
- Phasing of large training works;
- Keep impact on deep areas as low as possible (spawning sites);
- Less groins but with wing (although the total length of groins might be similar, groins with wings reduce works on the river bank and diverse habitats are maintained);
- Useful application of dredged material;
- Reduce length of bank protection accompanied with a monitoring program in order to take actions if necessary.

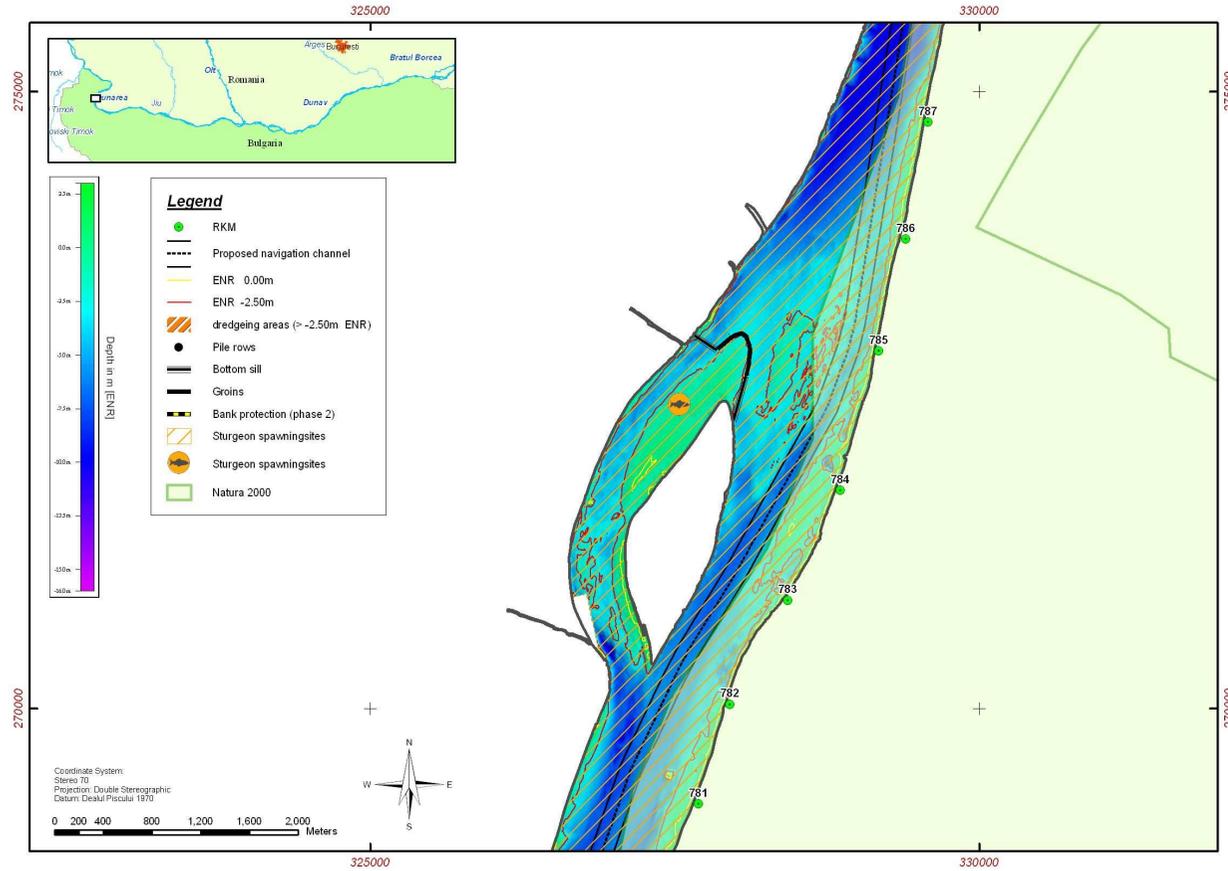
Figure 19: Bogdan Alternative Development Strategy

- Keep impact on deep areas as low as possible (spawning sites);
- Open guiding wall at river bank;
- Useful application of dredged material;
- Reduce length of bank protection.

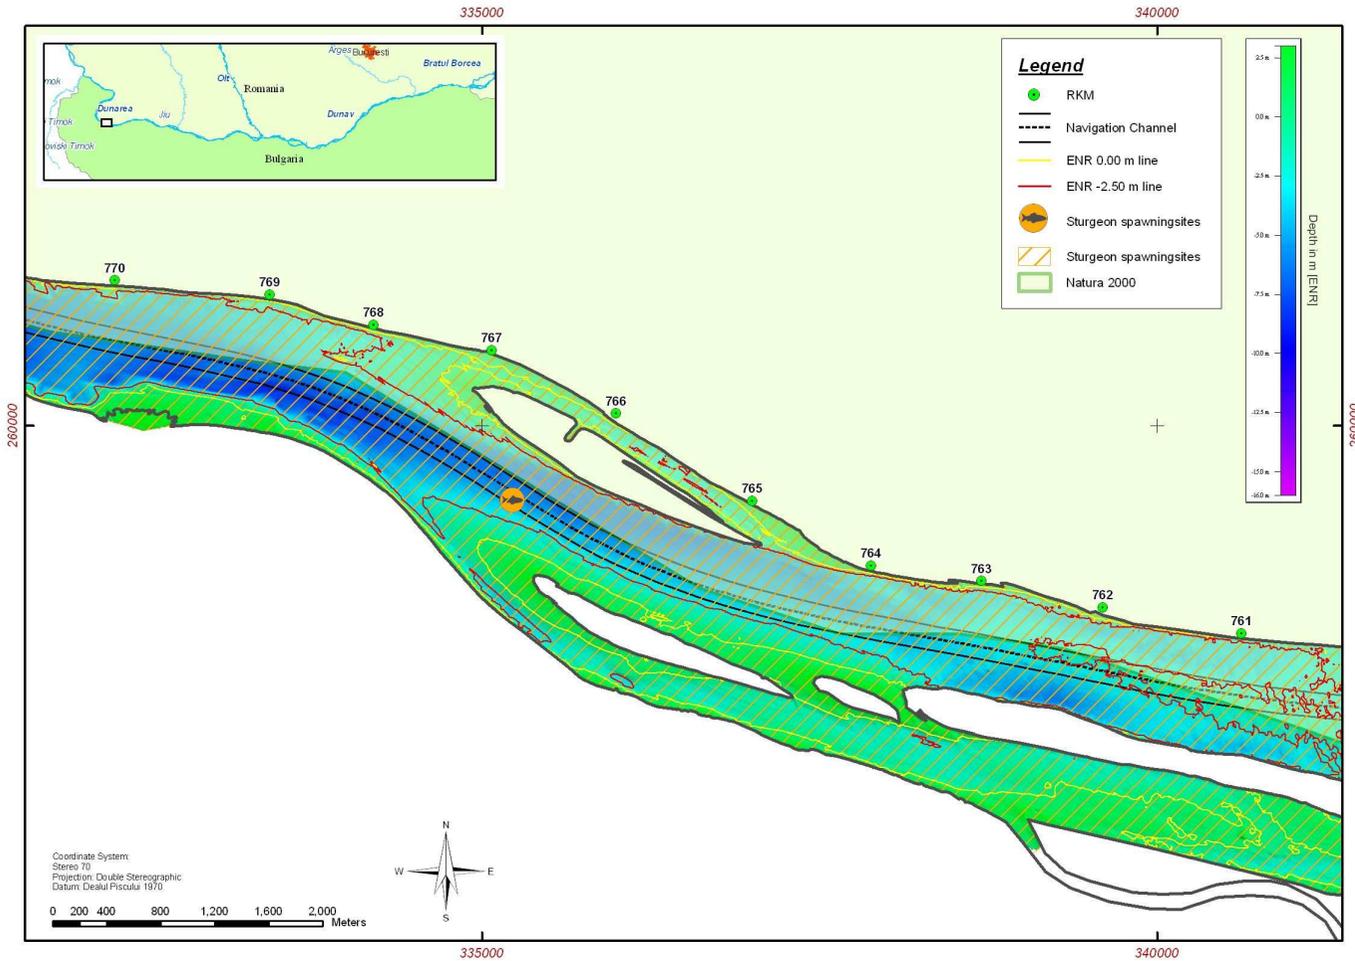
Figure 20: Artchar Present Conditions

Last update of this sheet:	18/09/08
	Critical Sector Number:	4
Location:		
Artchar		
Position:	Danube sector:	
rKm 768-764	Common Romanian – Bulgarian sector rKm 610 - 845.5	
Sector for detail measurements:		
Critical point reported by:		
<ul style="list-style-type: none"> • AFDJ Giurgiu 		
Description of the present situation:		
<p>A narrow channel width is present at rkm 768 during low waters, which cause difficulties for navigation.</p> <p>Besides, the main river branch is sedimenting and more flow is distributed towards the two other branches (Romania and Bulgaria; Desa and Dovlek Islands respectively). Although apparently small, a possible source of sediment is the Danube tributary coming from the Bulgarian side discharging at rkm 769-768.</p> <p>Maintenance of the navigation channel is necessary to assure a minimum width.</p>		
Proposed works:		
Harris (1999): None		
Alternative Development Strategies (Technum et al., 2008):

<p>This critical sector is attached to the next one (Pietrisul Island) and the proposed measures are thought to work for both critical sectors.</p> <p>The proposed structures at rkm760 and rkm757 (see Critical Sector 5, Pietrisul Island) reduce the flow discharges of secondary branches. No measures are proposed between rkm768 and 764.</p>		
Selected solutions JV Technum, Trapec, Tractebel, CNR, Safege (2008):

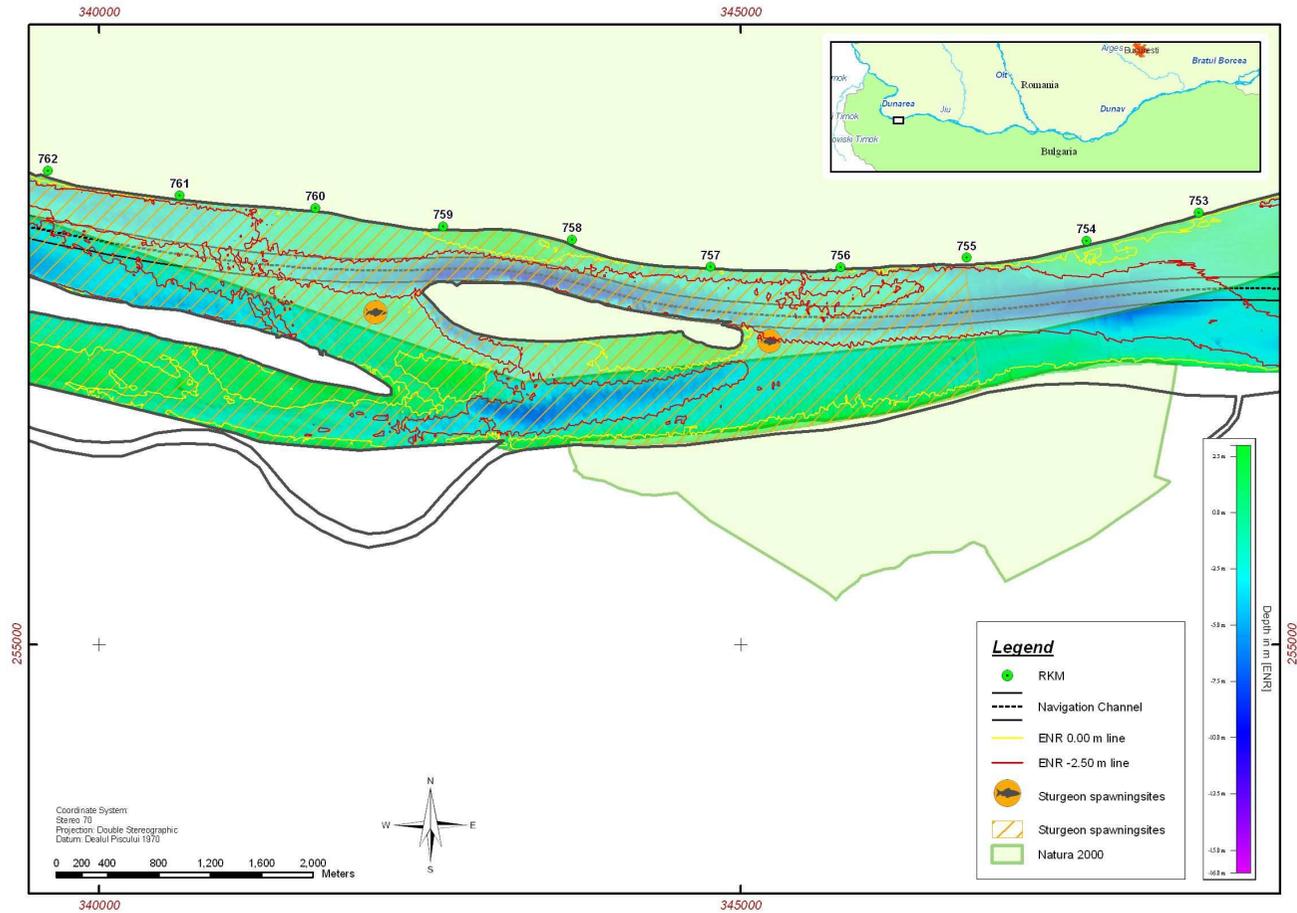
Figure 22: Pietrisul Island Present Conditions

- Open guiding wall at river bank;
- Useful application of dredged material;
- Look for alternative measure for the guiding wall at rkm 760, to avoid sedimentation at the spawning site and reduce impact on island (protected area).

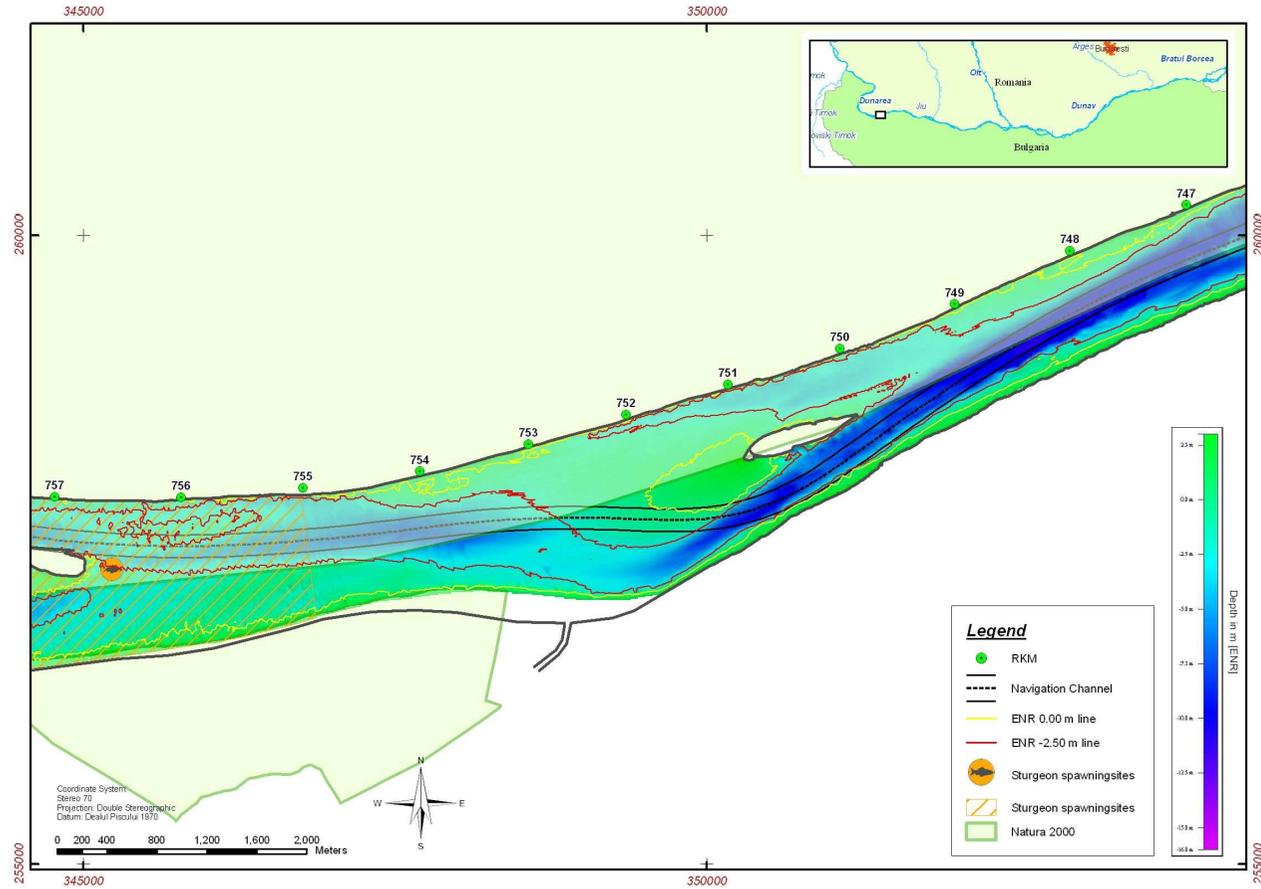
Figure 24: Nebuna Island Present Conditions

Last update of this sheet:	18/09/08
	Critical Sector Number:	6
Location:		
Nebuna Island		
Position:	Danube sector:	
rKm 760-755	Common Romanian – Bulgarian sector rKm 610 - 845.5	
Sector for detail measurements:		
Critical point reported by:		
<ul style="list-style-type: none"> • Navigation Directorate • Harris (1999) • AFDJ Giurgiu 		
Description of the present situation:		
At rkm 753-750 the navigation channel is towards the Bulgarian bank due to the Nebuna Island and low water depths nearby. This causes that the minimum radius of curvature is not complied.		
Proposed works:		
Harris (1999): None		
Alternative Development Strategies (Technum et al., 2008):		
<p>It is proposed the realignment of the navigation channel: to comply with the minimum radius of curvature and at the same time keeps dredging volumes to the minimum.</p> <p>In addition a groin and 2 chevrons are proposed in the TWS to redirect the flow towards the right branch, increasing velocities and reducing sediment deposition in the navigation channel. The area is morphologically active and the same measure is proposed in the MS.</p> <p>Other important aspects for the EES and GES, and in general for construction:</p> <ul style="list-style-type: none"> • Phasing of large training works; • Keep impact on deep areas as low as possible; • Open guiding wall at river bank;

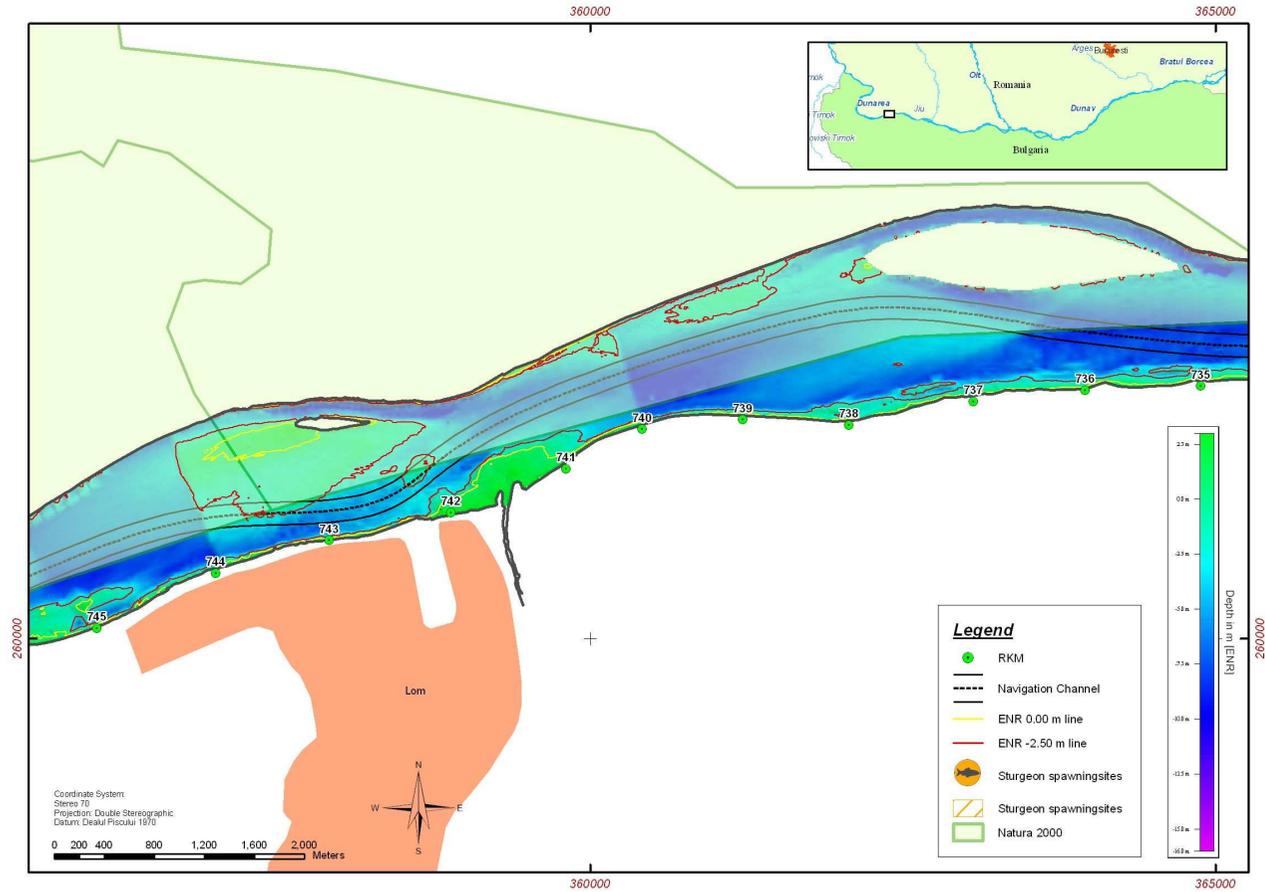
Figure 26: Lom – Linovo Island Present Conditions

- Keep impact on deep areas as low as possible (spawning sites);
- Open guiding wall at river bank;
- Less groins but with wing;
- Useful application of dredged material;

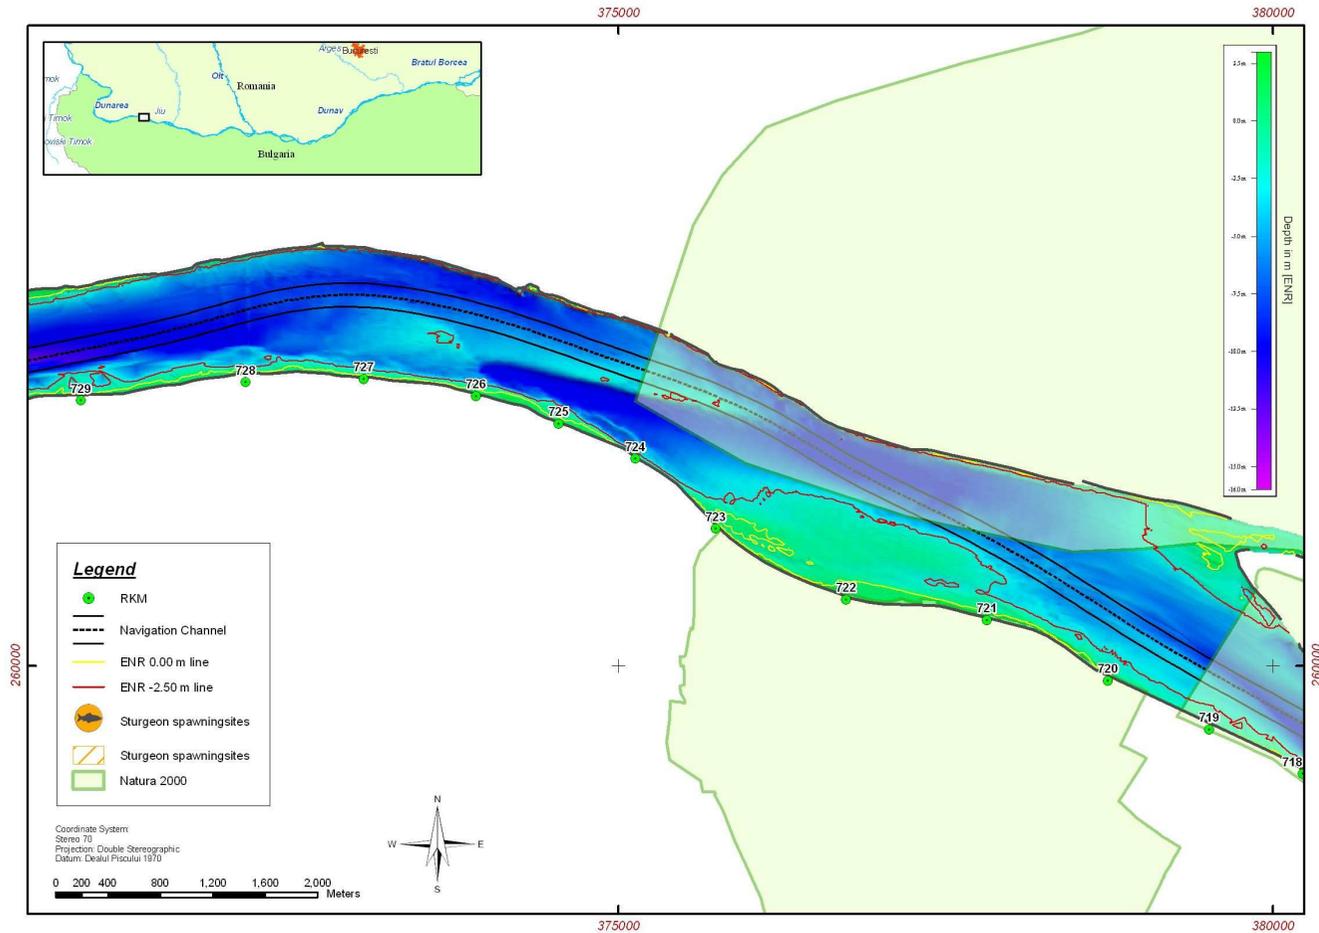
Figure 28: Archar Outlet - Alimanu Present Conditions

Last update of this sheet:	18/09/08
	Critical Sector Number:	8
Location:		
Archar Outlet - Alimanu		
Position:	Danube sector:	
rKm 728-721	Common Romanian – Bulgarian sector rKm 610 - 845.5	
Sector for detail measurements:		
Critical point reported by:		
<ul style="list-style-type: none"> • AFDJ Giurgiu 		
Description of the present situation:		
<p>Due to sediments in the middle of the riverbed, it is very difficult to bound the navigable channel.</p> <p>The navigable depth is less than 2.5 m at some periods of the year.</p> <p>The south side of the Tibar Island between rkm 719-718 has a shallow bathymetry causing the relocation of the navigation channel towards the Bulgarian bank of the river. There are robust and very long bank protection works at this location in Bulgarian territory.</p> <p>There are also active sand bars in the middle of the Danube between rkm 728-721 which made move the navigation channel from the right to the left bank. Regardless the morphological changes which require monitoring and relocation of the axis of the navigation channel, there are no difficulties for navigation.</p>

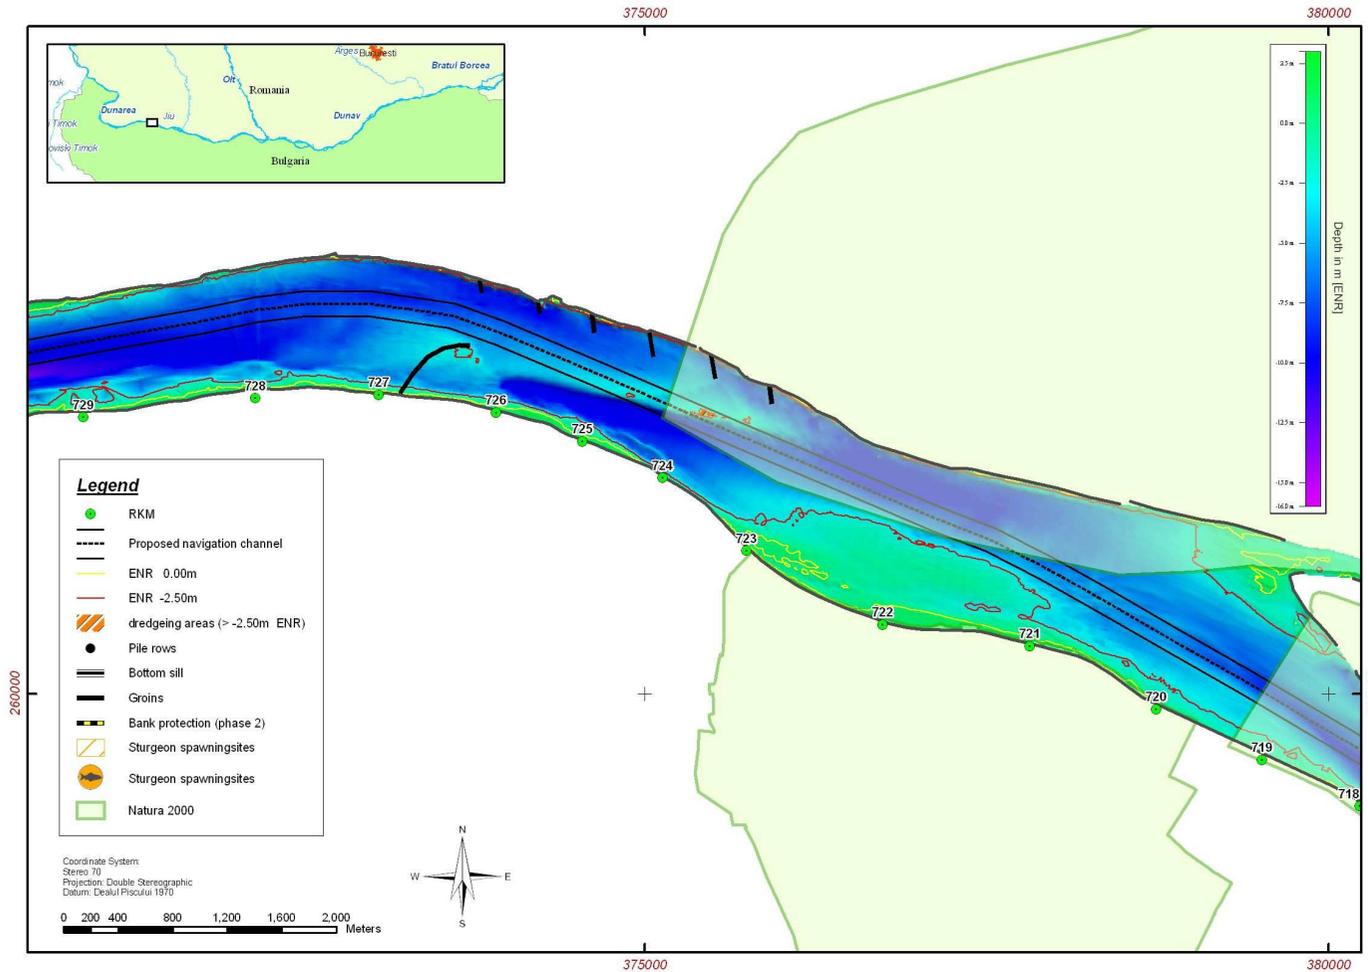
Figure 29: Archar Outlet - Alimanu Alternative Development Strategy

Proposed works:		
Harris (1999): None		
Alternative Development Strategies (Technum et al., 2008):		
<p>There are no significant changes in the axis of the navigation channel in this area. The structures proposed in TWS aim to concentrate the flow in the center of the river and reduce sediment deposition in the navigation channel. The area is morphologically active and the same measures of the TWS are proposed in the MS.</p> <p>Other important aspects for the EES and GES, and in general for construction:</p> <ul style="list-style-type: none"> • Phasing of dredging to take into account fish spawning/migration; • Phasing of large training works; • Keep impact on deep areas as low as possible; • Open guiding wall at river bank; • Less groins but with wing; • Useful application of dredged material. 		
Selected solutions JV Technum, Trapec, Tractebel, CNR, Safege (2008):

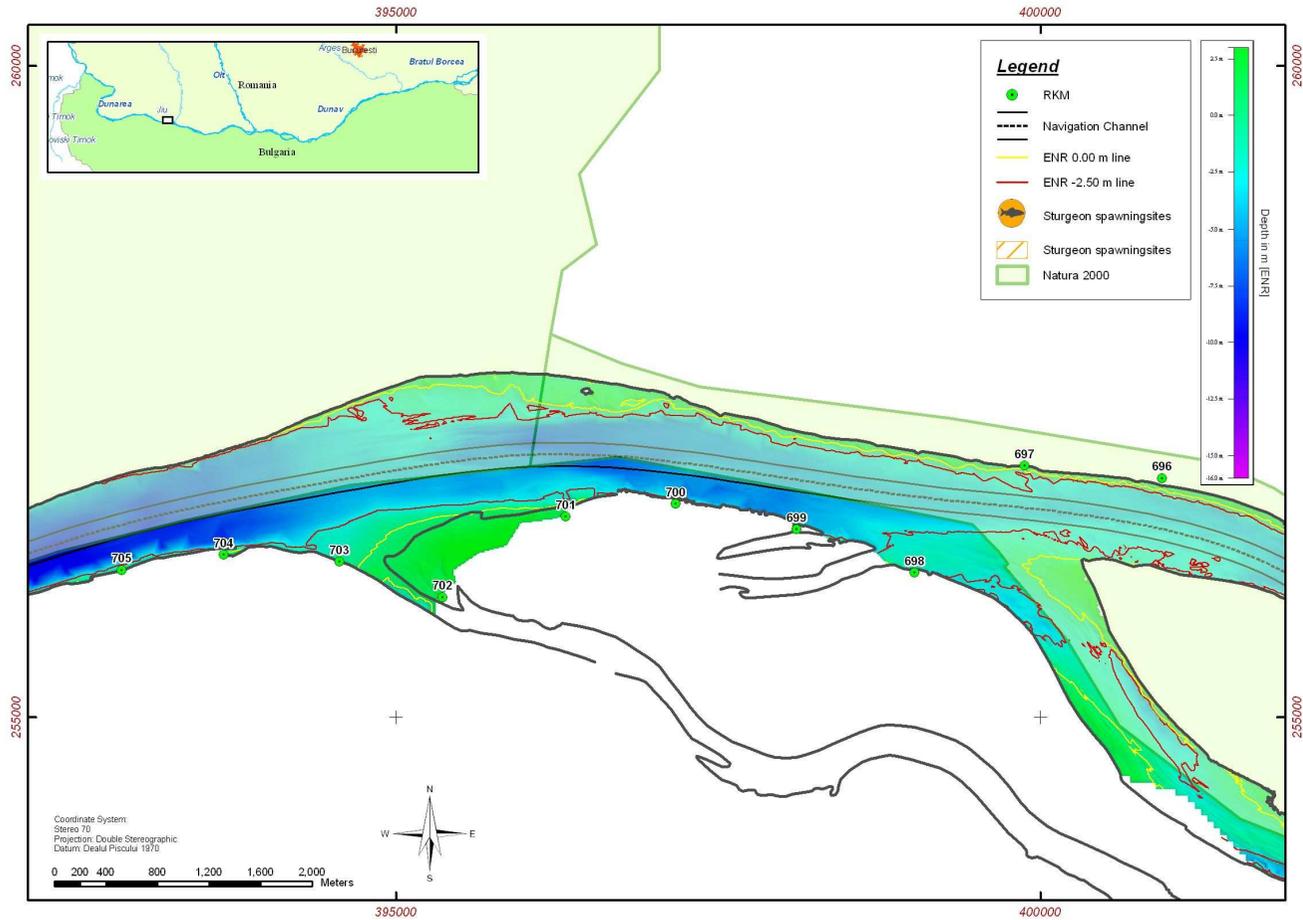
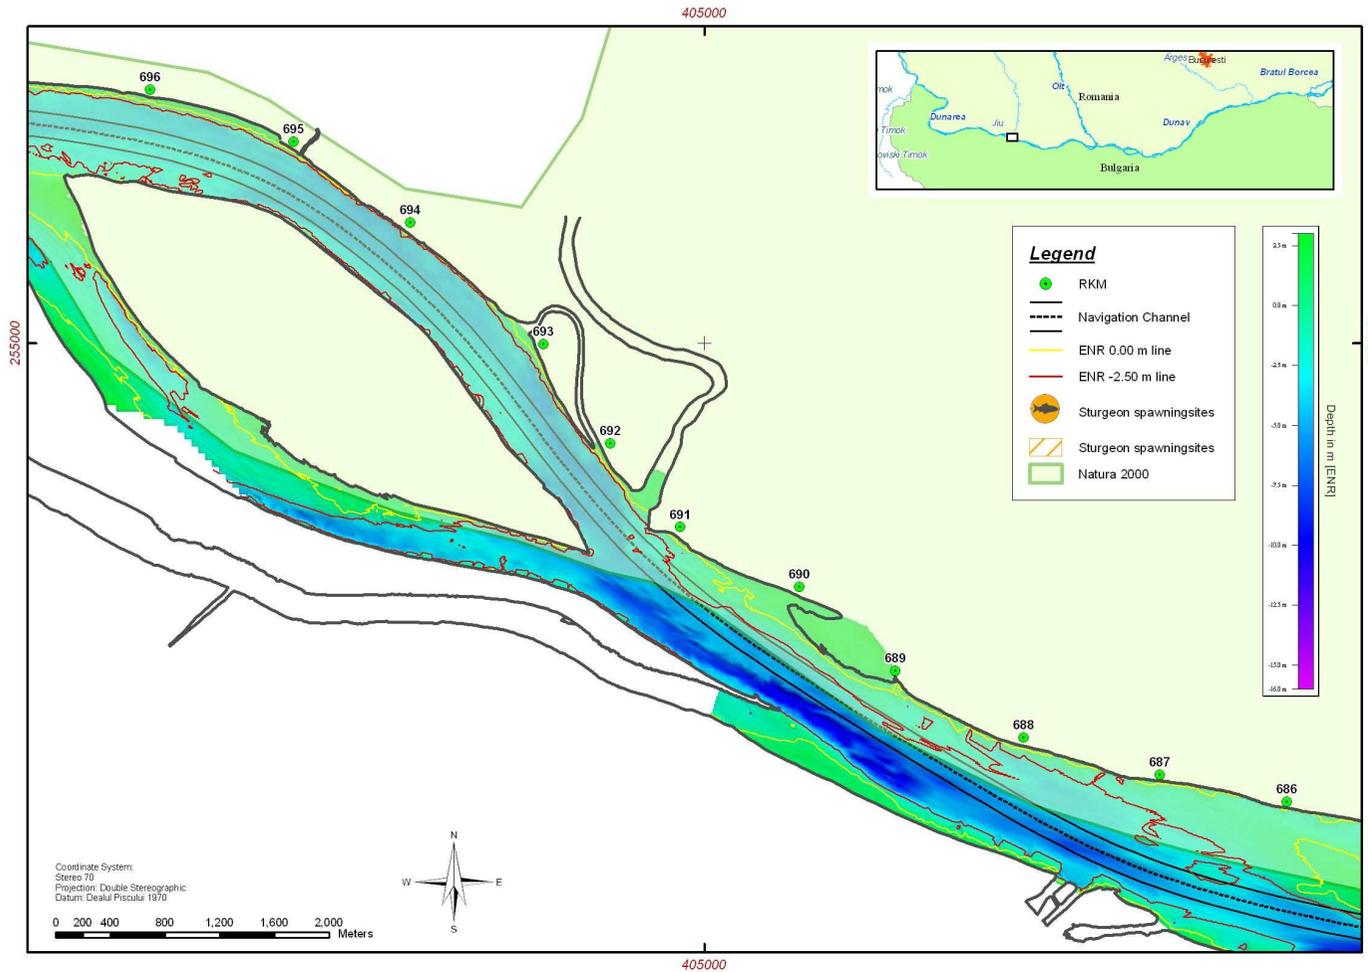
Figure 30: Kozlodui and Kapanita Islands Present Conditions A

Last update of this sheet:	18/09/08
	Critical Sector Number:	9
Location:		
Kozlodui and Kopanita Islands		
Position:	Danube sector:	
rkm 705+300-696 and rkm696+700-687+400	Common Romanian – Bulgarian sector rKm 610 - 845.5	
Sector for detail measurements:		
Critical point reported by:		
<ul style="list-style-type: none"> • AFDJ Galati 		
Description of the present situation:		
<p>Outlet of Jiu River. There are numerous islands and river bifurcations at this location. There are also sand bars at rkm 702 on Romanian side. There are no difficulties for navigation at present.</p>		
Proposed works:		
Harris (1999): None		
Alternative Development Strategies (Technum et al., 2008):		
<p>Regardless the numerous river branches, the last bathymetry of 2008 confirms no difficulties for navigation in the sector. Furthermore, a slight realignment of the navigation channel avoids the necessity of dredging. No measures are proposed in this area.</p>
