TECHNICAL MEMOIR FOR ENVIRONMENT PERMIT ISSUANCE

The ISPA EUROPEAID/122137/D/SV/RO - "Technical assistance for improvement of conditions for navigation on the Common Romanian - Bulgarian Danube sector and further studies".

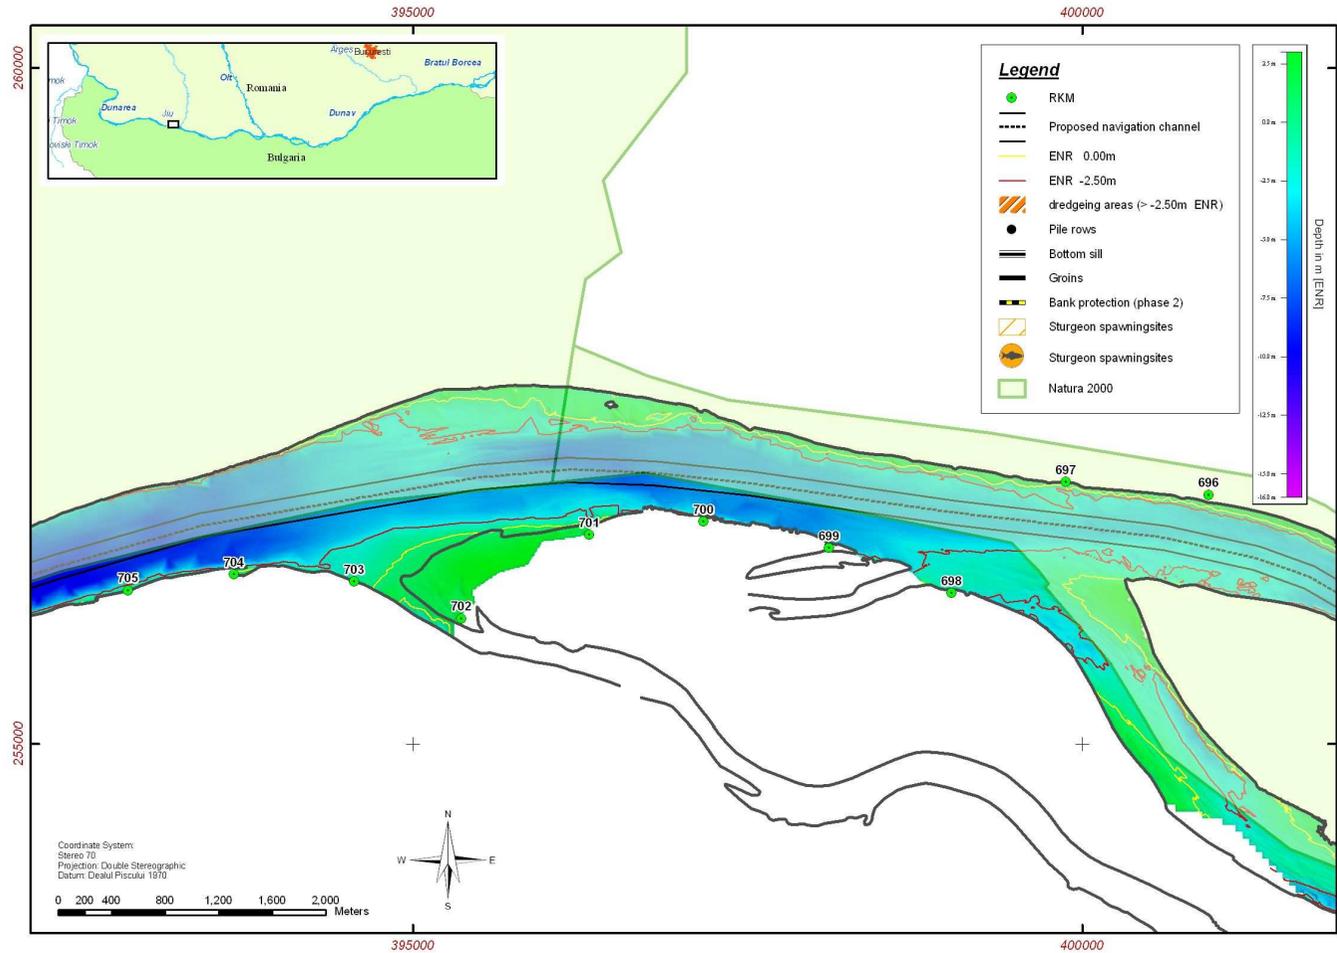
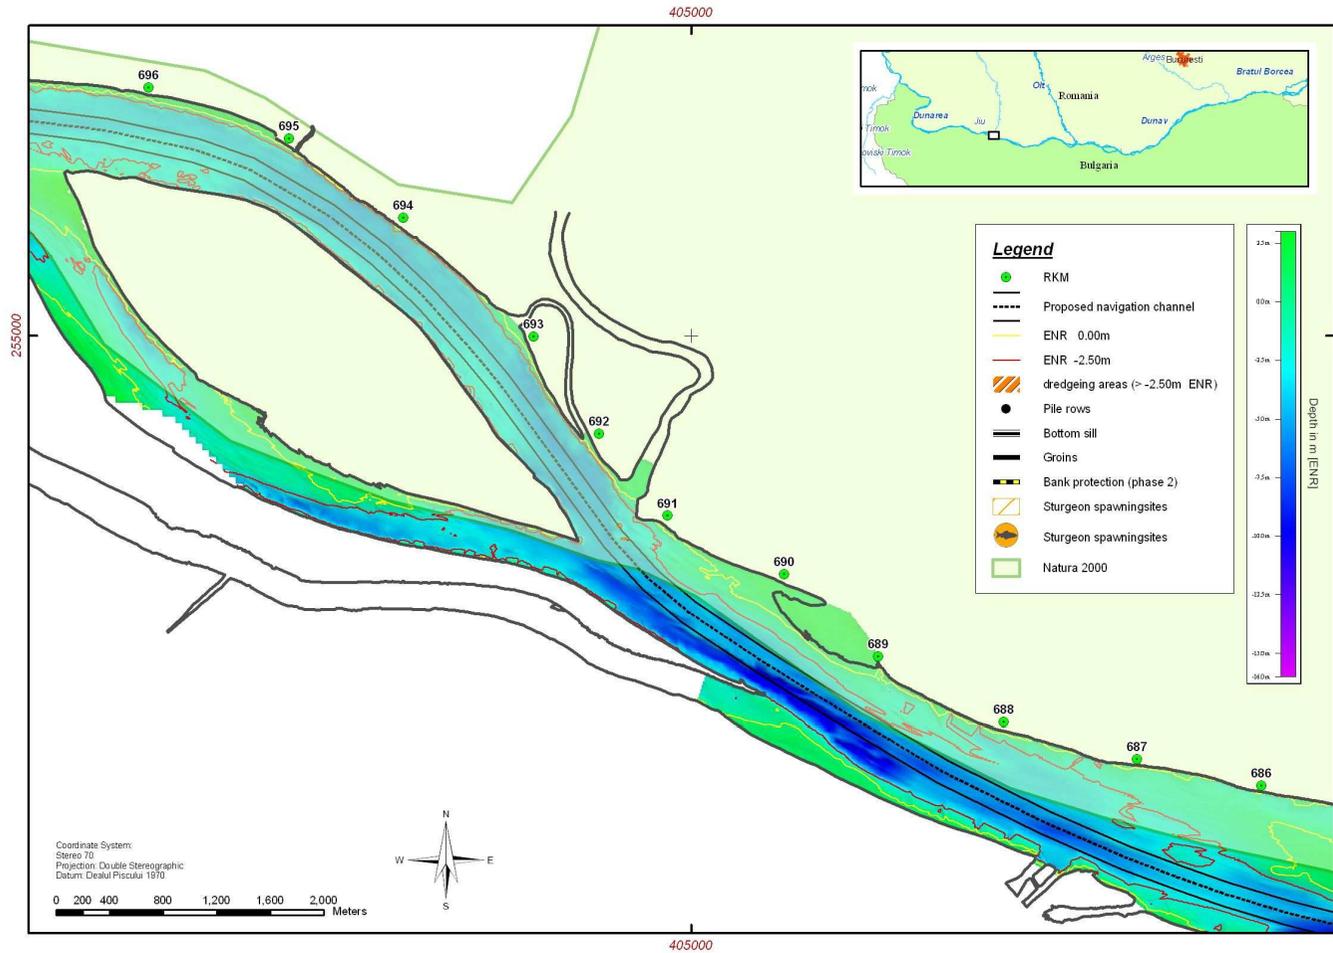
Figure 31: Kozlodui and Kopanita Islands Alternative Development Strategy A

Last update of this sheet:	18/09/08
	Critical Sector Number:	9
Location:		
Kozlodui and Kopanita Islands		
Position:	Danube sector:	
rkm 705+300-696 and rkm696+700-687+400	Common Romanian – Bulgarian sector rKm 610 - 845.5	
Sector for detail measurements:		
Critical point reported by:		
<ul style="list-style-type: none"> • AFDJ Galati 		
Description of the present situation:		
<p>Outlet of Jiu River. There are numerous islands and river bifurcations at this location. There are also sand bars at rkm 702 on Romanian side. There are no difficulties for navigation at present.</p>		
Proposed works:		
Harris (1999): None		
Alternative Development Strategies (Technum et al., 2008):		
<p>Regardless the numerous river branches, the last bathymetry of 2008 confirms no difficulties for navigation in the sector. Furthermore, a slight realignment of the navigation channel avoids the necessity of dredging. No measures are proposed in this area.</p>

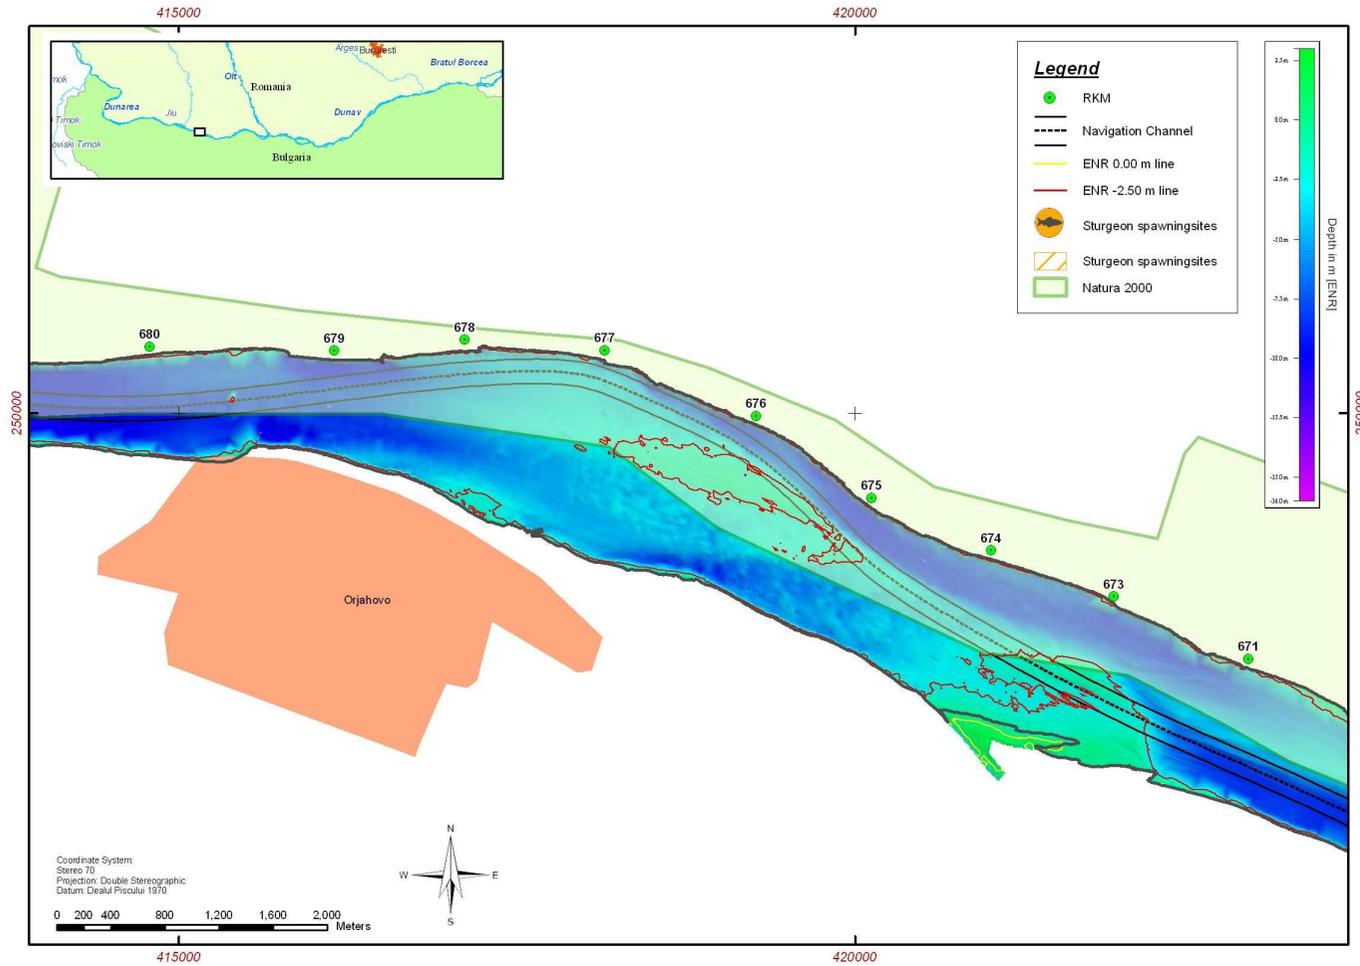
Figure 34: Carabulea: Bechet / Oriahovo Present Conditions

- Phasing of dredging to take into account fish spawning/migration;
- Phasing of large training works;
- Keep impact on deep areas as low as possible;
- Open guiding wall at river bank;
- Useful application of dredged material;
- Reduce length of bank protection.

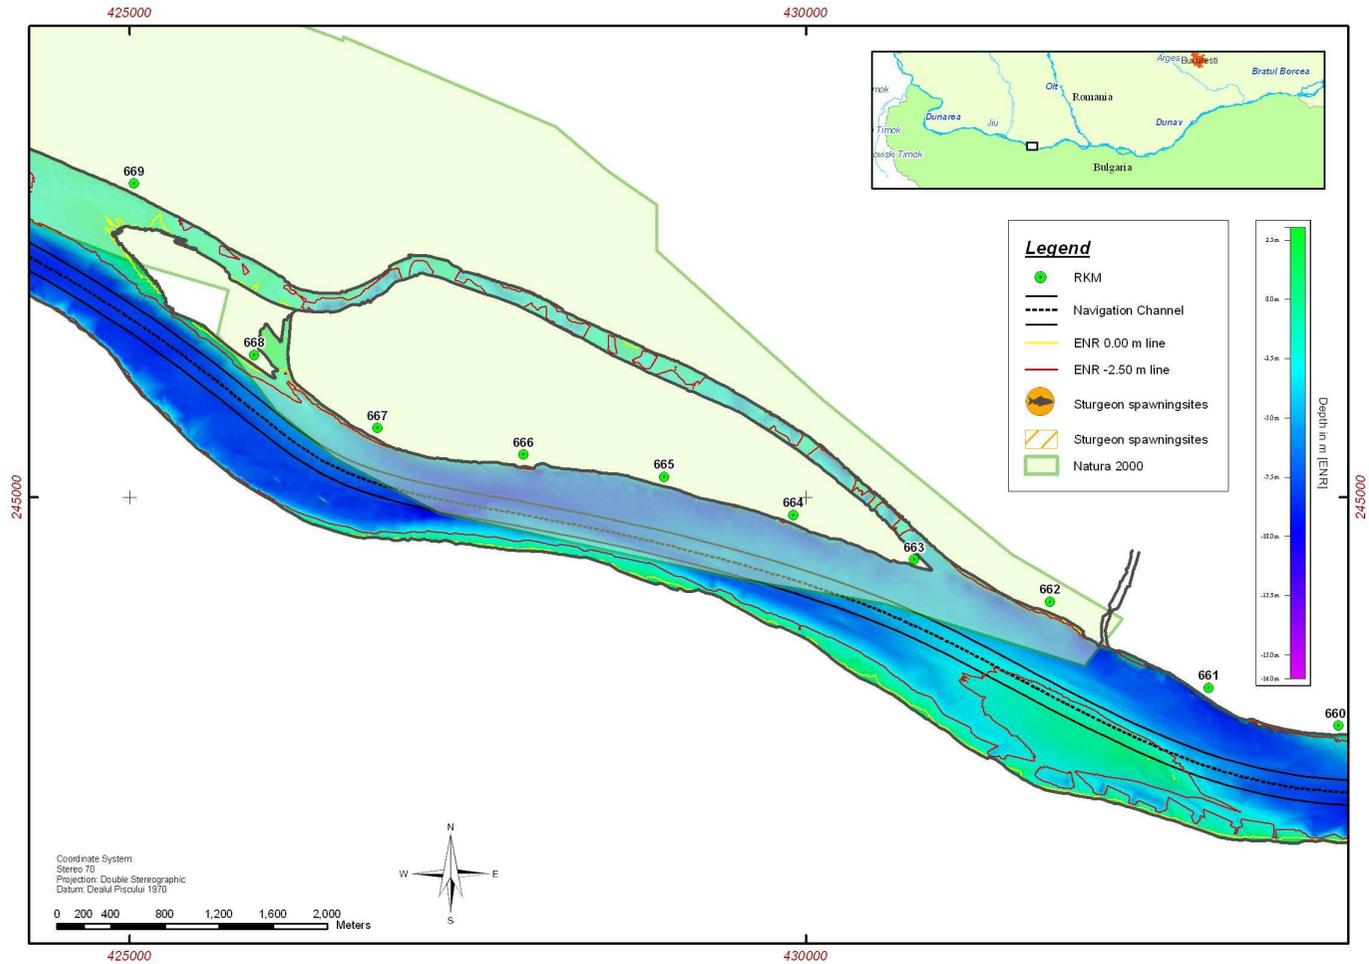
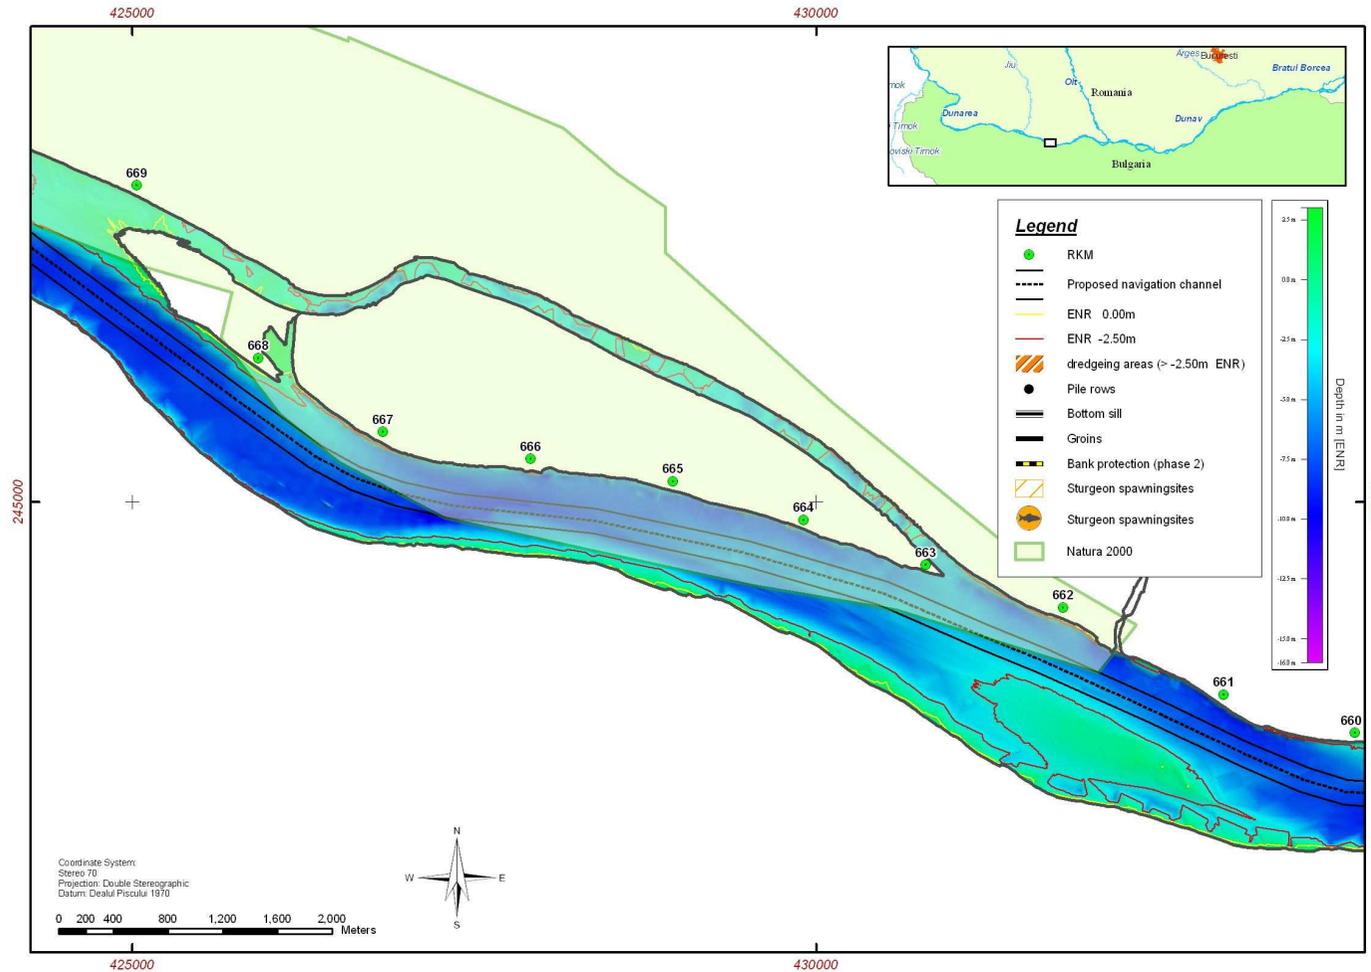
Figure 36: Ostrov Present Conditions

Last update of this sheet:	18/09/08
	Critical Sector Number:	11
Location:		
Ostrov		
Position:	Danube sector:	
rKm 668-666	Common Romanian – Bulgarian sector rKm 610 - 845.5	
Sector for detail measurements:		
Critical point reported by:		
<ul style="list-style-type: none"> • Navigation Directorate 		
Description of the present situation:		
Inactive critical point. There is a shipwreck at rkm 667.		
Proposed works:		
Harris (1999): Groins		
Alternative Development Strategies (Technum et al., 2008):		
The realignment of the navigation channel avoids the necessity of dredging. No measures are proposed in this area.		
Selected solutions JV Technum, Trapec, Tractebel, CNR, Safege (2008):

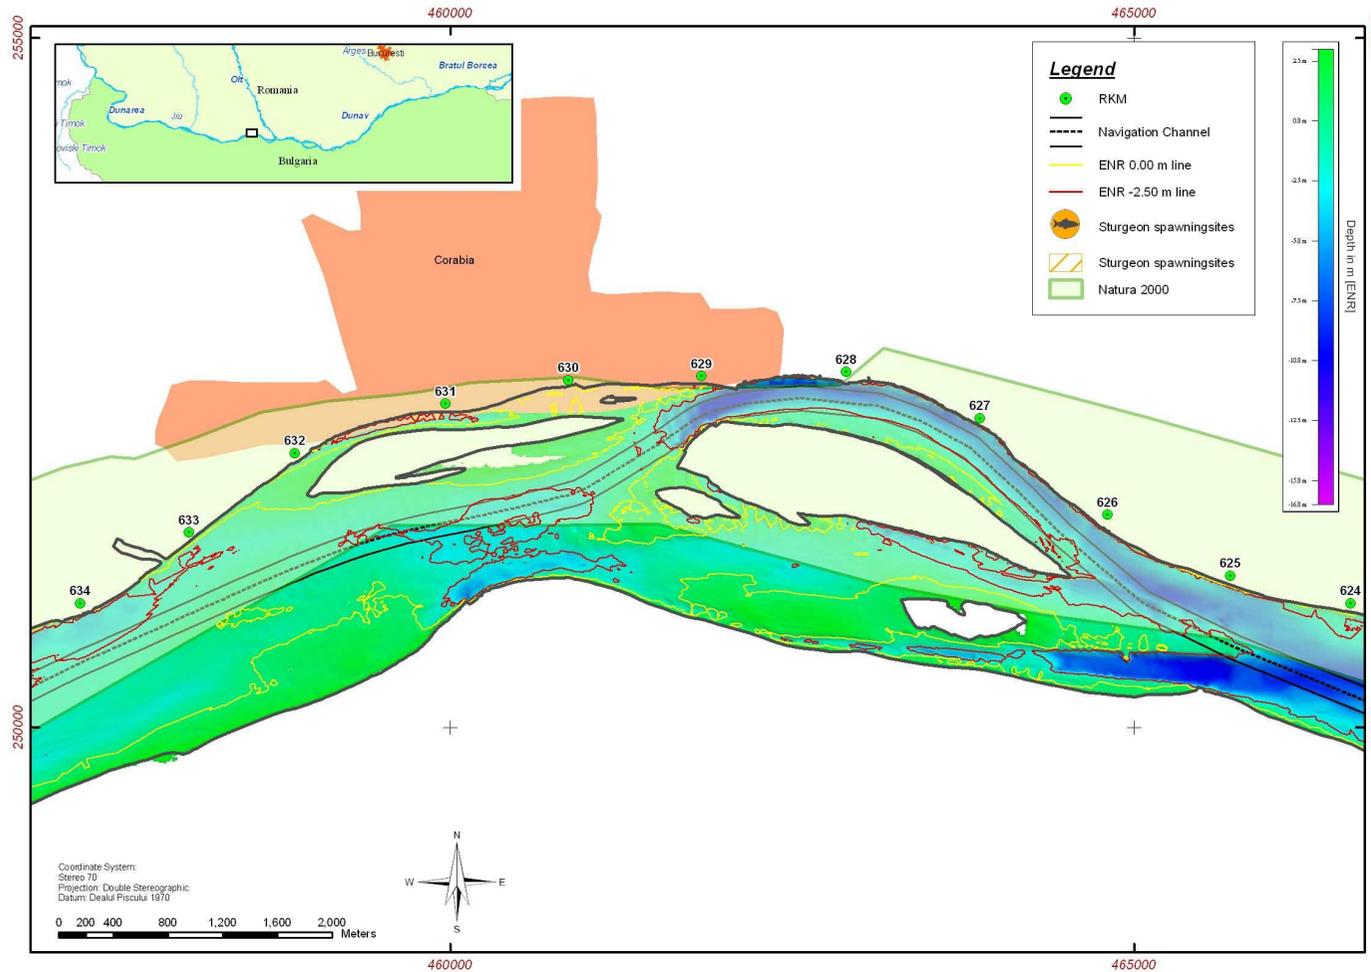
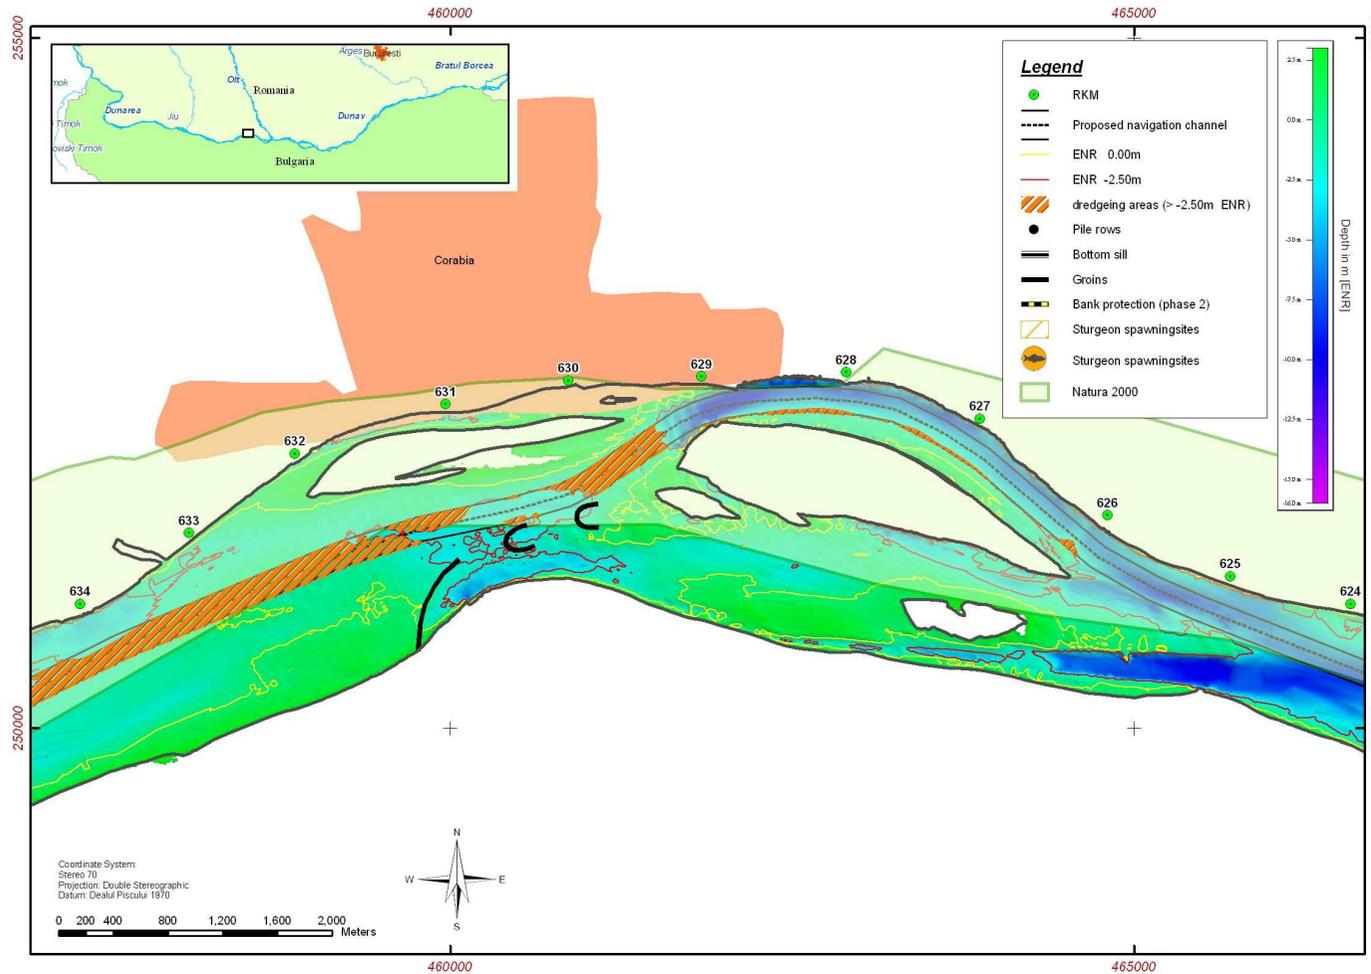
Figure 38: Corabia – Baloiu branch (Bulgarian) Present Conditions

- Phasing of dredging to take into account fish spawning/migration;
- Phasing of large training works;
- Keep impact on deep areas as low as possible;
- Open guiding wall at river bank;
- Useful application of dredged material;
- Reduce length of bank protection.

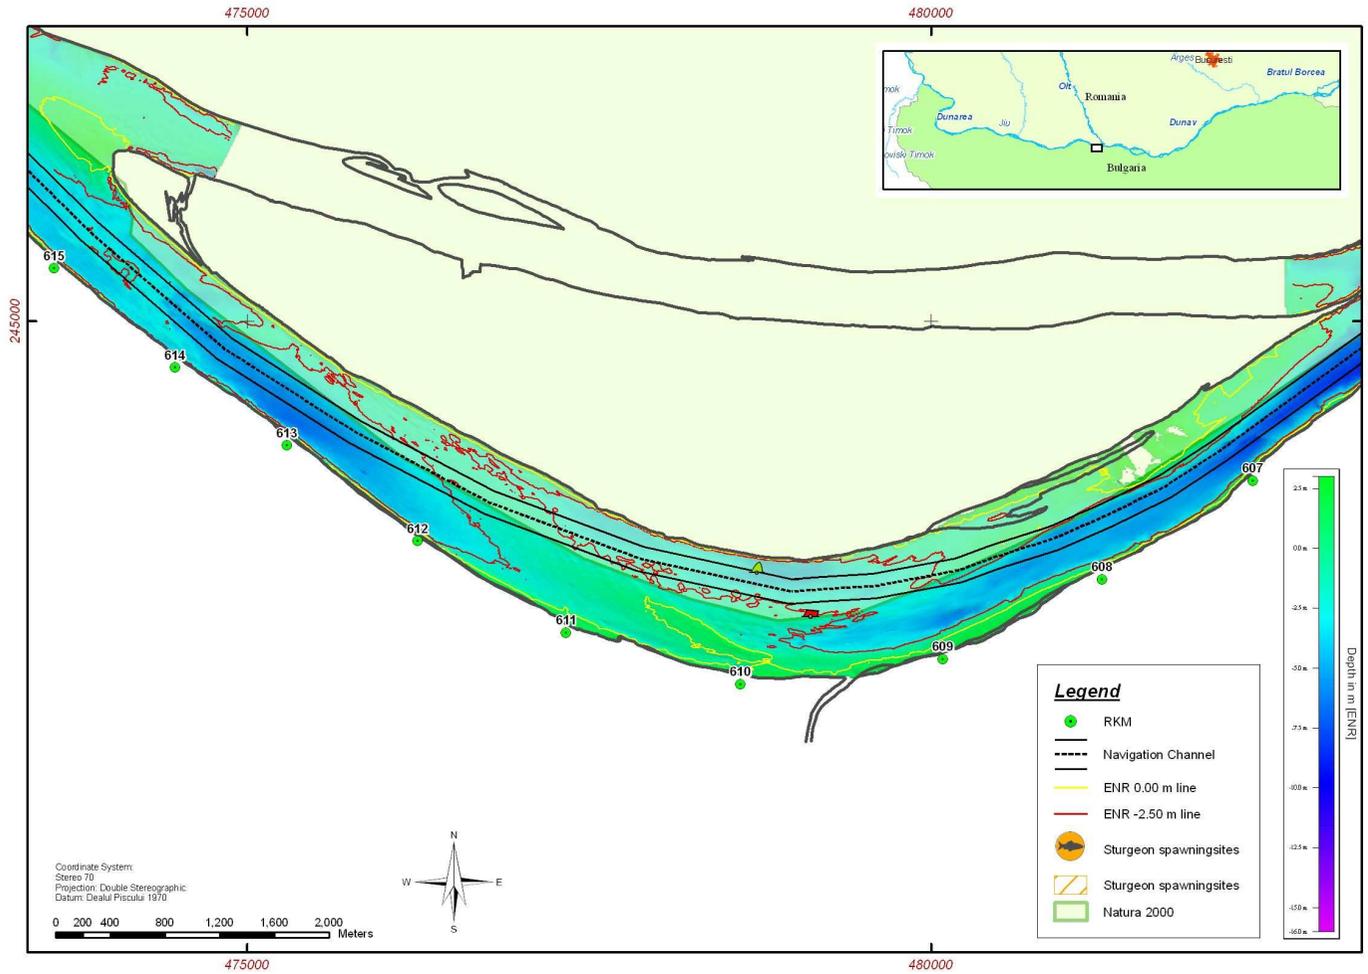
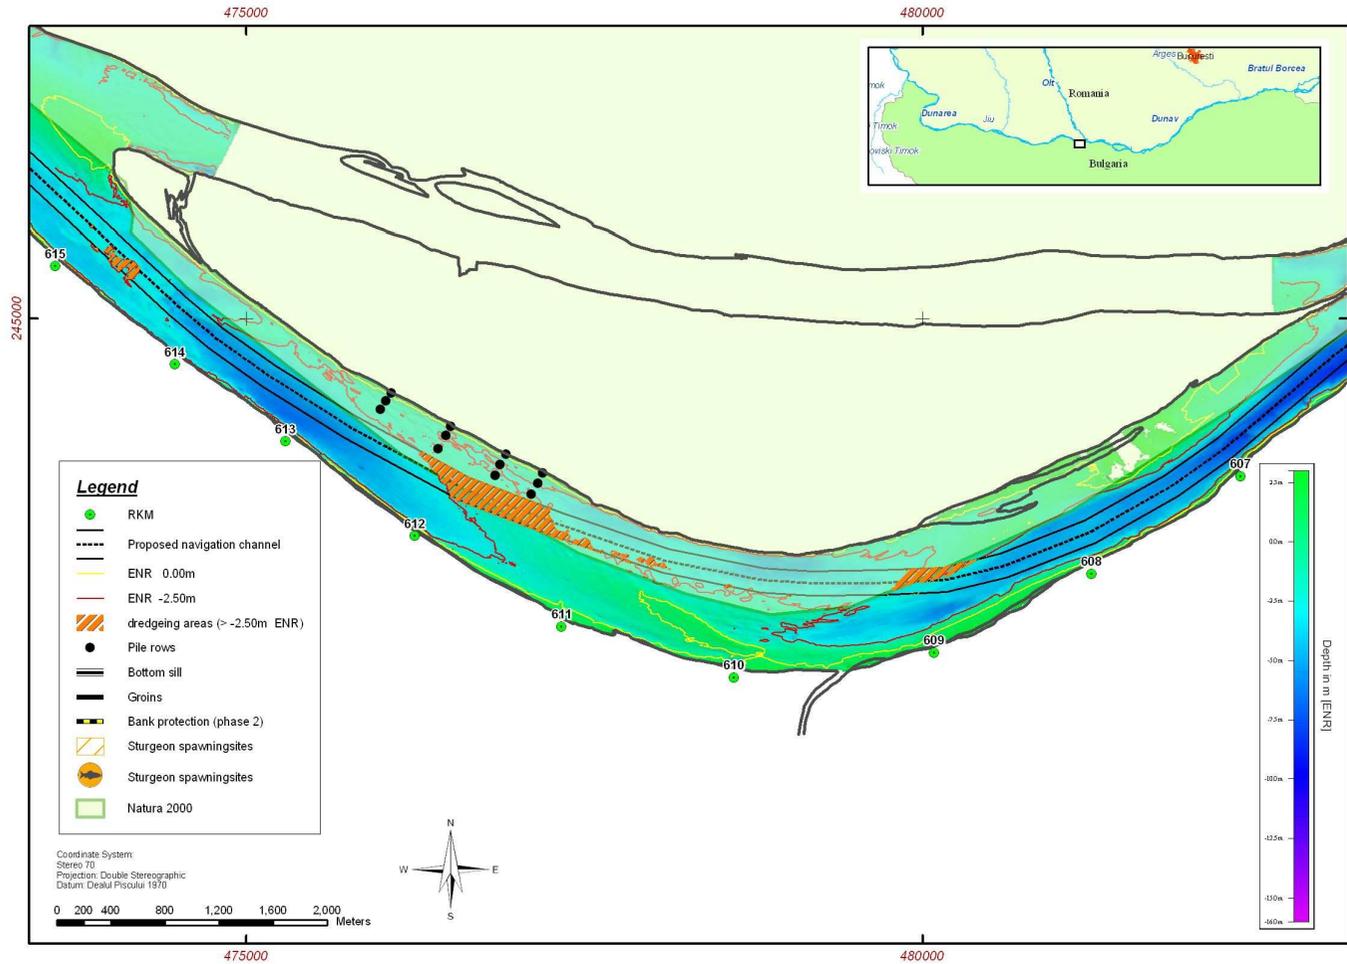
Figure 40: Kalnovats Present Conditions

- Keep impact on deep areas as low as possible;
- Useful application of dredged material;

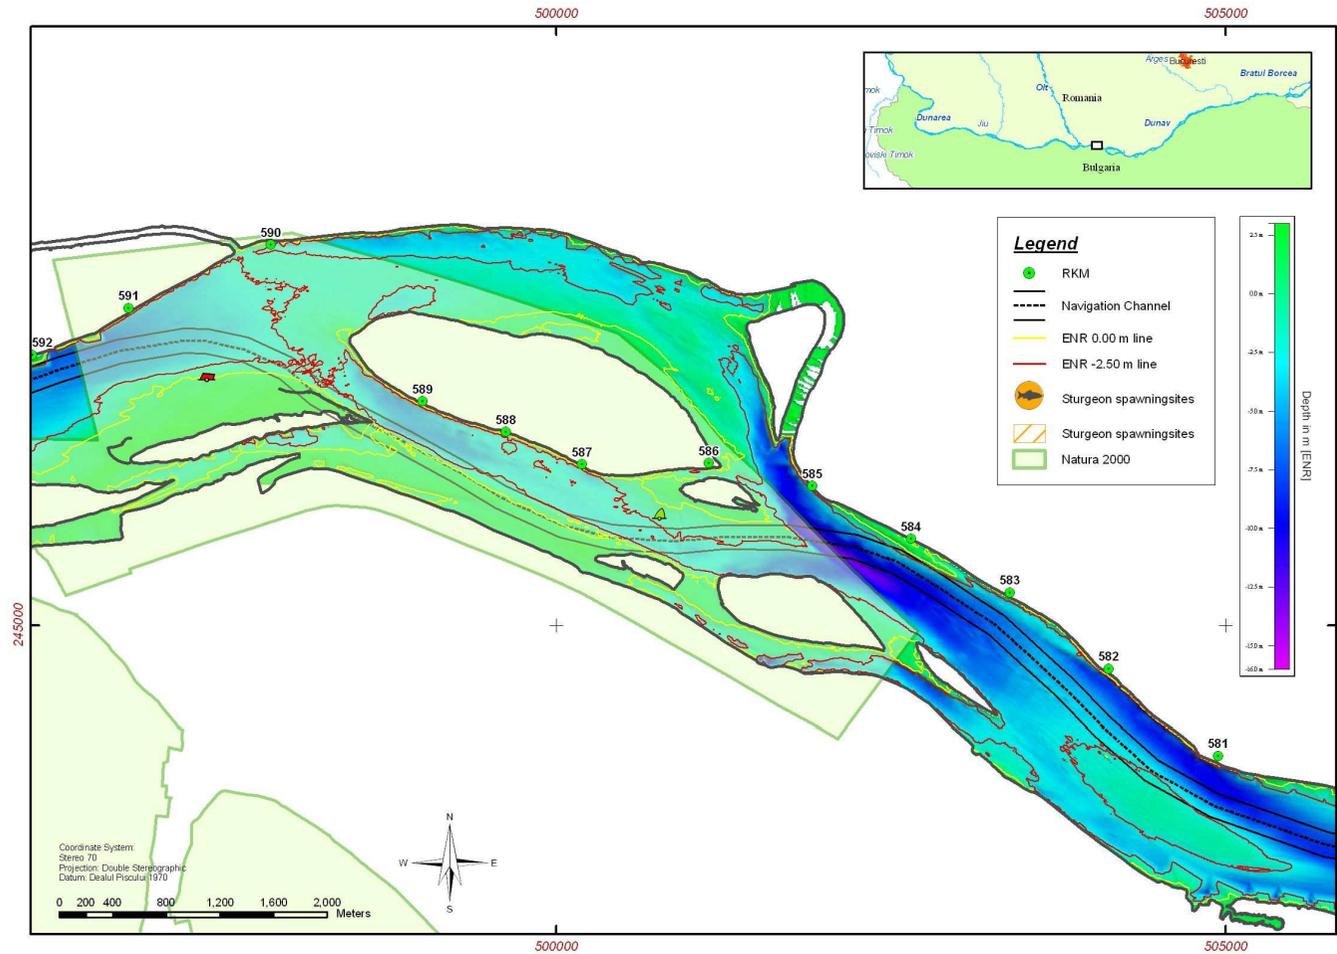
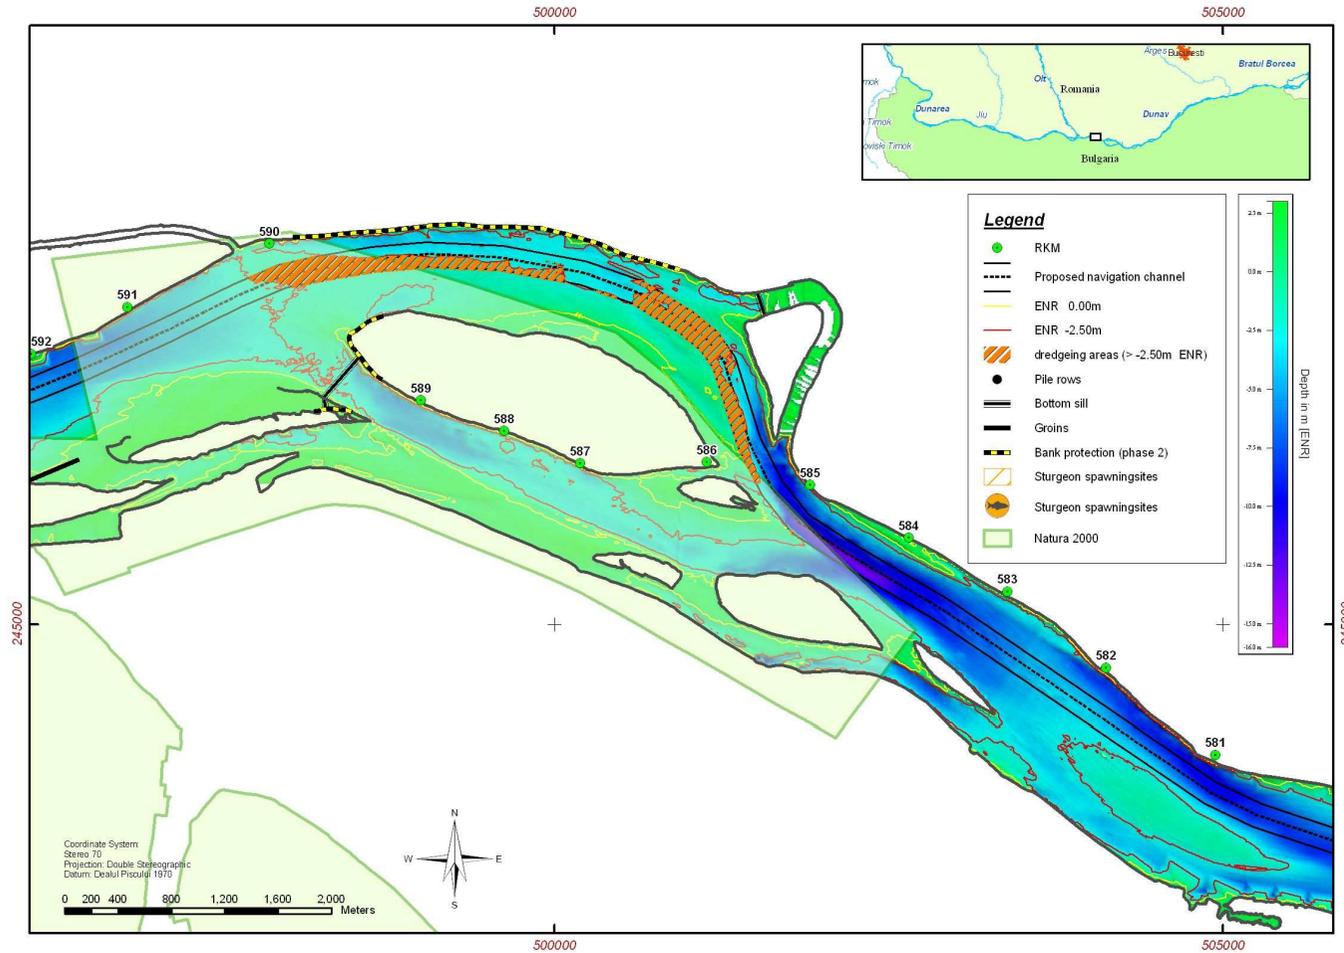
Figure 42: Lakat/ Paletz Island Present Conditions

- Phasing of dredging to take into account fish spawning/migration;
- Phasing of large training works;
- Keep impact on deep areas as low as possible;
- Useful application of dredged material;
- Reduce length of bank protection;
- No bottom sill at small branch (rkm586).

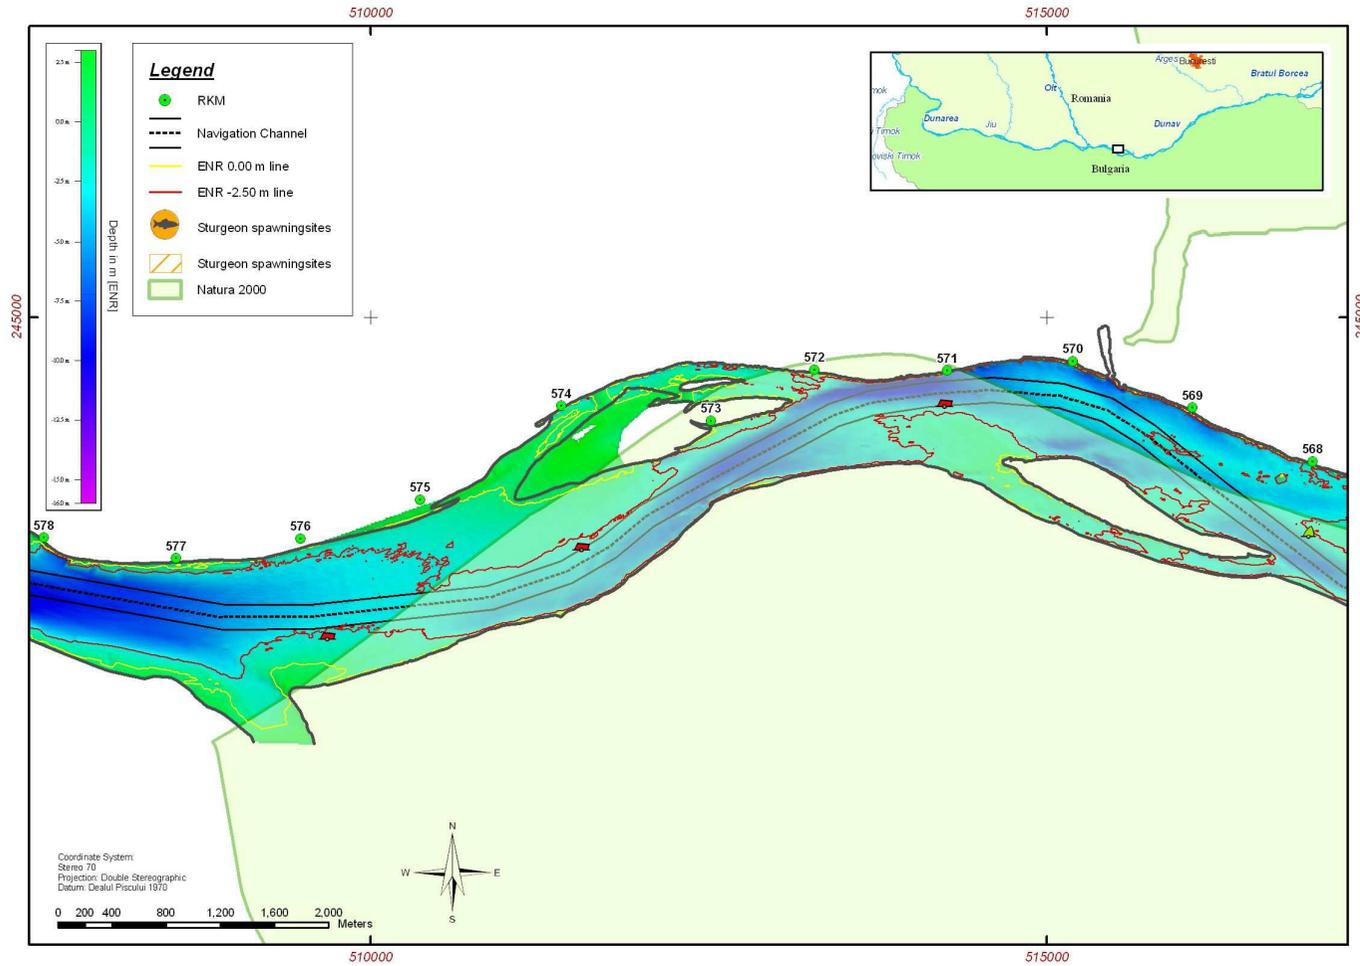
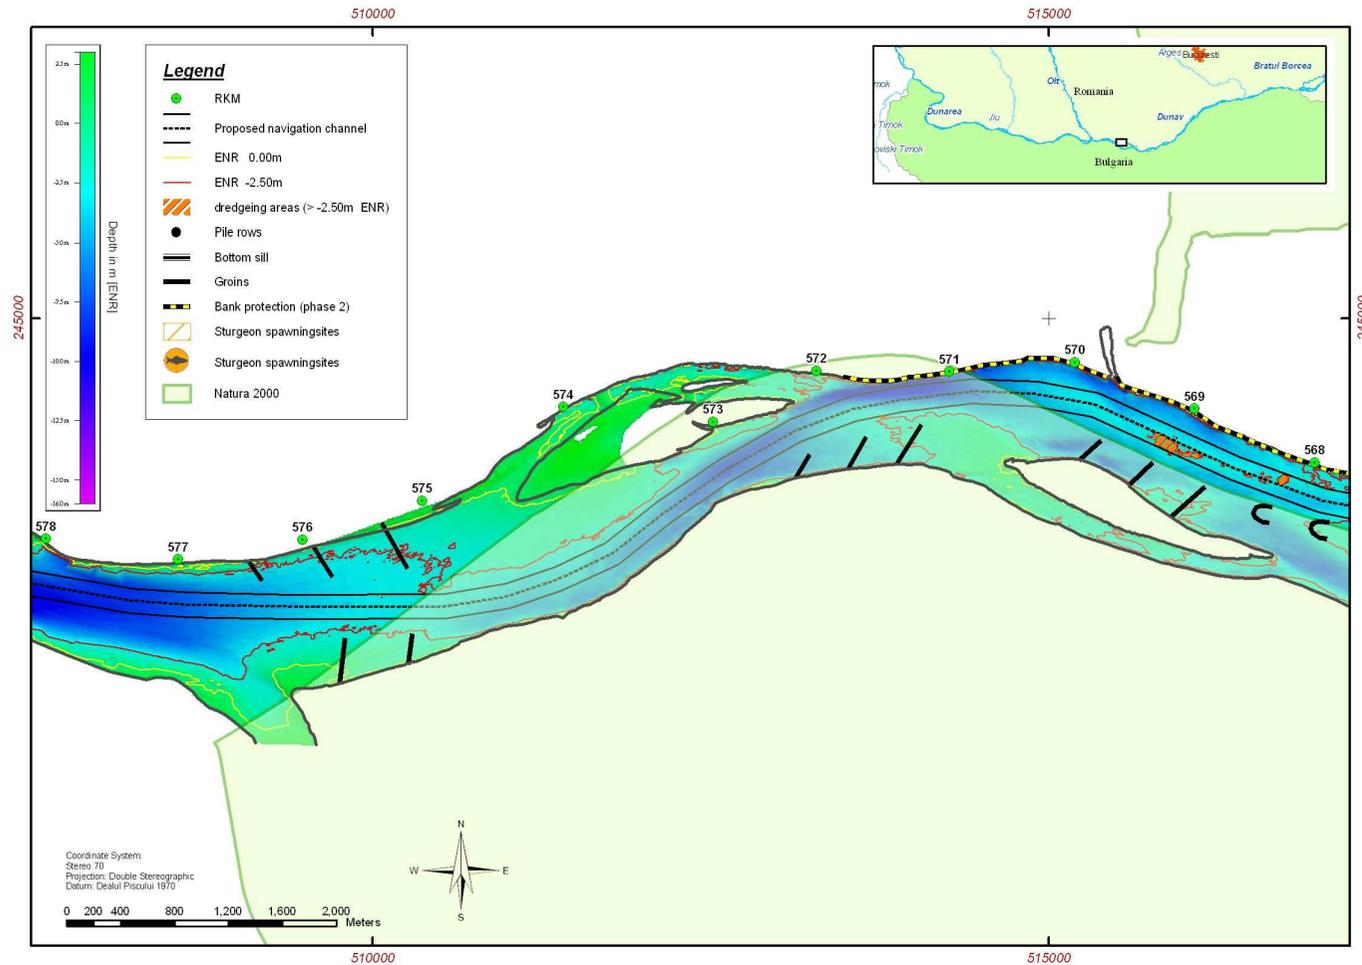
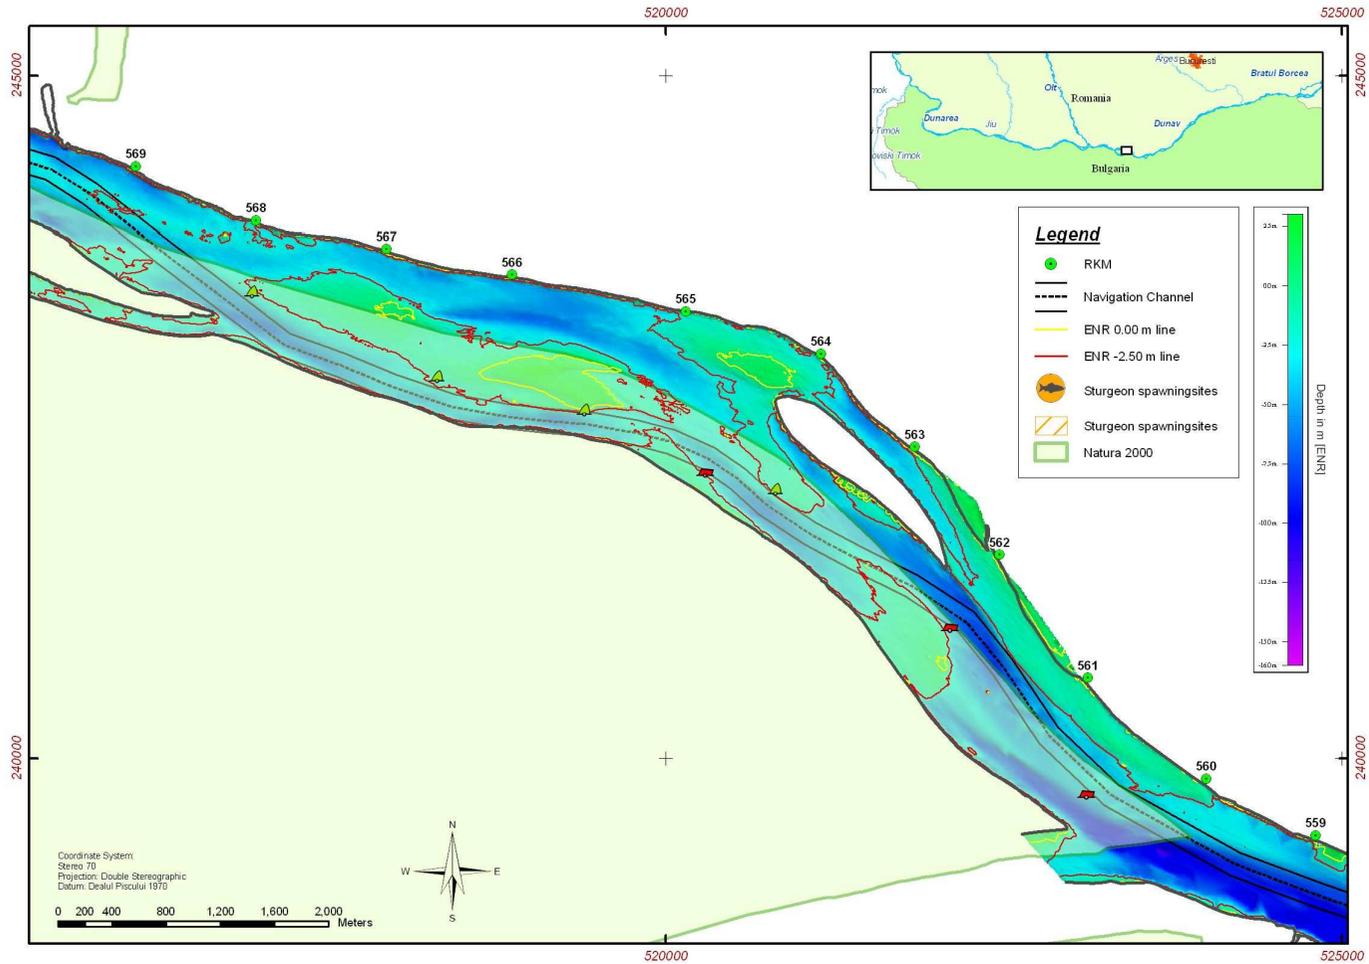
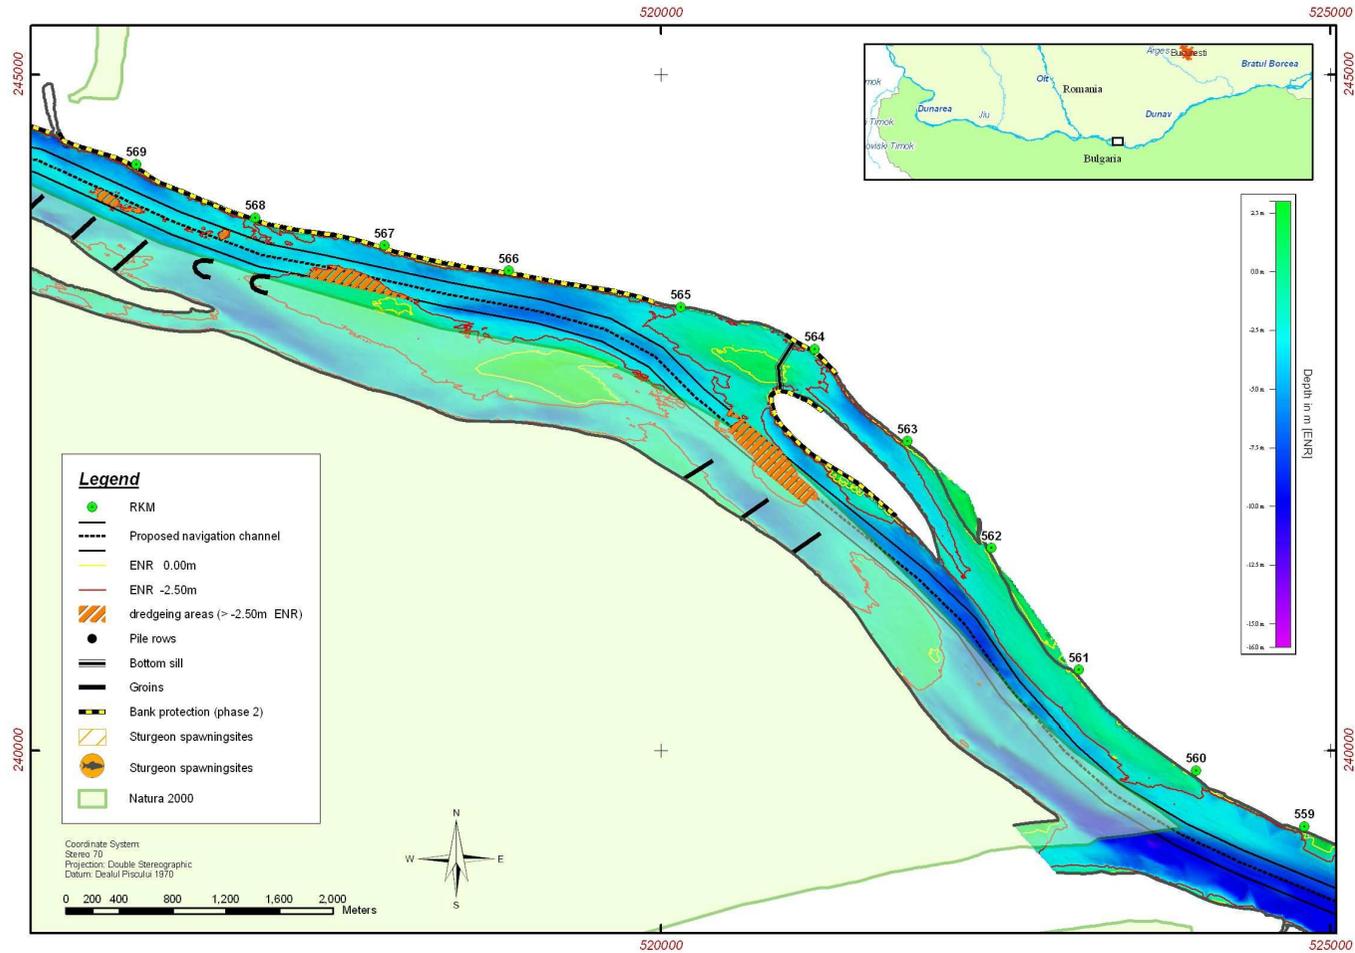
Figure 44: Belene Island upstream Present Conditions A

- Phasing of dredging to take into account fish spawning/migration;
- Phasing of large training works;
- Keep impact on deep areas as low as possible;
- Useful application of dredged material;
- Two open bottom sills instead of one;
- Reduce length of bank protection;

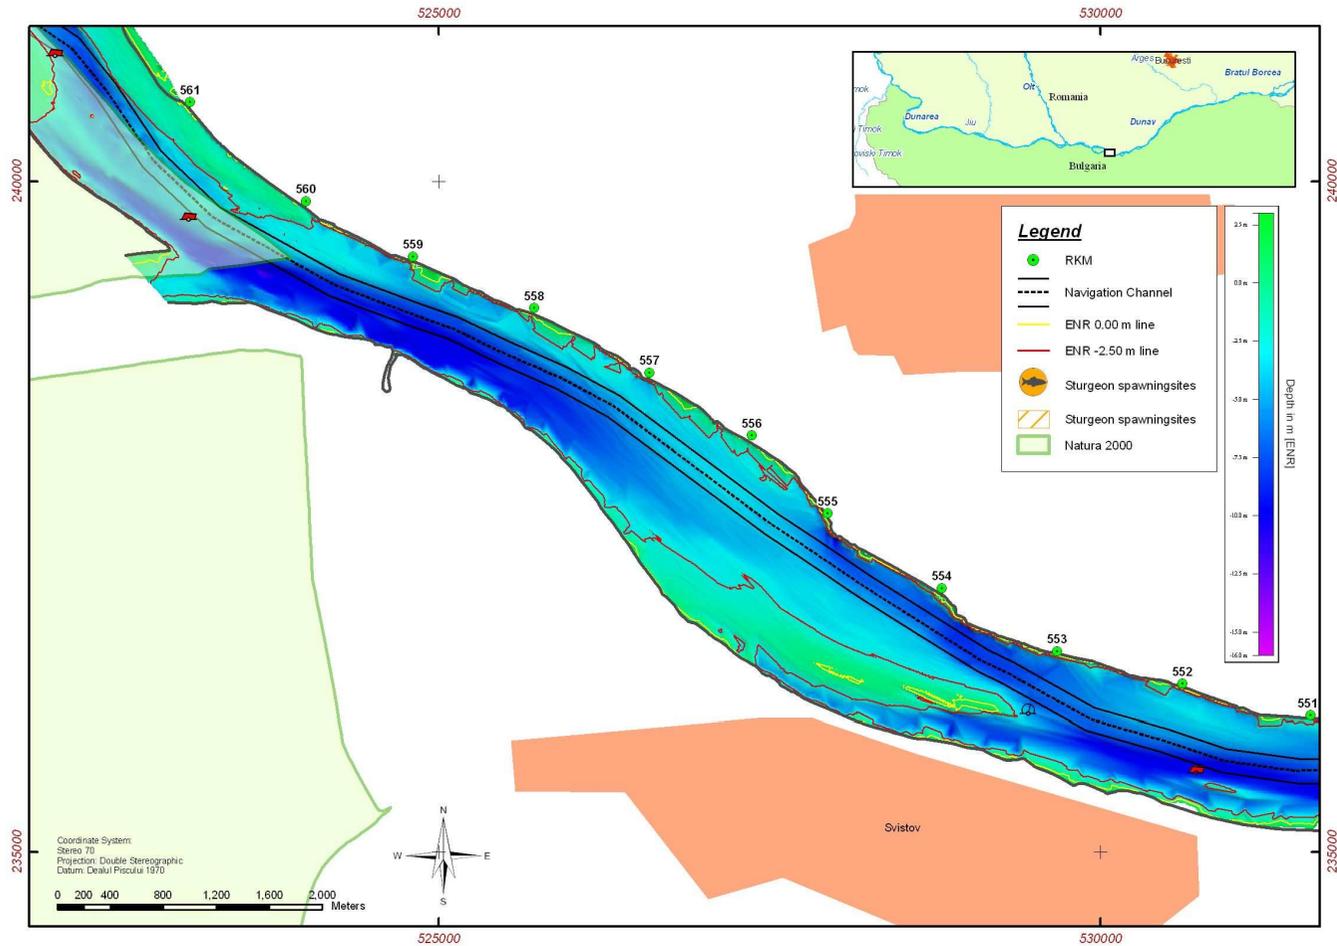
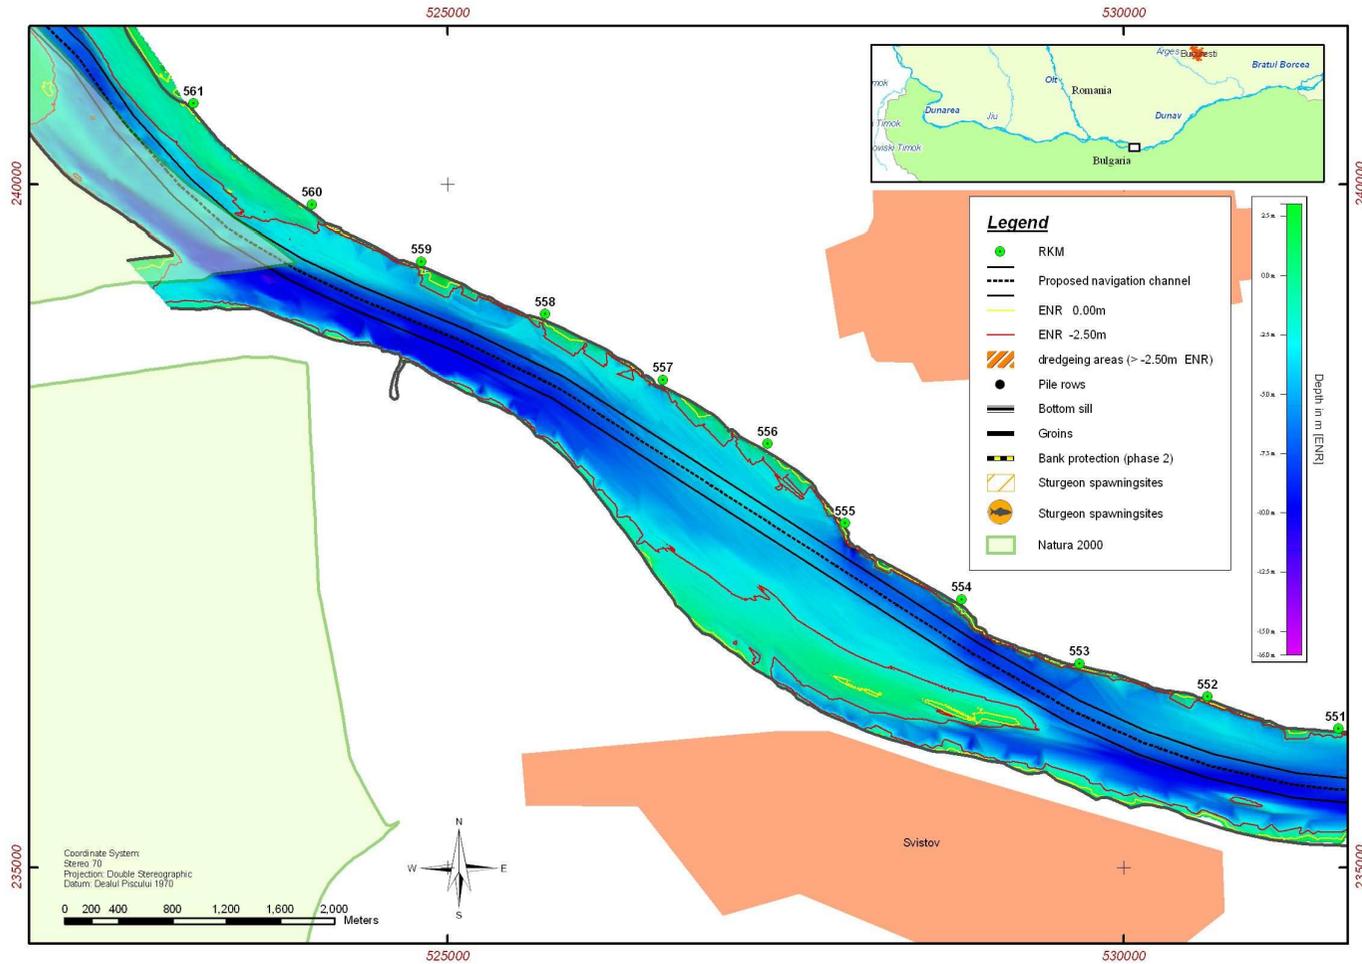
Figure 48: Zimnicea/Svistov Present Conditions

Last update of this sheet:	18/09/08
	Critical Sector Number:	16
Location:		
Zimnicea/Svistov		
Position:	Danube sector:	
rKm 557 - 553	Common Romanian – Bulgarian sector rKm 610 - 845.5	
Sector for detail measurements:		
Critical point reported by:		
<ul style="list-style-type: none"> • AFDJ Giurgiu 		
Description of the present situation:		
The navigation channel varies at rkm 555 at both sides of the existent sand bar. Not really a problem for navigation.
