TECHNICAL MEMOIR FOR ENVIRONMENT PERMIT ISSUANCE

The ISPA EUROPEAID/122137/D/SV/RO - "Technical assistance for improvement of conditions for navigation on the Common Romanian - Bulgarian Danube sector and further studies".

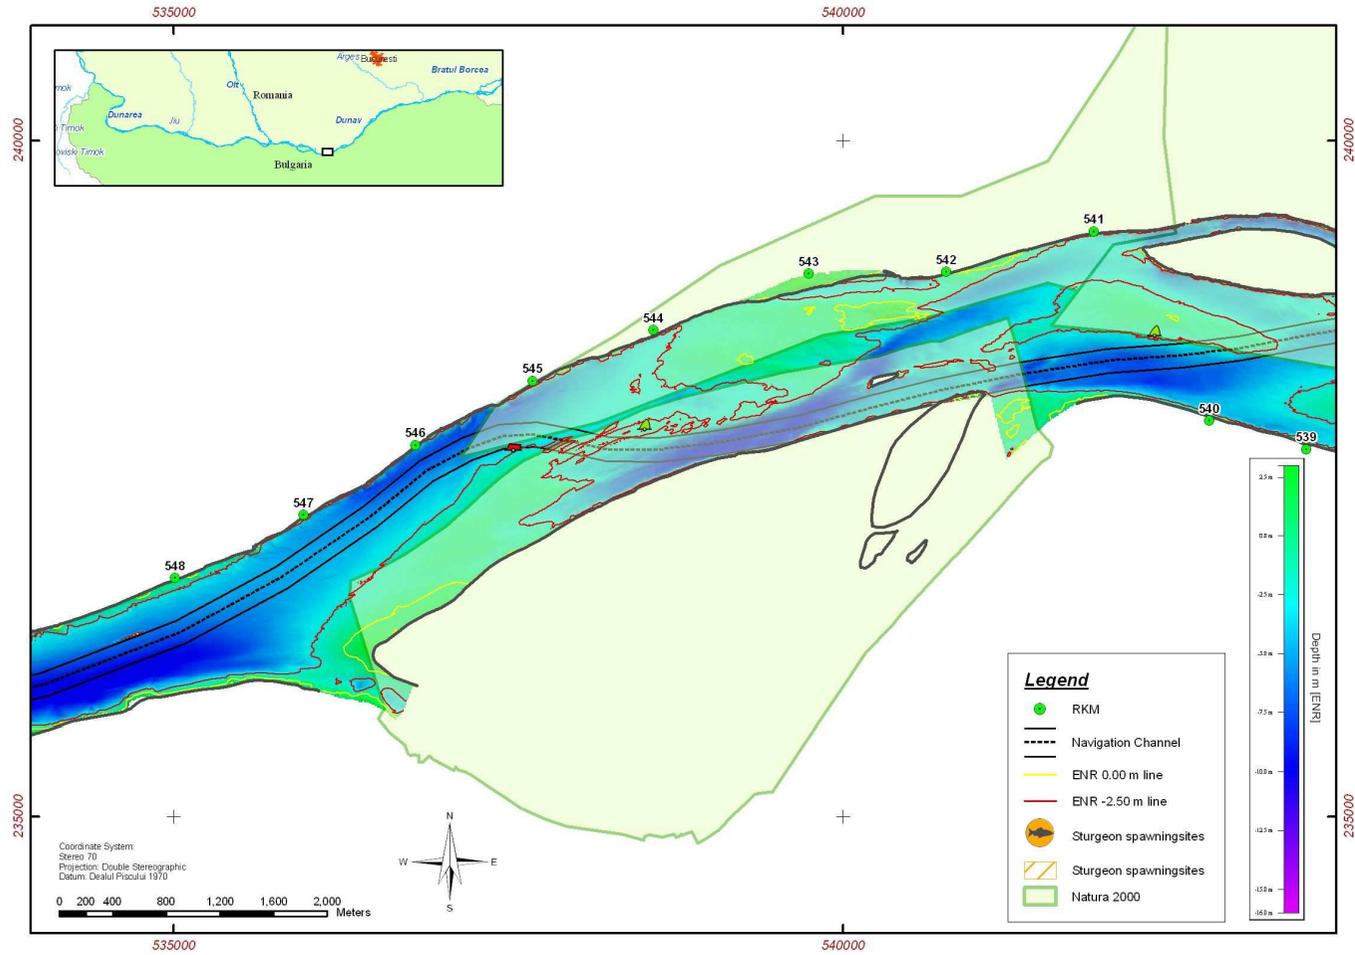
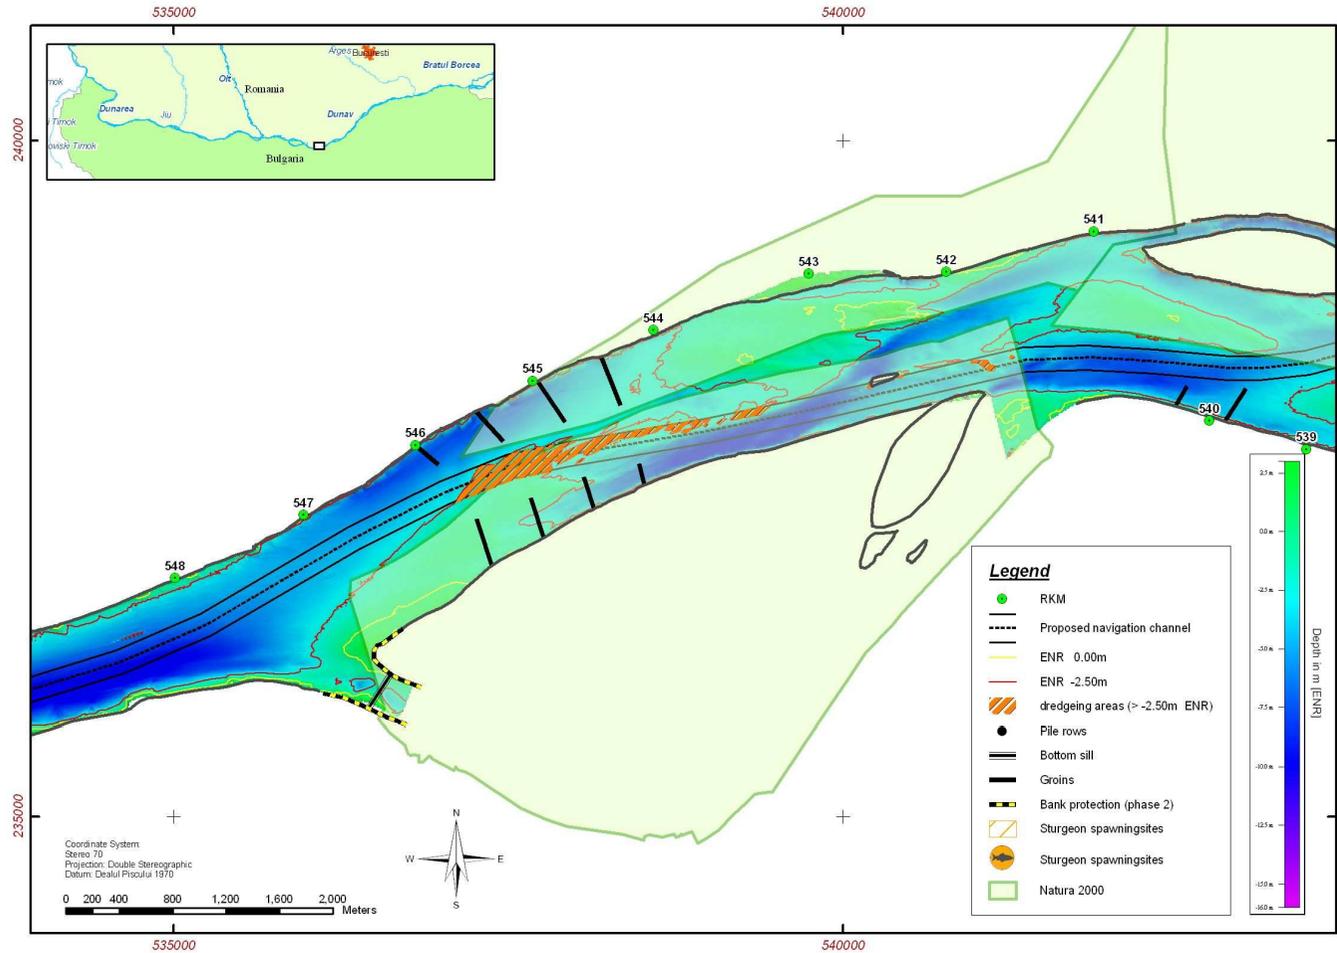
Figure 50: Vardim Island Present Conditions

- Phasing of dredging to take into account fish spawning/migration;
- Phasing of large training works;
- Keep impact on deep areas as low as possible;
- Useful application of dredged material;
- Less groins but with wing;
- Open groins at river bank;
- Two partial bottom sills instead of one;
- Reduce length of bank protection;

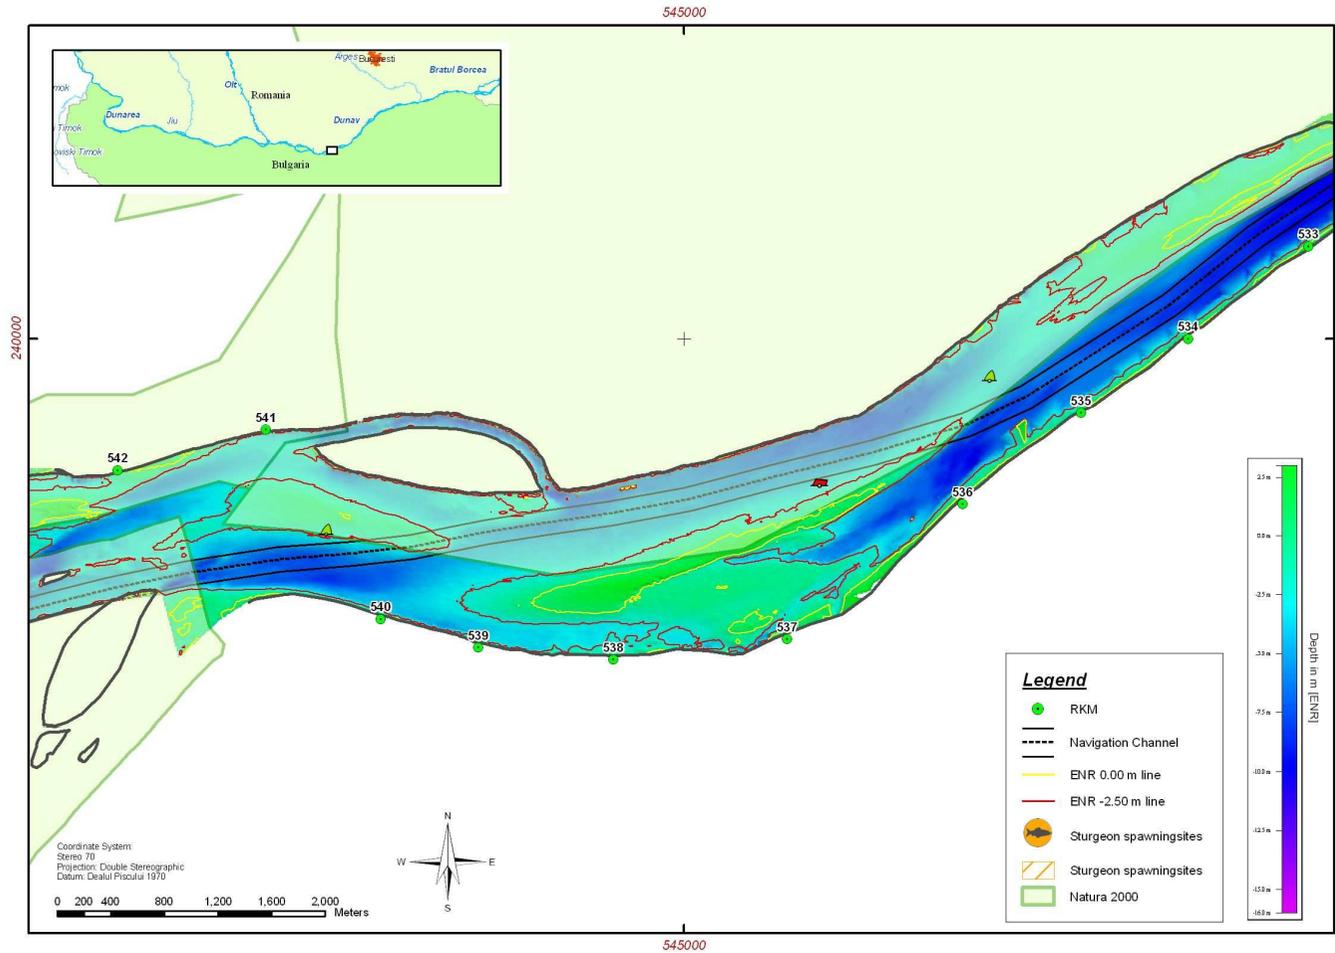
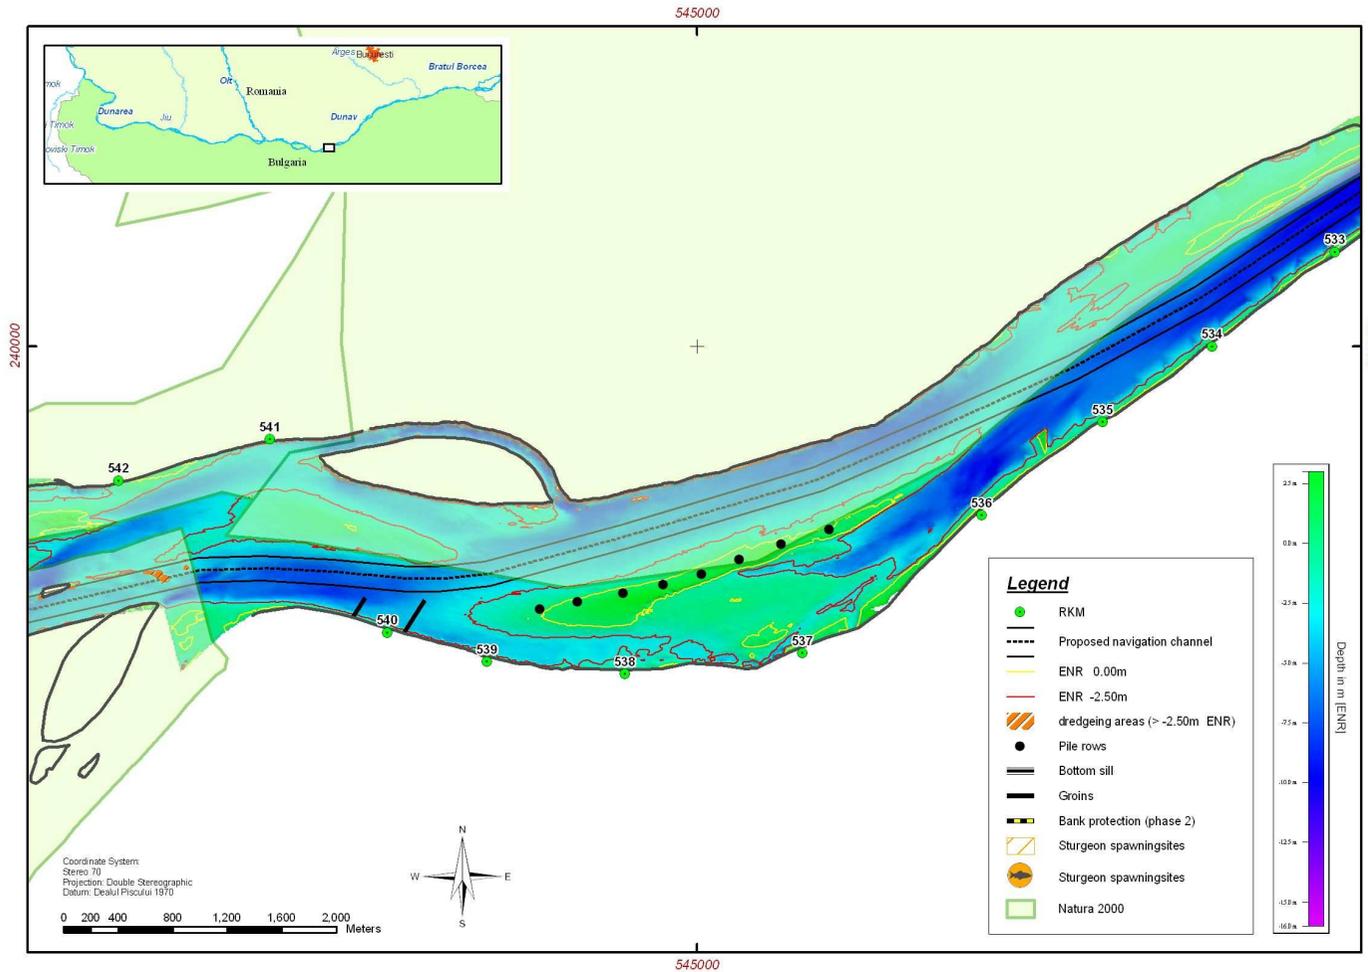
Figure 52: Gaska – Vardim Island Present Conditions

Last update of this sheet:	23.06.2008
		Critical Sector Number:	18
Location:			
Insula Gaska – Vardim			
Position:		Danube sector:	
Km 540 - 536		Common Romanian – Bulgarian sector rKm 610 - 845.5	
Sector for detail measurements:			
Critical point reported by:			
AFDJ Giurgiu Directia de Transporturi Navale Harris (1999)			
Description of the present situation:			
Navigation depths may be less than 2.5m and width between 60 and 100m. Shipwrecks.			
Proposed works:			
Harris (1999): It is proposed to construct groins at rkm 538			
Alternatives proposed by JV Technum, Trapec, Tractebel, CNR, Safege (2008): The TWS proposes realignment of the navigation channel to reduce dredging volumes; besides, groins and an additional measure (e.g. pile rows) to concentrate the main flow on the left bank and induce the sedimentation at the sector of the pile rows on the right bank. An option to be considered in the EES is the construction of the groins detached from the banks (e.g. wing dam notching) allowing flow between the structures and the banks. Other important aspects for the EES and GES, and in general for construction:

<ul style="list-style-type: none"> • Phasing of dredging to take into account fish spawning/migration; • Phasing of large training works; • Keep impact on deep areas as low as possible (spawning sites); • Useful application of dredged material; 			
Selected solutions JV Technum, Trapec, Tractebel, CNR, Safege (2008):

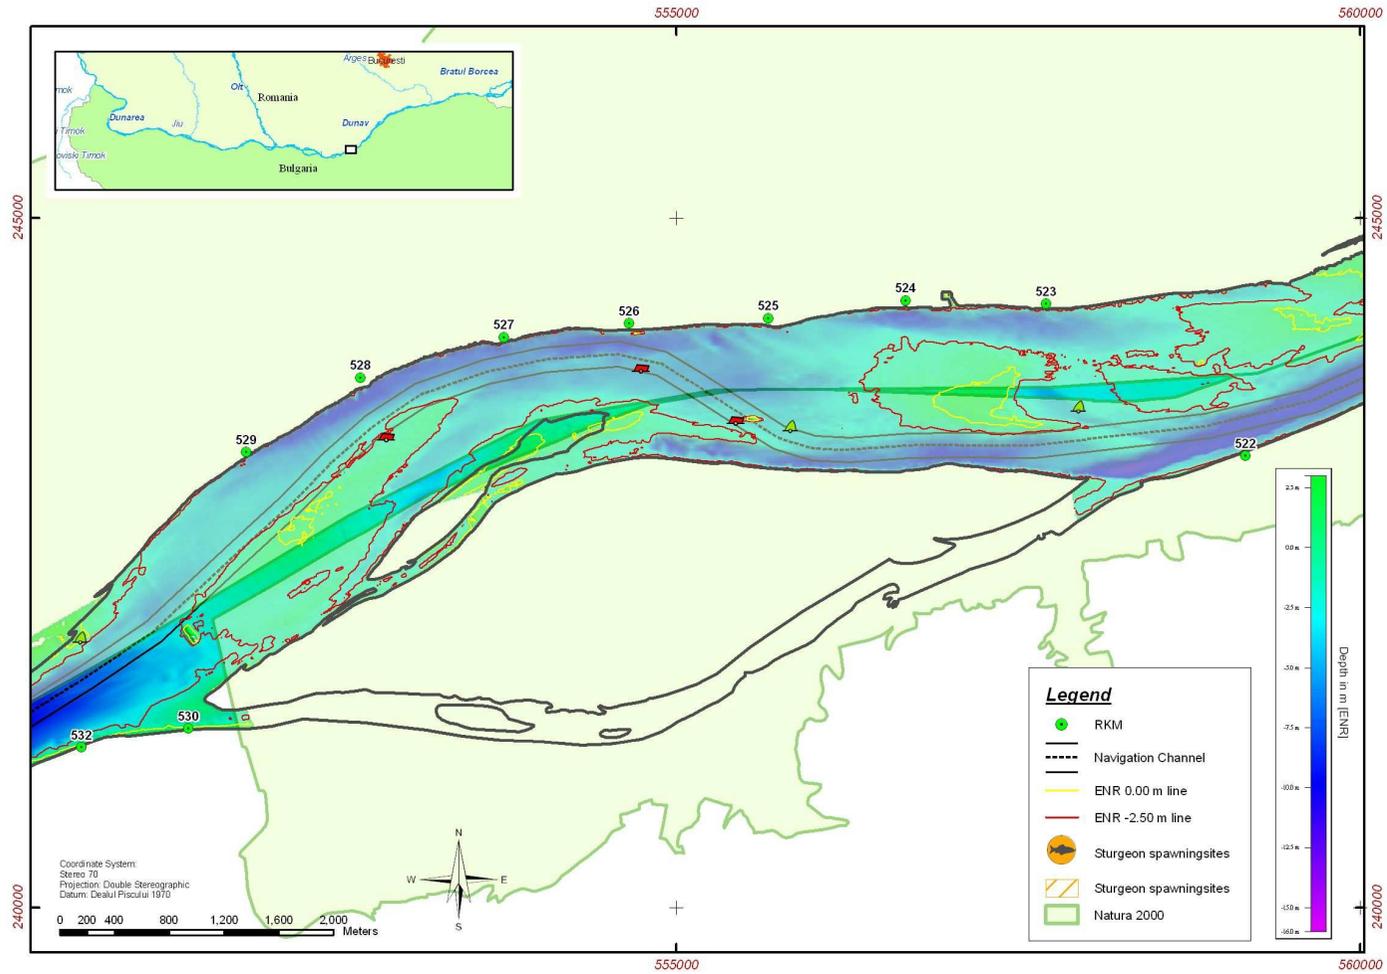
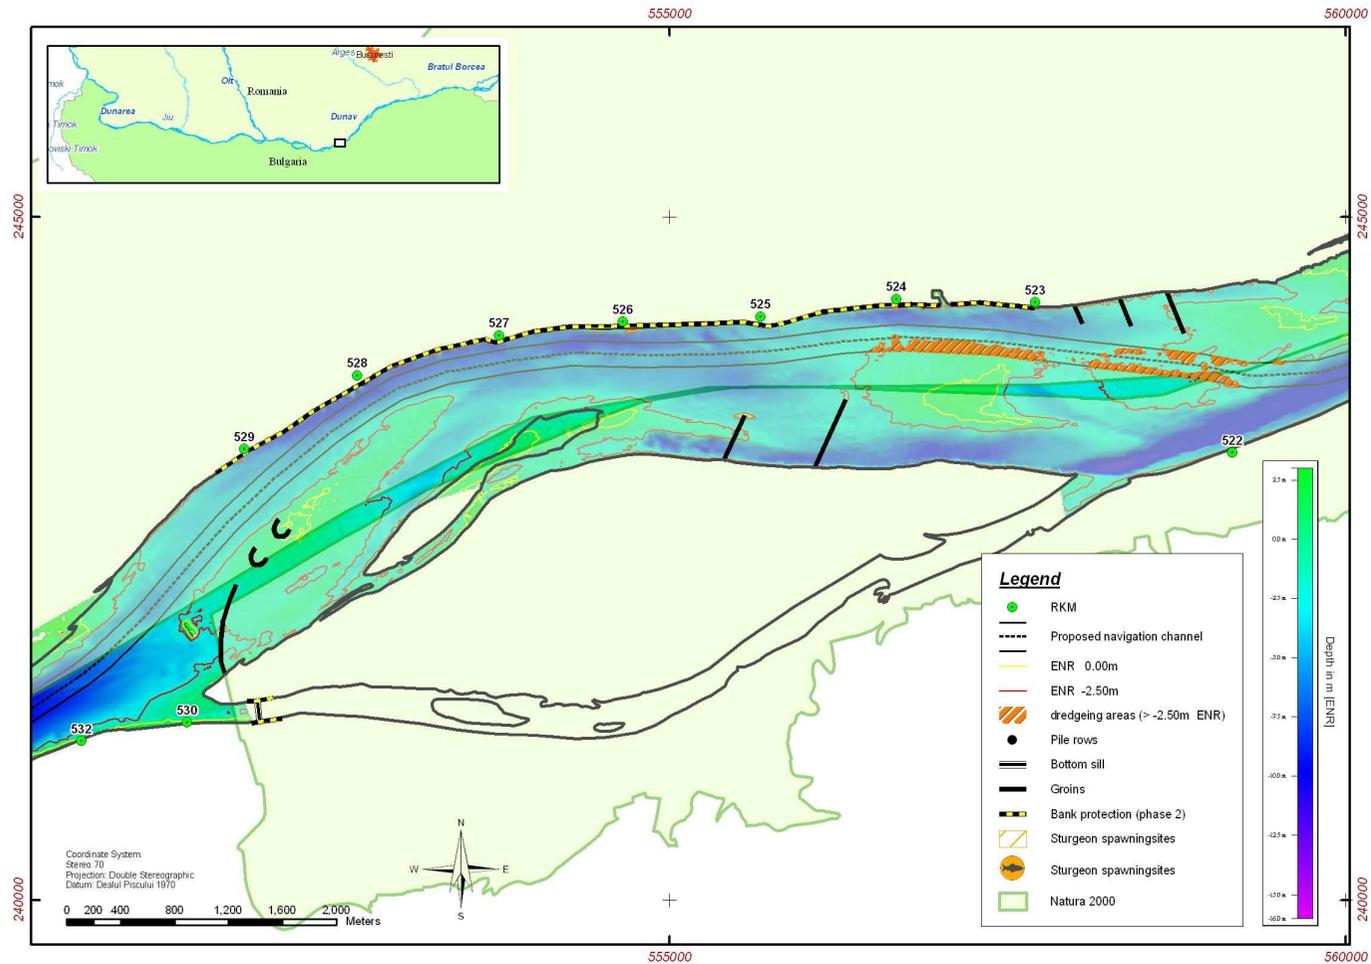
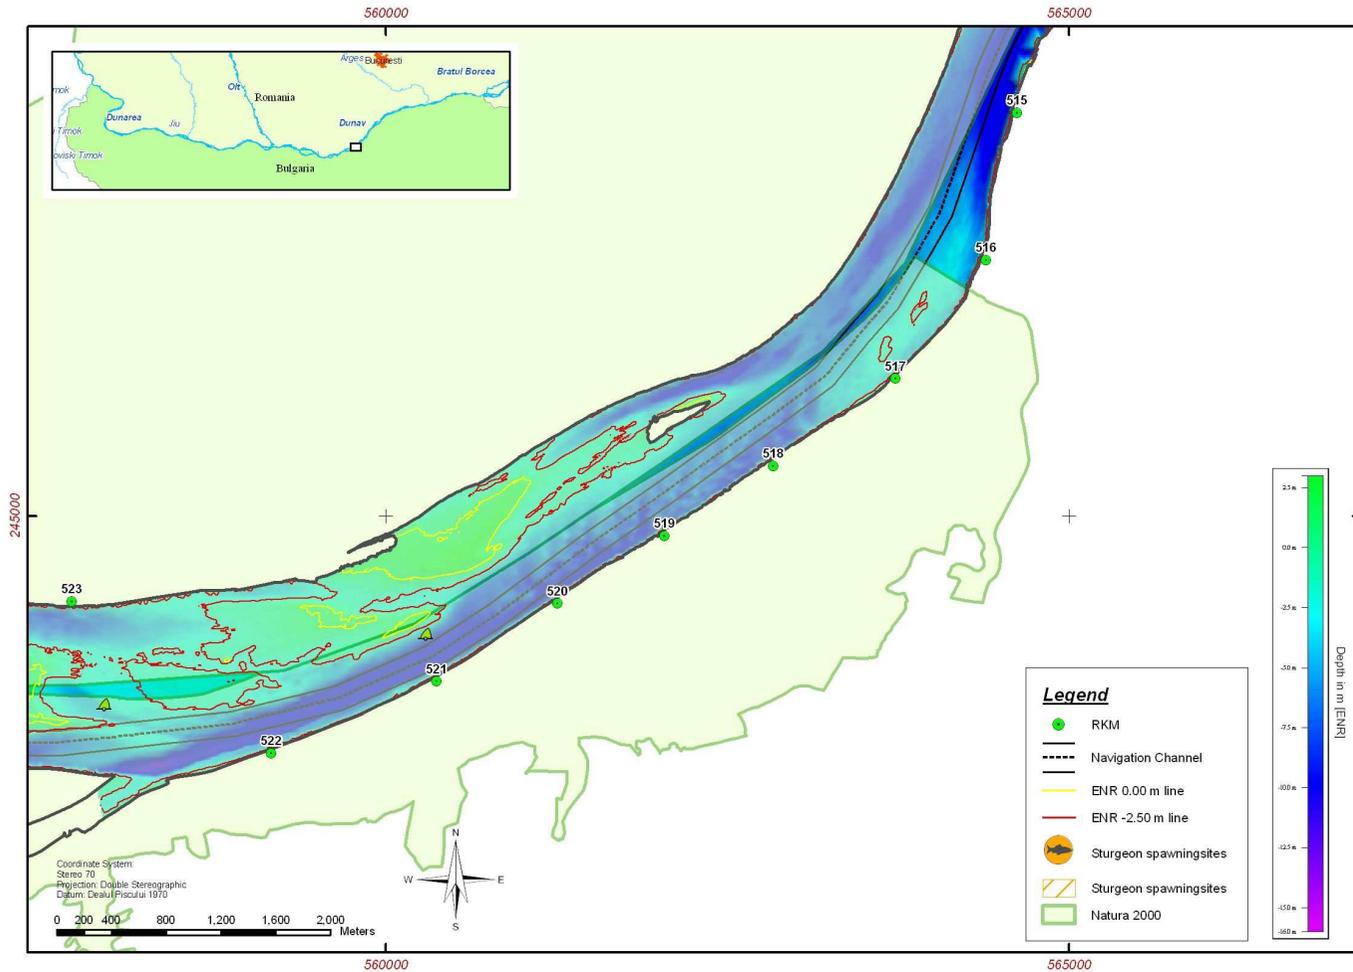
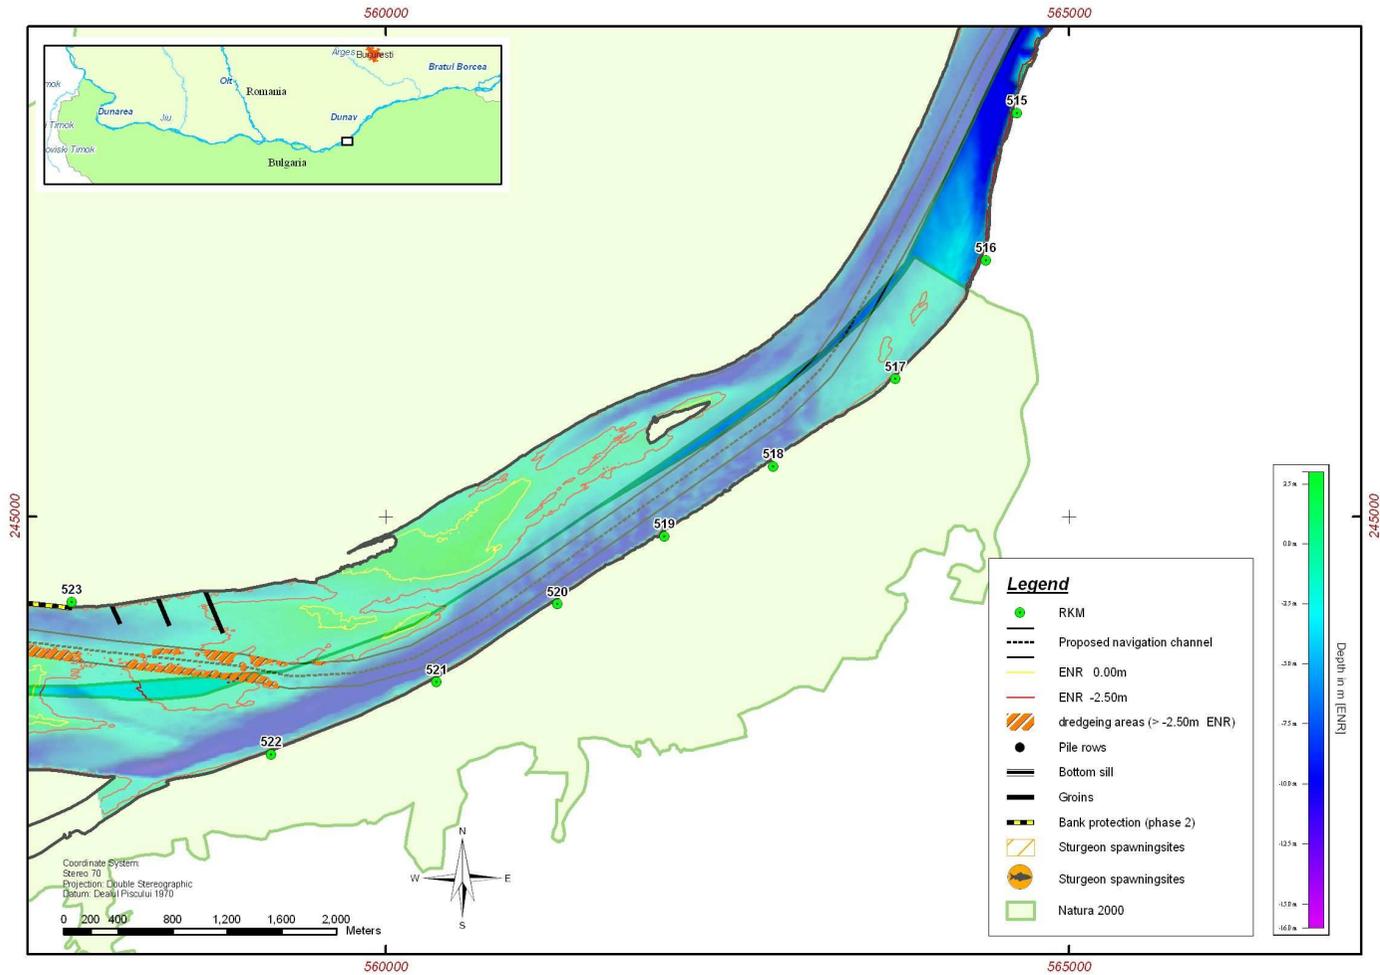
Figure 54: Batin Island - Stilpiste Present Conditions A

- Phasing of dredging to take into account fish spawning/migration;
- Phasing of large training works;
- Keep impact on deep areas as low as possible;
- Useful application of dredged material;
- Two open bottom sills instead of one;
- Smaller number of groins with L-shape;
- Reduce length of bank protection accompanied with a monitoring program in order to take actions if necessary.

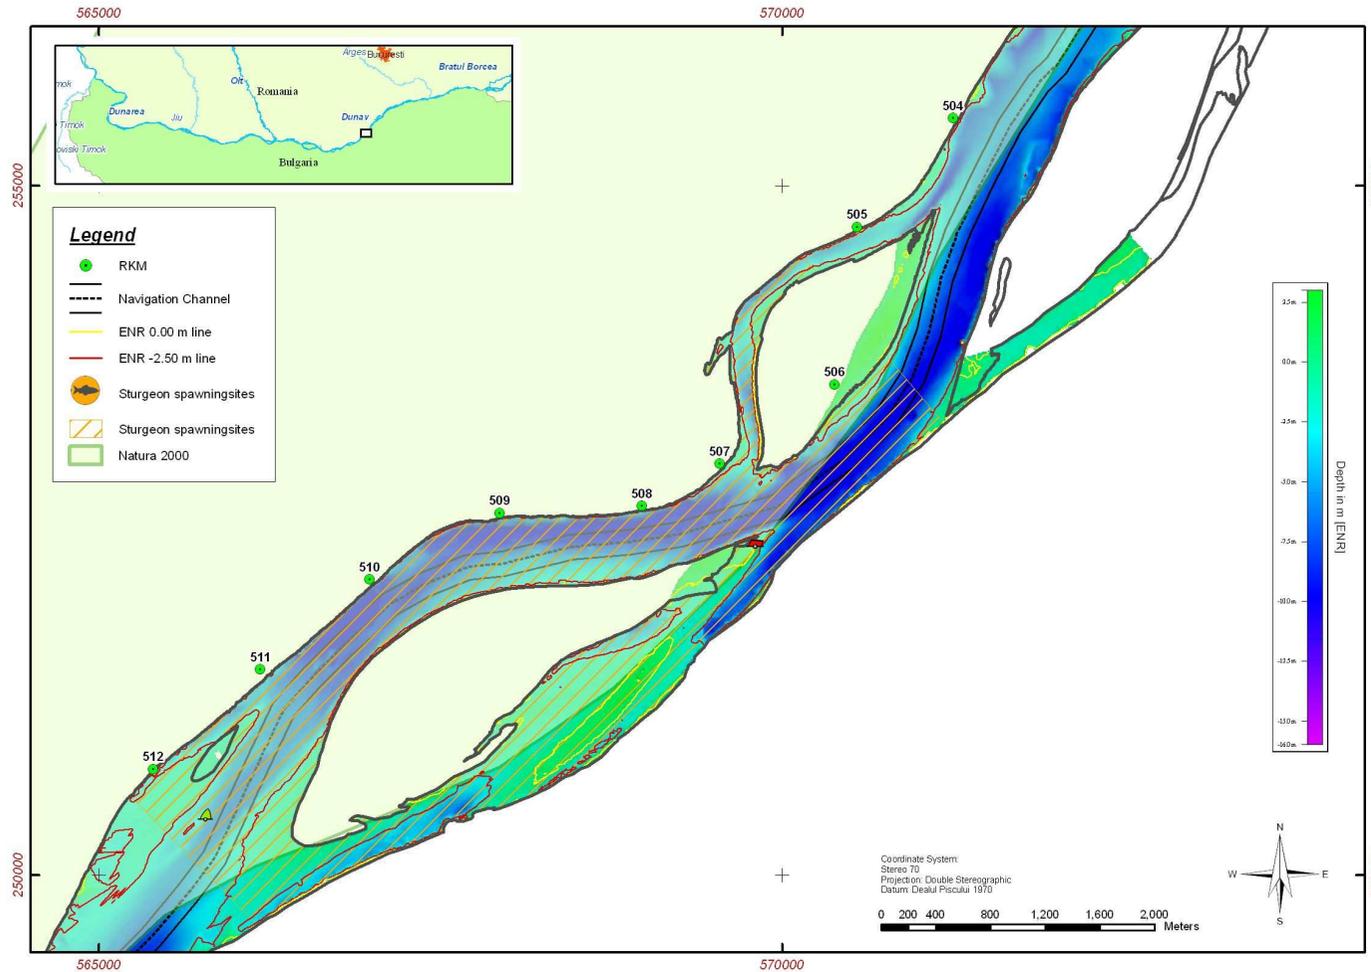
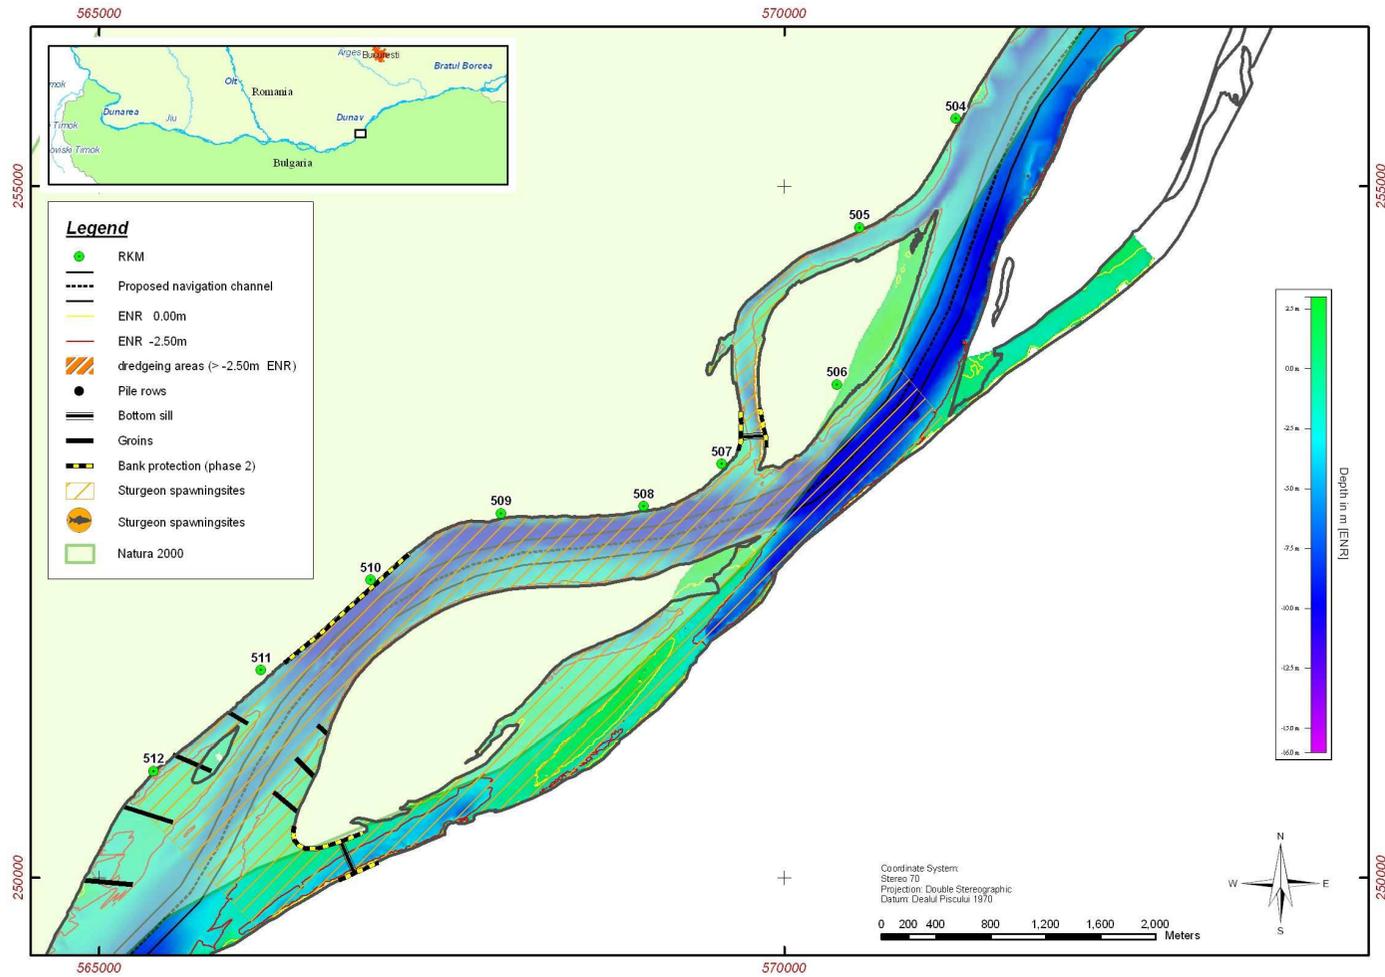
Figure 58: Kama and Dinu Islands Present Conditions

Last update of this sheet:	18/09/08
	Critical Sector Number:	20
Location:		
Kama and Dinu Islands		
Position:	Danube sector:	
rKm 512 – 504	Common Romanian – Bulgarian sector rKm 610 - 845.5	
Sector for detail measurements:		
Critical point reported by:		
<ul style="list-style-type: none"> • Harris (1999) • Navigation Directorate • APPD Ruse 		
Description of the present situation:		
<p>A wide river and the presence of islands (Cama Island amongst others) is the cause of this bottleneck during low flow regimes. A small emerging sand bank occurs in this section of the river at rkm 512-511 where the widening of the river starts.</p> <p>The navigation channel has been relocated on the Bulgarian branch between rkm 507-505 since 1995. There is sand at the old navigation channel on the Romanian branch at rkm 507-506 and big erosion is happening at the peak of the downstream island at rkm 507.</p>		
Proposed works:

- Smaller number of groins with L-shape;
- Reduce length of bank protection accompanied with a monitoring program in order to take actions if necessary.

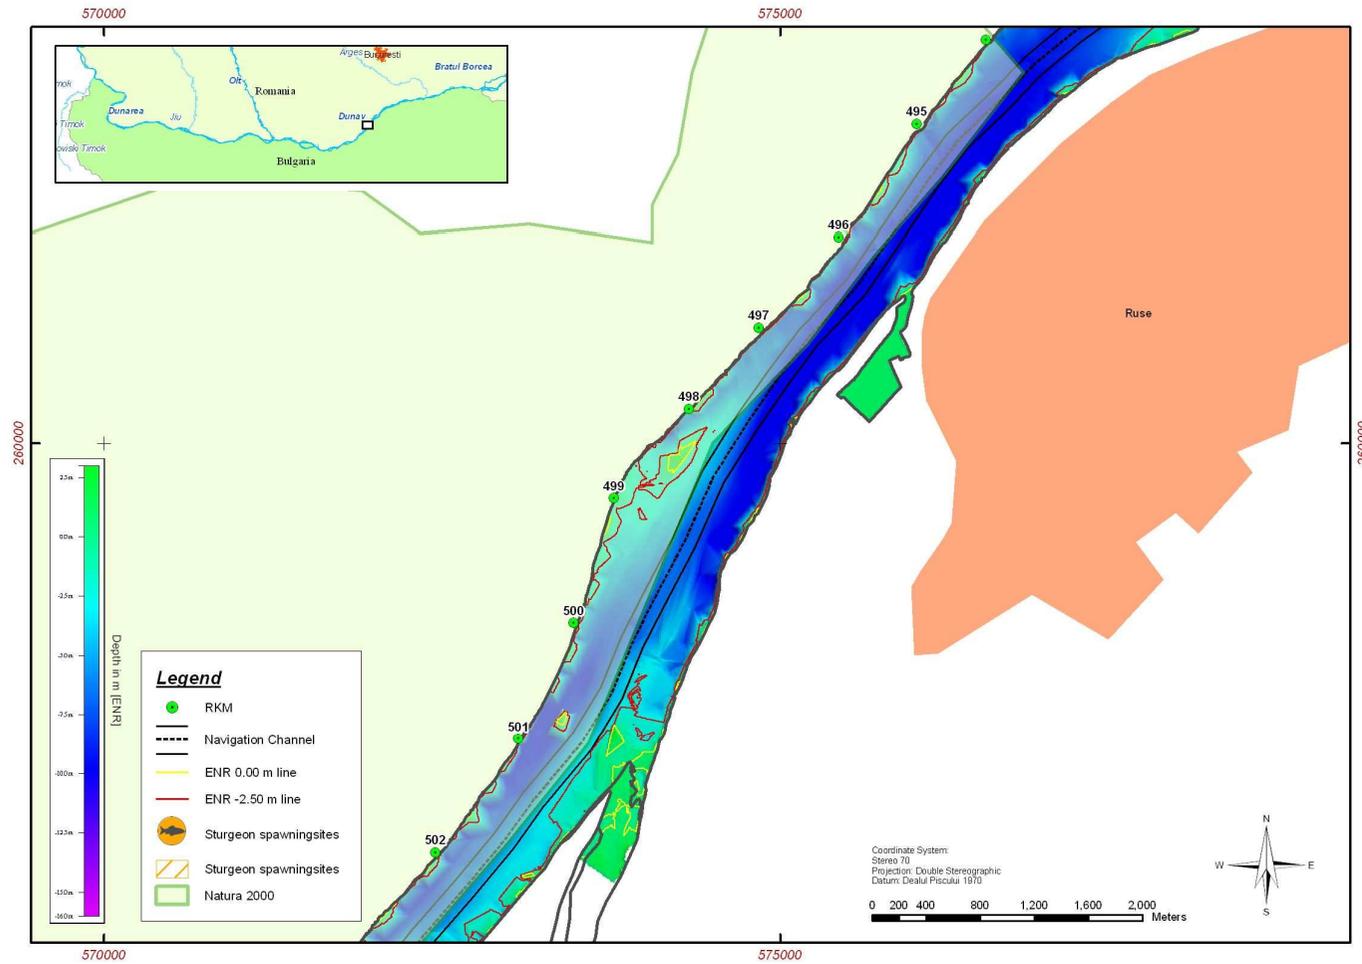
Figure 60: Slobozia Present Conditions

Last update of this sheet:	18/09/08
	Critical Sector Number:	21
Location:		
Slobozia		
Position:	Danube sector:	
rKm 500 – 497	Common Romanian – Bulgarian sector rKm 610 - 845.5	
Sector for detail measurements:		
Critical point reported by:		
<ul style="list-style-type: none"> • APPD Ruse 		
Description of the present situation:		
No problems for navigation at present.		
Proposed works:		
Harris (1999): None		
Solutions proposed by JV Technum, Trapec, Tractebel, CNR, Safege:		
The last bathymetry of 2008 confirms no difficulties for navigation in the sector. No measures are proposed in this area.		
Selected solutions JV Technum, Trapec, Tractebel, CNR, Safege (2008):

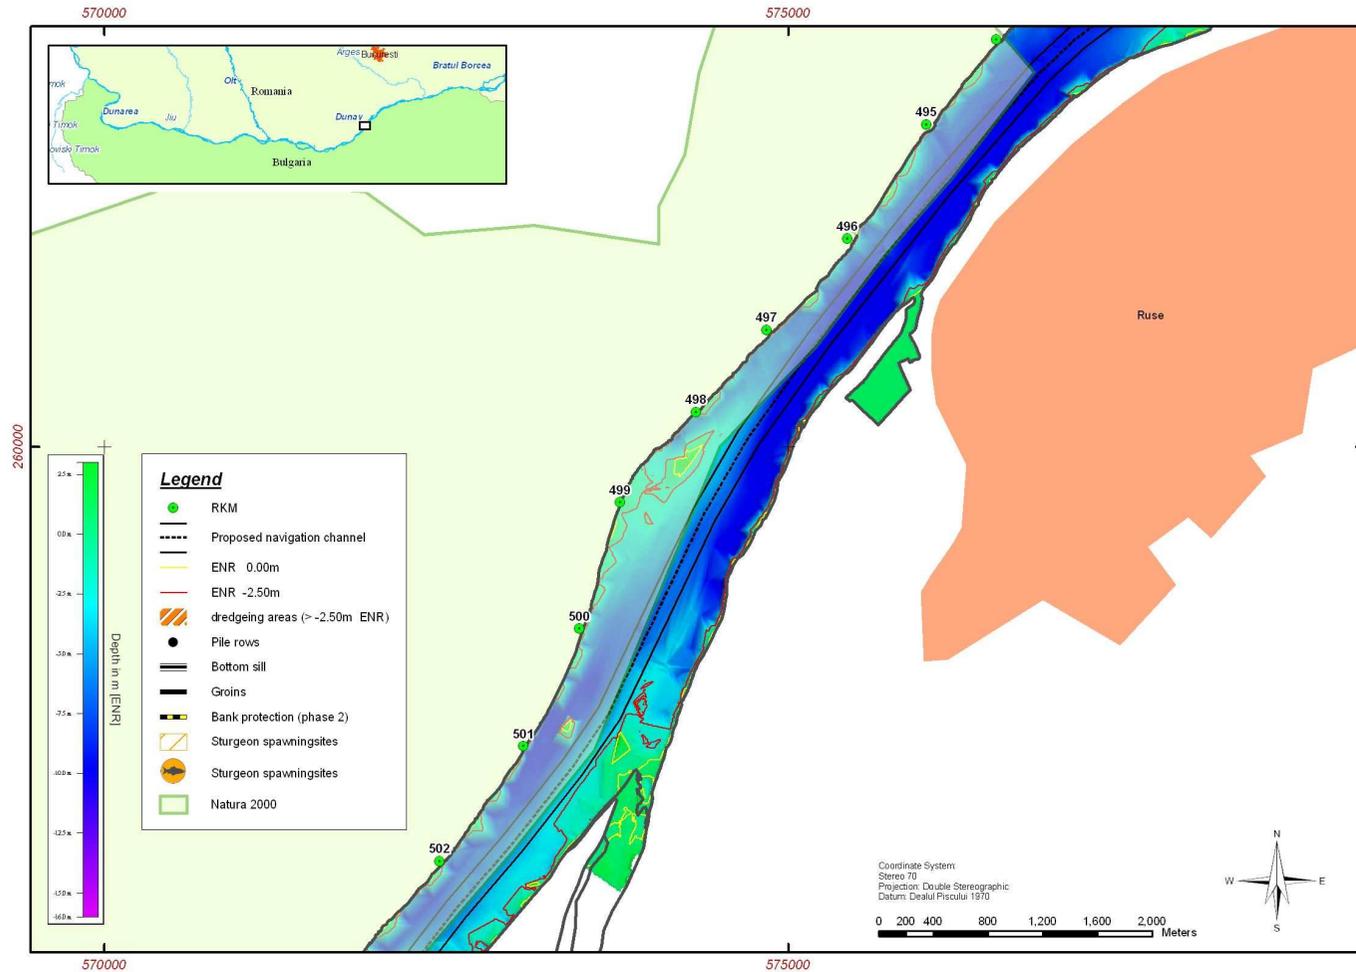
Figure 61: Slobozia Alternative Development Strategy

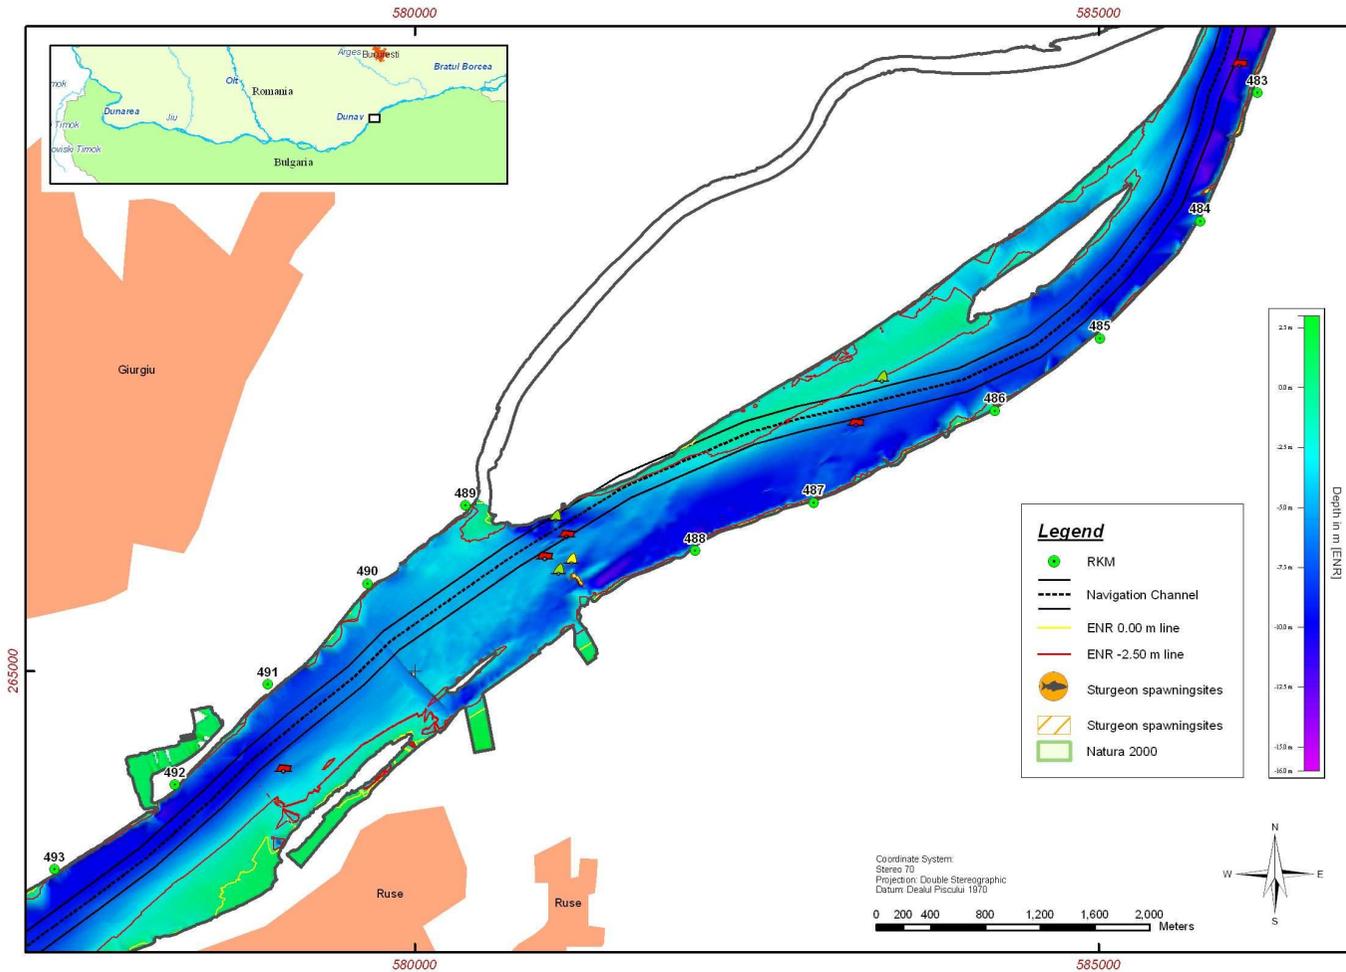
Last update of this sheet:	18/09/08
	Critical Sector Number:	21
Location:		
Slobozia		
Position:	Danube sector:	
rKm 500 – 497	Common Romanian – Bulgarian sector rKm 610 - 845.5	
Sector for detail measurements:		
Critical point reported by:		
<ul style="list-style-type: none"> • APPD Ruse 		
Description of the present situation:		
No problems for navigation at present.		
Proposed works:		
Harris (1999): None		
Solution proposed by JV Technum, Trapec, Tractebel, CNR, Safege:		
The last bathymetry of 2008 confirms no difficulties for navigation in the sector. No measures are proposed in this area.		
Selected solutions JV Technum, Trapec, Tractebel, CNR, Safege (2008)

Figure 62: Giurgiu Present Conditions

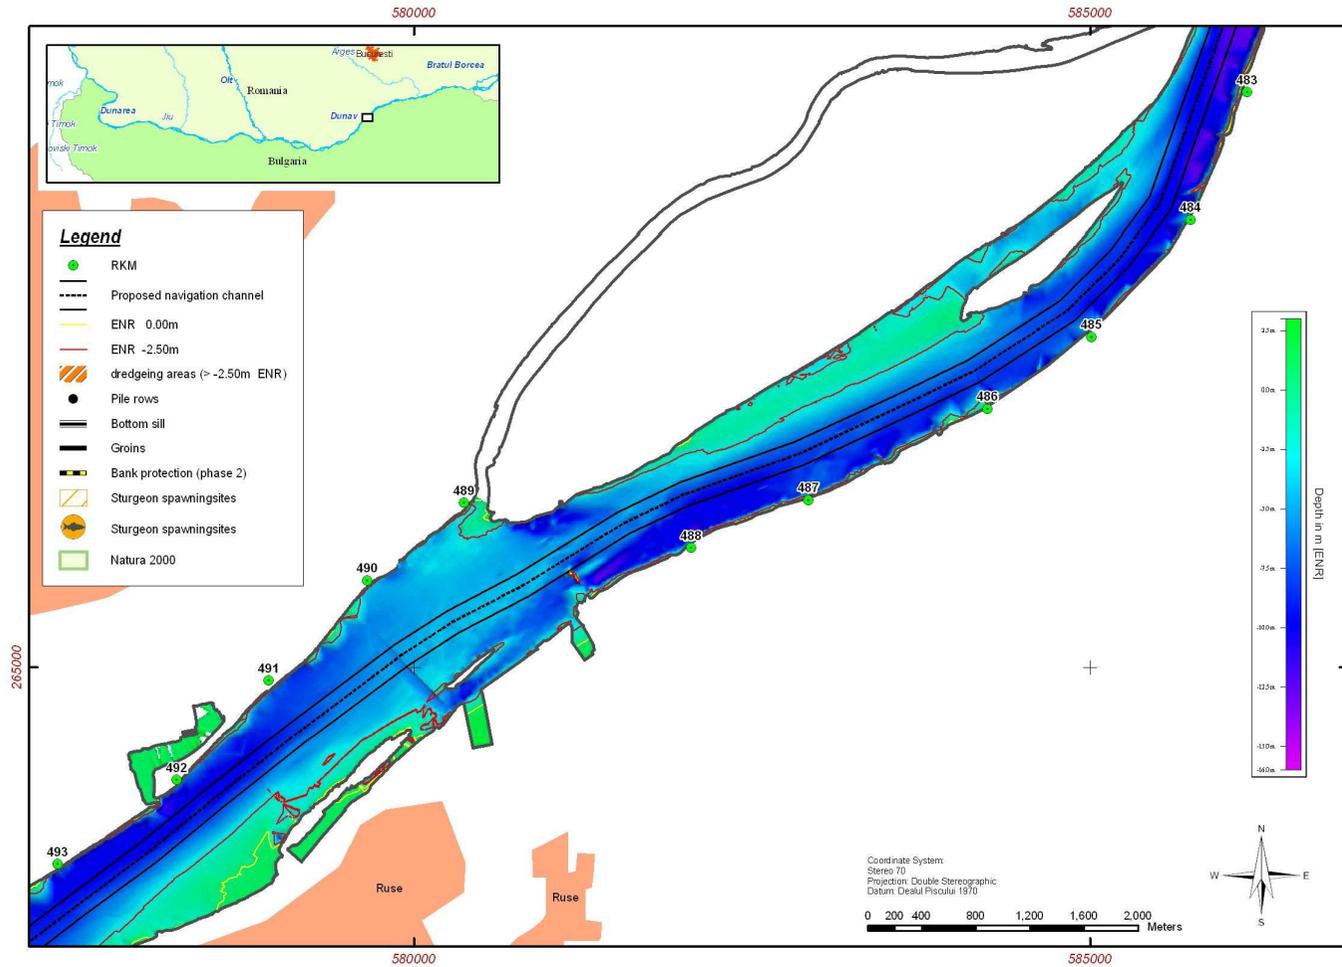
Figure 63: Giurgiu Alternative Development Strategy

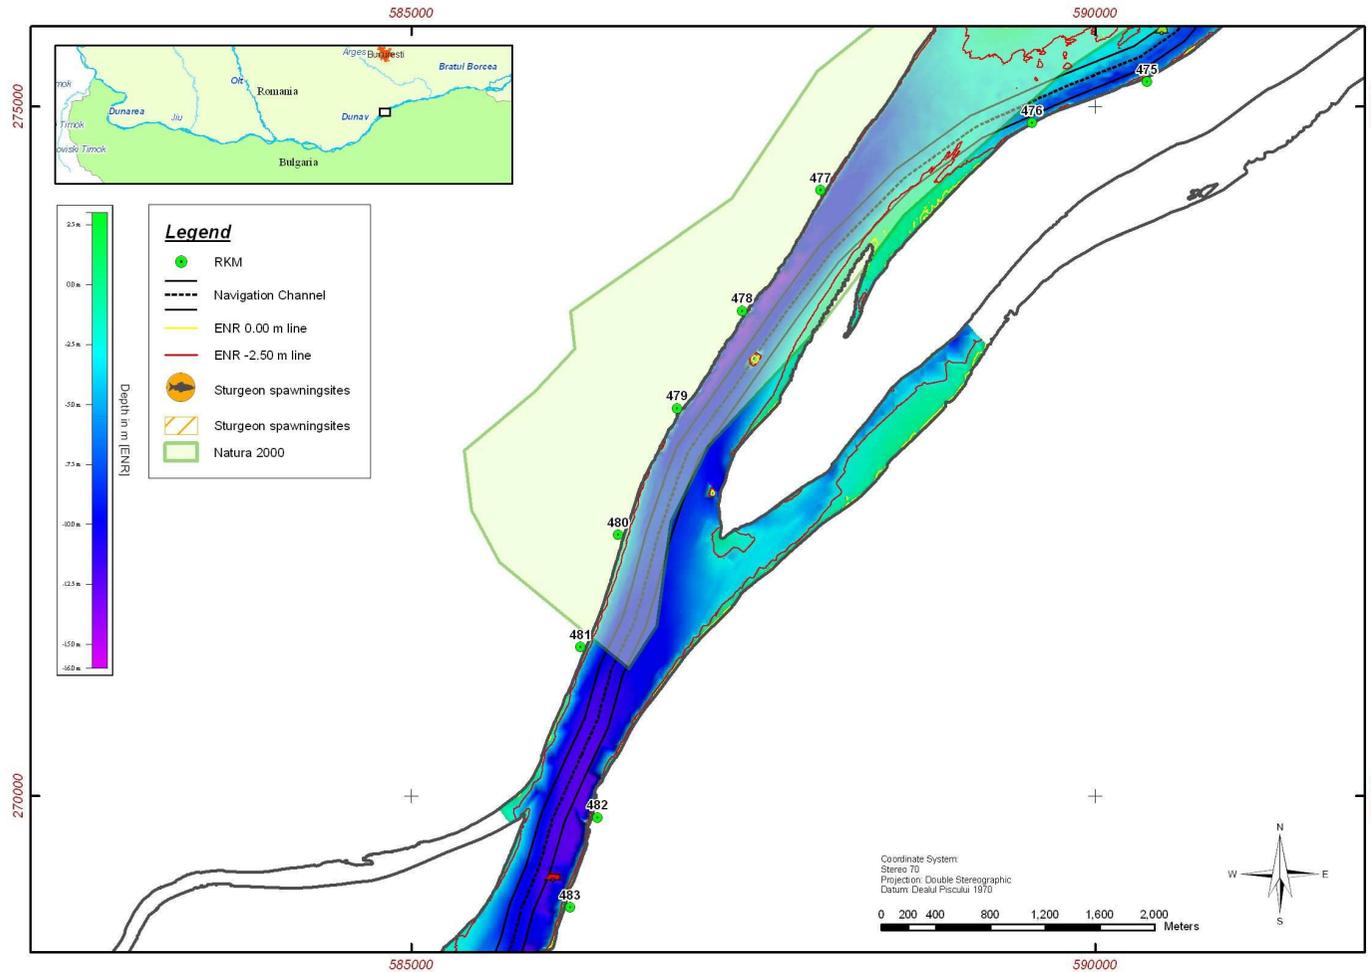
Figure 64: Ostrovul Alek Present Conditions

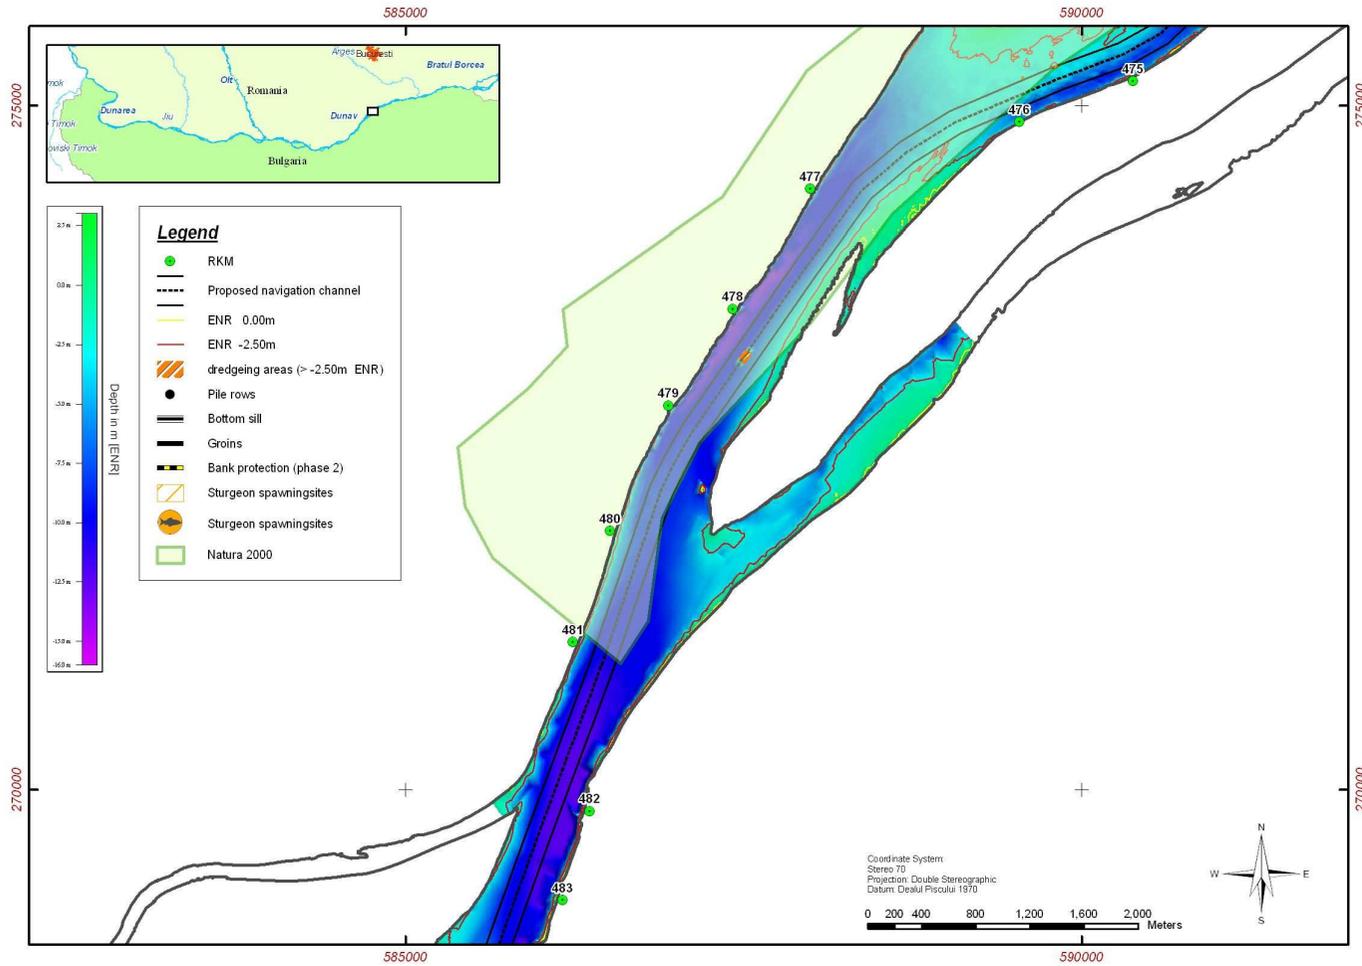
Figure 65: Ostrovul Alek Alternative Development Strategy
