TECHNICAL MEMOIR FOR ENVIRONMENT PERMIT ISSUANCE

The ISPA EUROPEAID/122137/D/SV/RO - "Technical assistance for improvement of conditions for navigation on the Common Romanian - Bulgarian Danube sector and further studies".

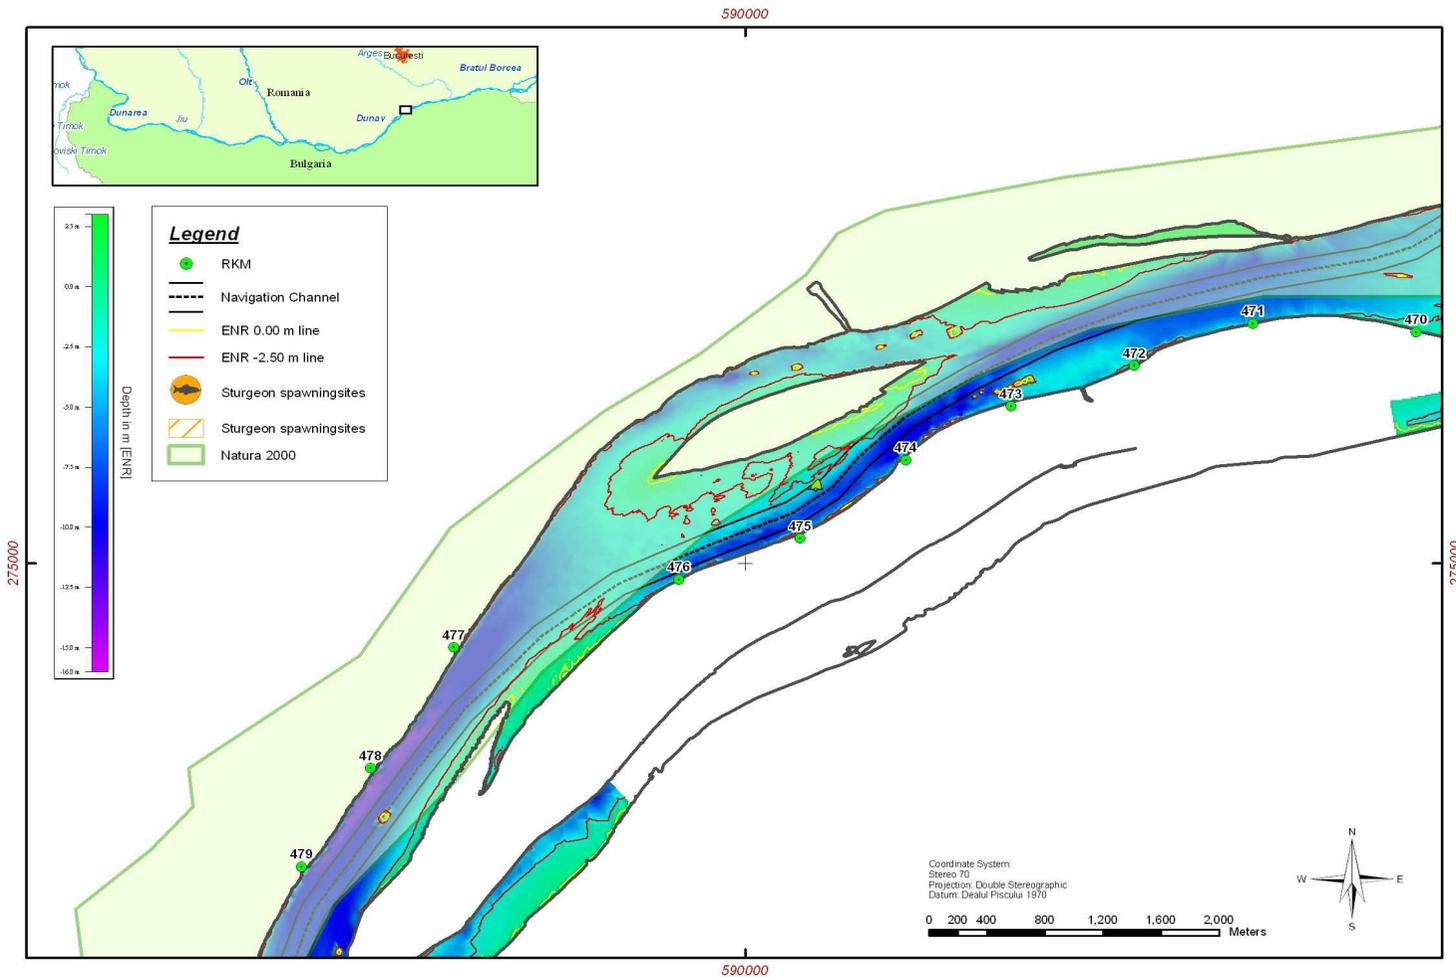
Figure 66: Gostinu Island Present Conditions

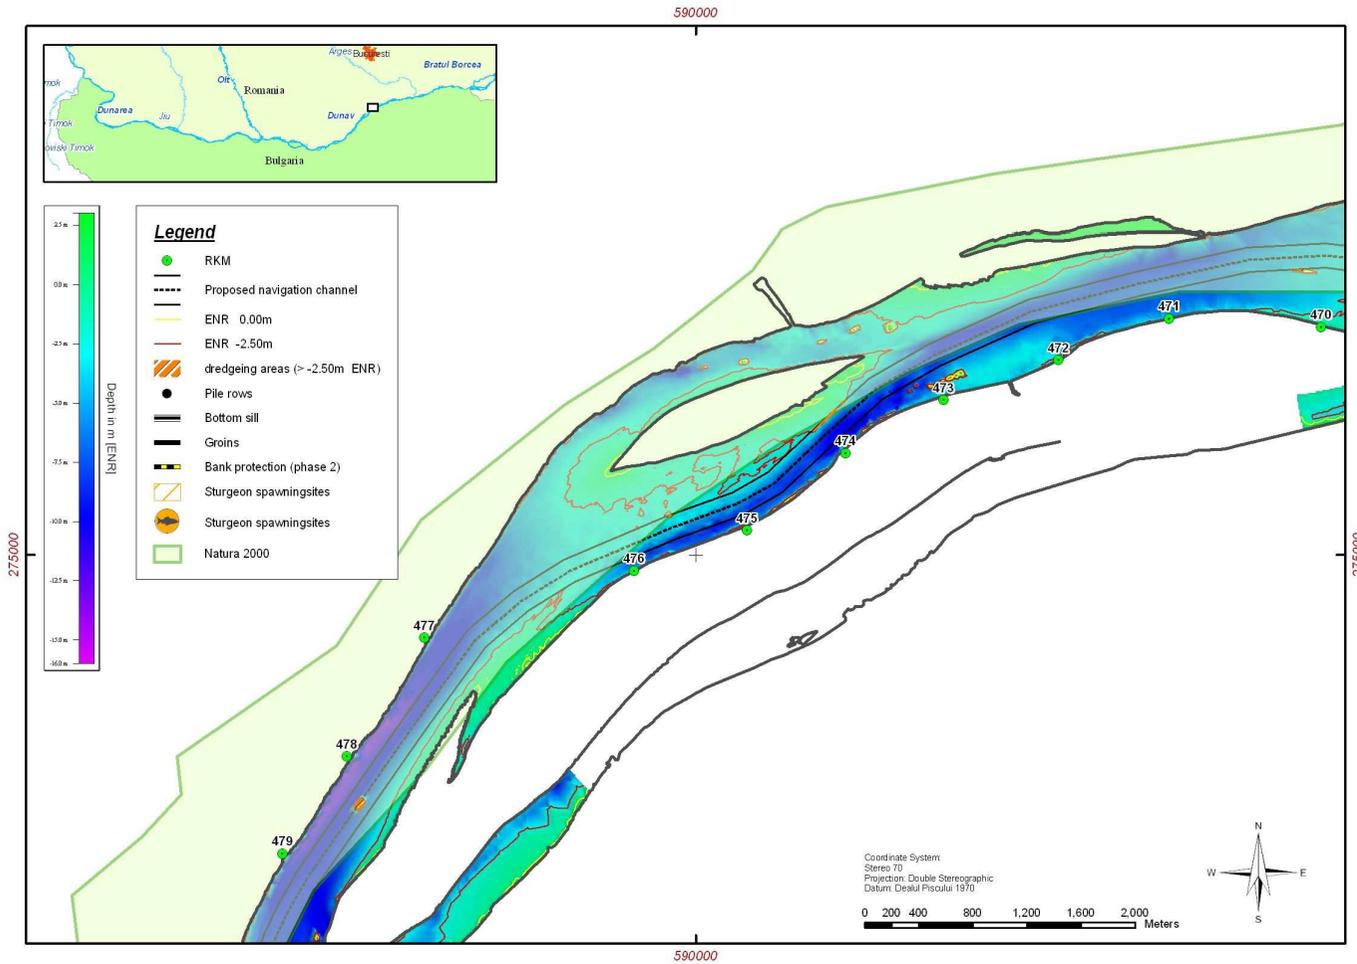
Figure 67: Gostinu Island Alternative Development Strategy

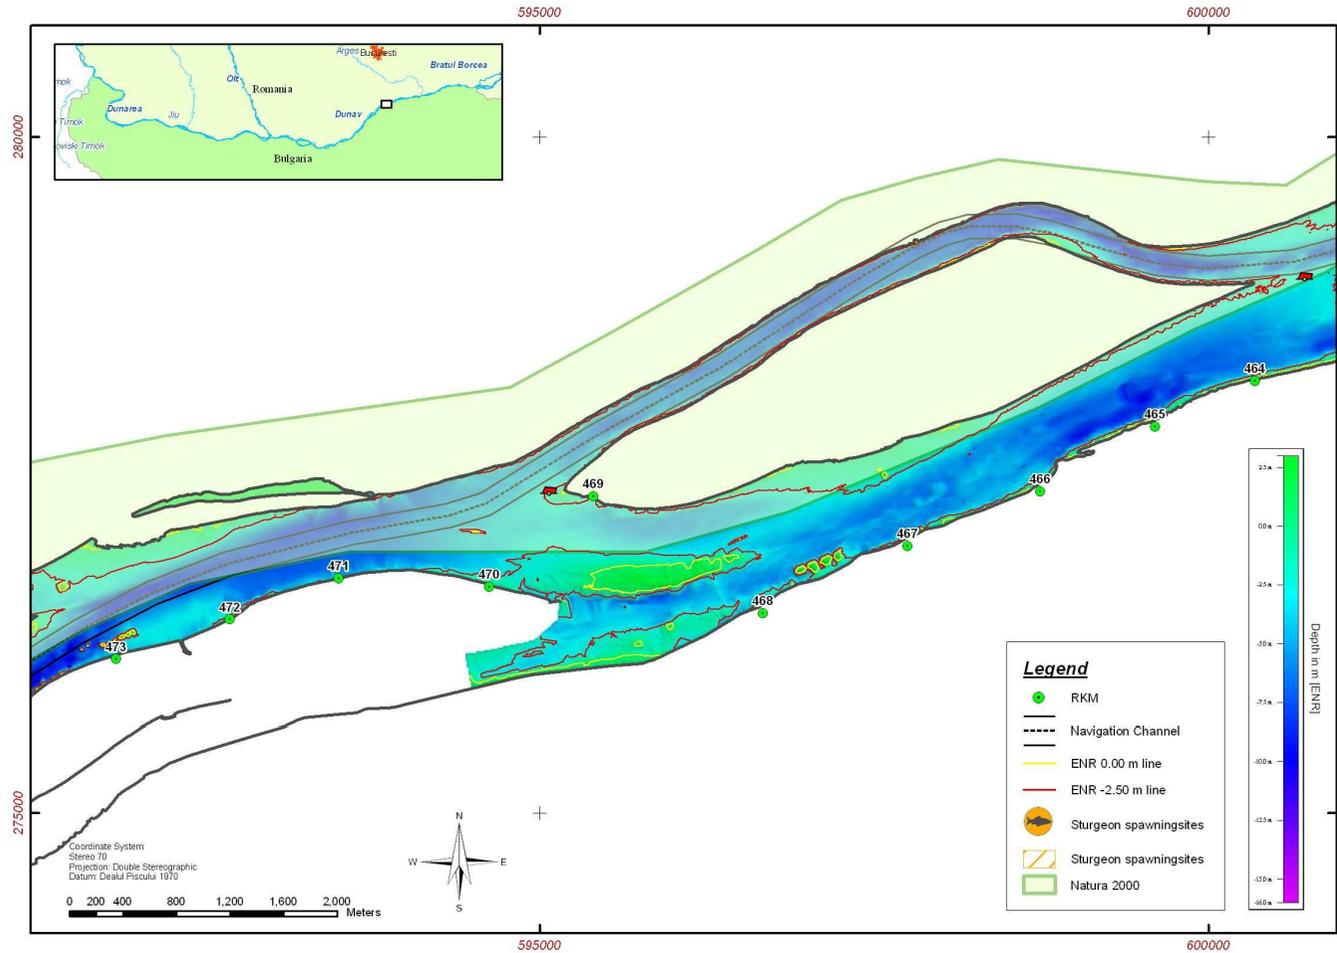
Last update of this sheet:	18/09/08
	Critical Sector Number:	25
Location:		
Lungu Island		
Position:	Danube sector:	
rKm 470-467	Common Romanian – Bulgarian sector rKm 610 - 845.5	
Sector for detail measurements:		
Critical point reported by:		
<ul style="list-style-type: none"> Harris (1999) 		
Description of the present situation:		
<p>The width of the navigation channel does not comply the recommendations of the Danube Committee for the Danube maritime fairway at rkm 465. There is an industrial pump station at rkm 465+500.</p>		
Proposed works:		
<p>Harris (1999): The proposed structure is a bottom sill at Gostinul.</p>		
Solution proposed by JV Technum, Trapec, Tractebel, CNR, Safege:		
<p>The realignment of the navigation channel on the right bank is necessary to assure its minimum width, together with some dredging. Besides, a bottom sill on the secondary branch and a directional groin are proposed in the TWS. An alternative design of the bottom sill and the groin detached from the bank (e.g. wing dam notching) are suggested in the EES allowing flow between the structure and the banks. Other important aspects for the EES and GES, and in general for construction:</p> <ul style="list-style-type: none"> Phasing of dredging to take into account fish spawning/migration; Phasing of large training works; Keep impact on deep areas as low as possible (spawning sites); Two open bottom sills instead of one; Useful application of dredged material;

Figure 68: Lungu Island Present Conditions

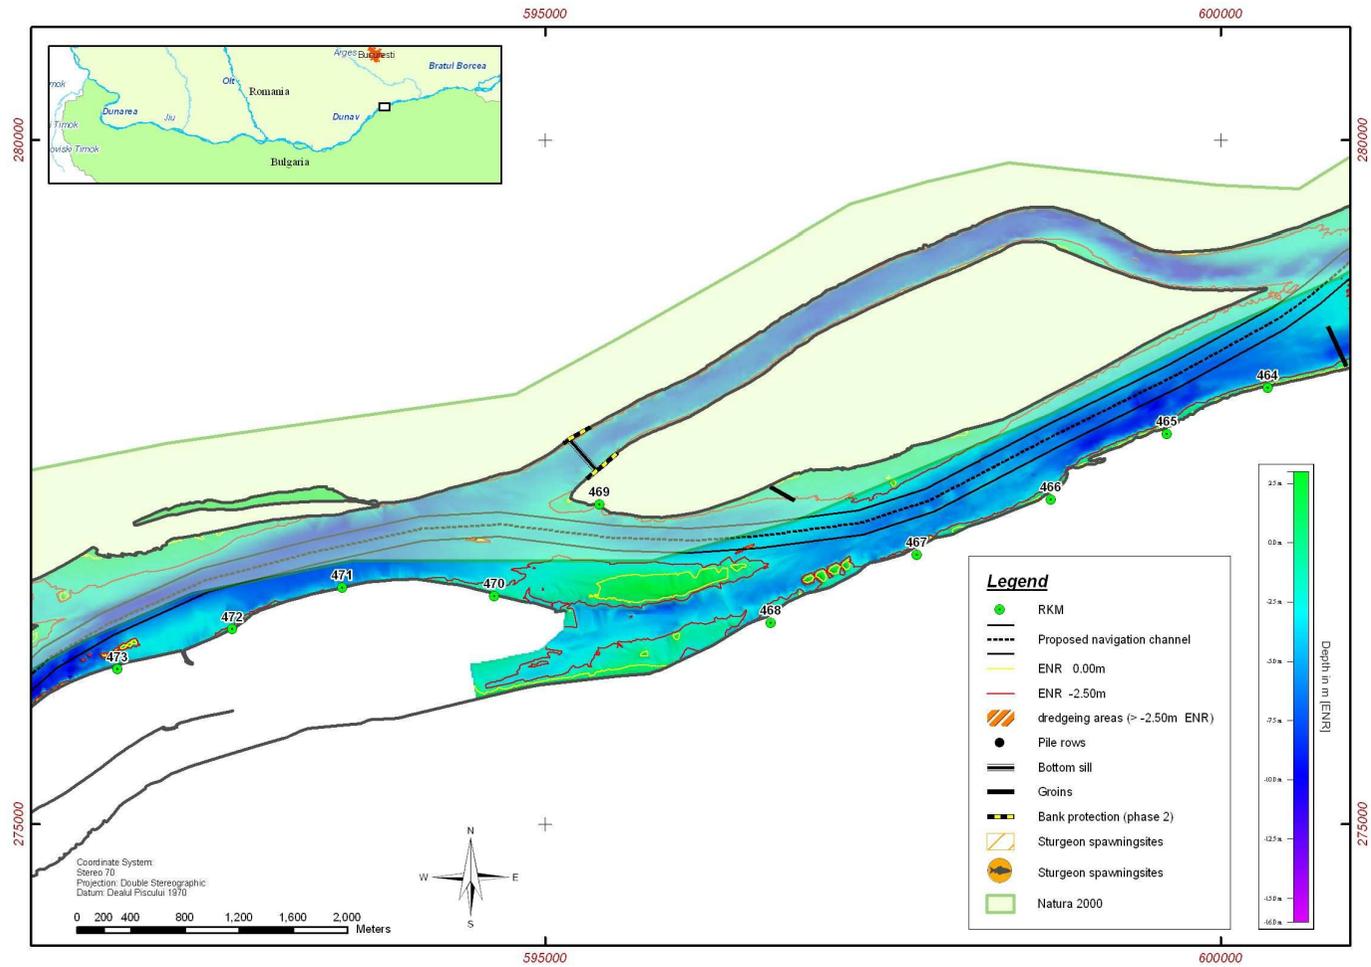
Figure 69: Lungu Island Alternative Development Strategy

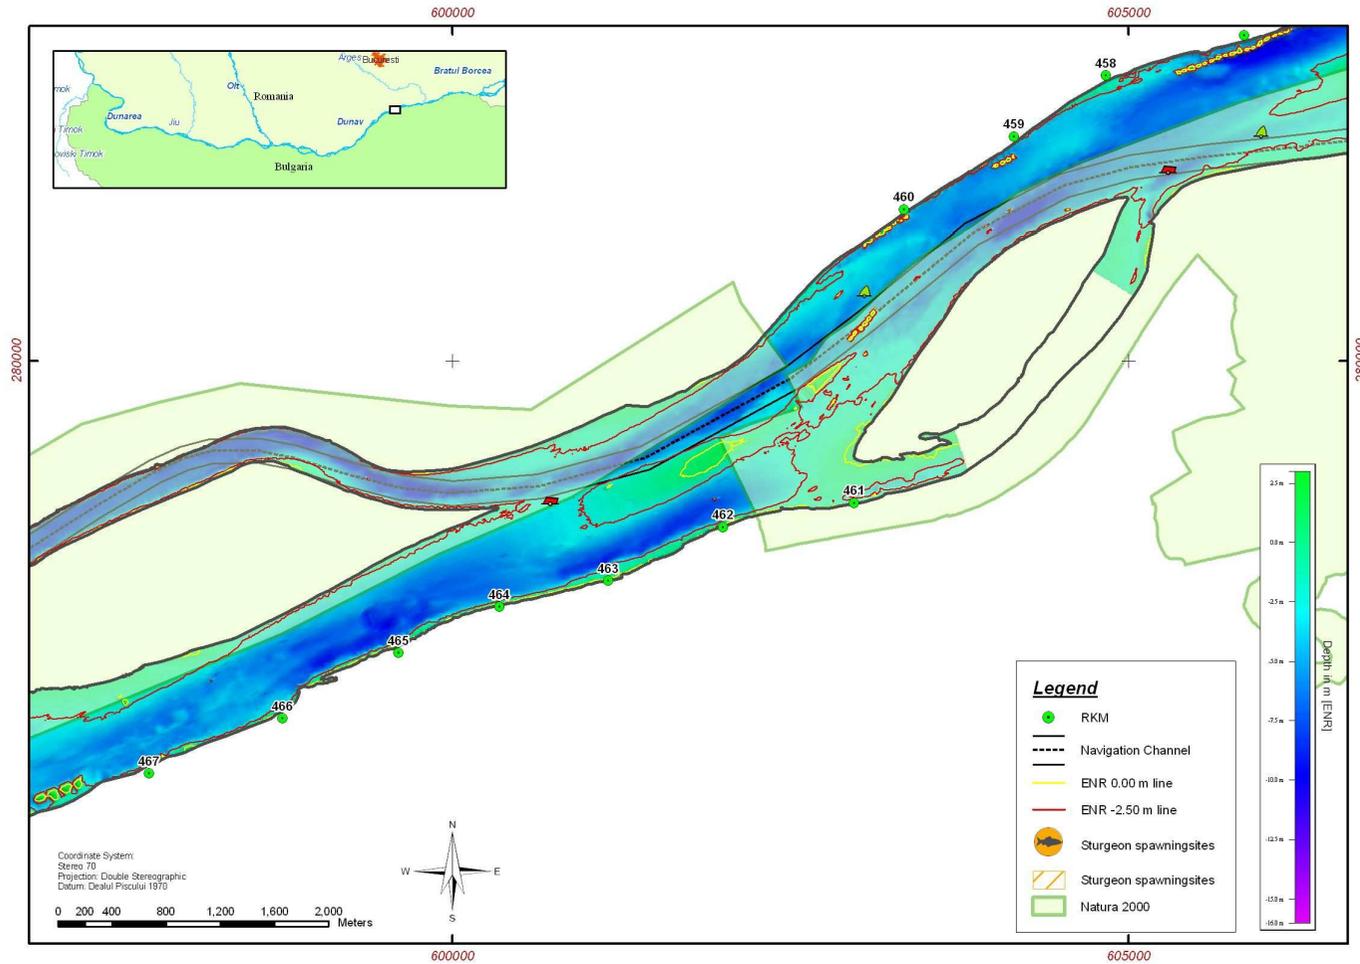
Last update of this sheet:	18/09/08
	Critical Sector Number:	26
Location:		
Mishka Island		
Position:	Danube sector:	
rKm 467-450	Common Romanian – Bulgarian sector rKm 610 - 845.5	
Sector for detail measurements:		
Critical point reported by:		
<ul style="list-style-type: none"> • Harris (1999) • APPD Ruse 		
Description of the present situation:		
<p>The numerous branches of the river in this area make a wide river with shoals. Difficulties for navigation occur during low flow conditions when flow is distributed among the several branches.</p> <p>There are no problems for navigation at present.</p>		
Proposed works:		
<p>Harris (1999):</p> <p>The option is to construct series of groins that reduce the river cross-section and concentrates the flow in the branch of the navigation channel. Bank protection may be necessary.</p>		
Alternative Development Strategies (Technum et al., 2008):		
<p>The realignment of the navigation channel on the right branch is proposed (rkm468-464). This will allow a wider and straighter channel. The TWS also includes three groins between rkm464-461 on the right bank, and a set of structures (3 groins and 3 chevrons) between rkm458-456; these structures confine the river flow in the wide present cross sections.</p> <p>The MS (and EES) does not include the structures of the TWS. There are no problems for navigation at present and these structures can be implemented in a second phase of construction works.</p> <p>Other important aspects for the EES and GES, and in general for construction:</p> <ul style="list-style-type: none"> • Phasing of dredging to take into account fish spawning/migration; • Phasing of large training works; • Keep impact on deep areas as low as possible (spawning sites); • Useful application of dredged material; • Open groins at the river bank; • Smaller number of groins with L-shape;

Figure 70: Mishka Island Present Conditions A

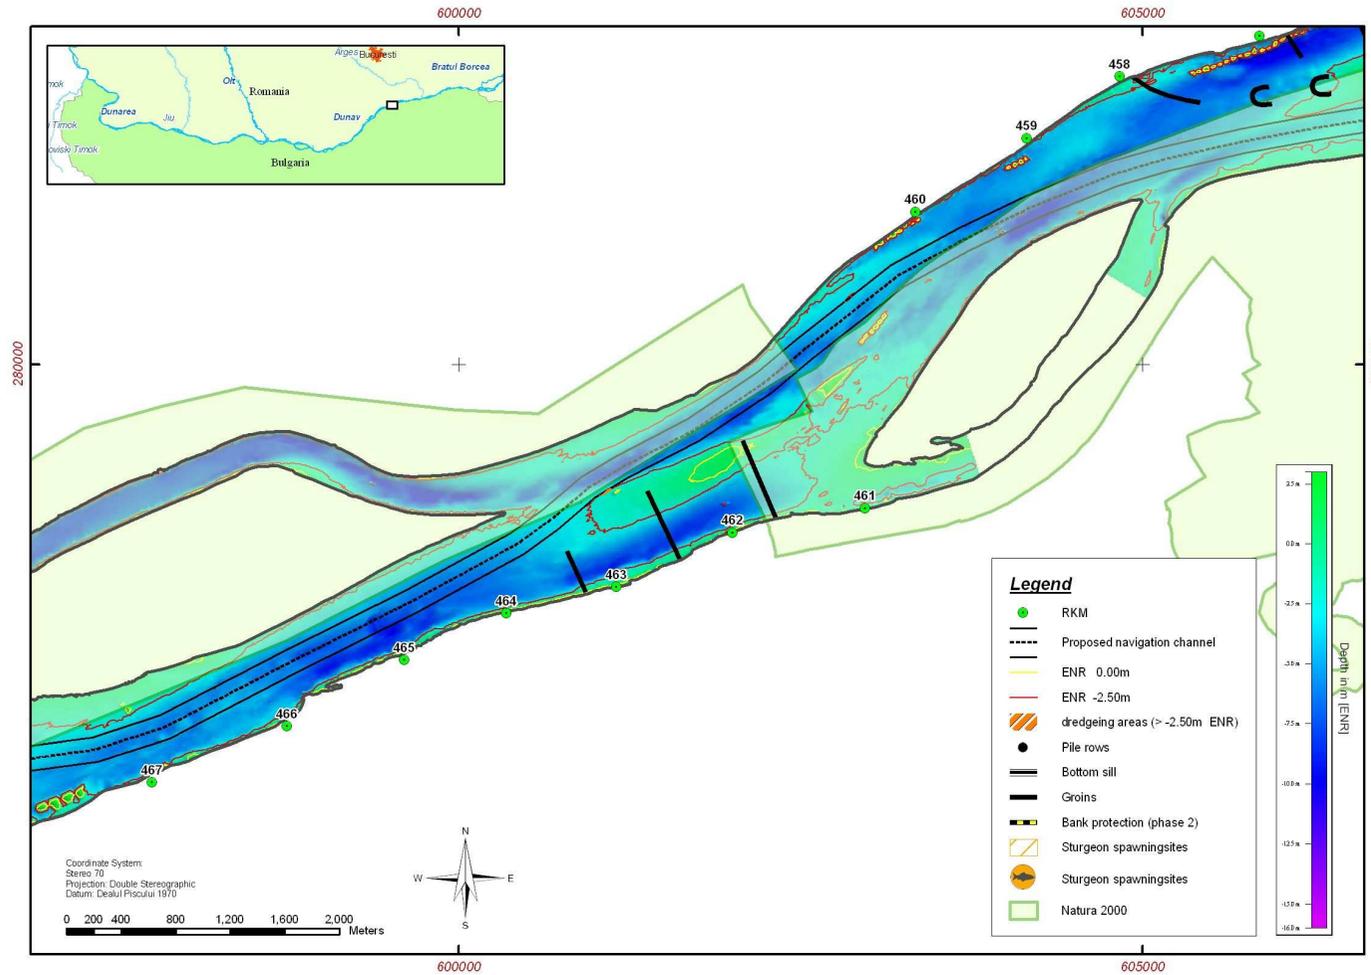
Figure 71: Mishka Island Alternative Development Strategy A

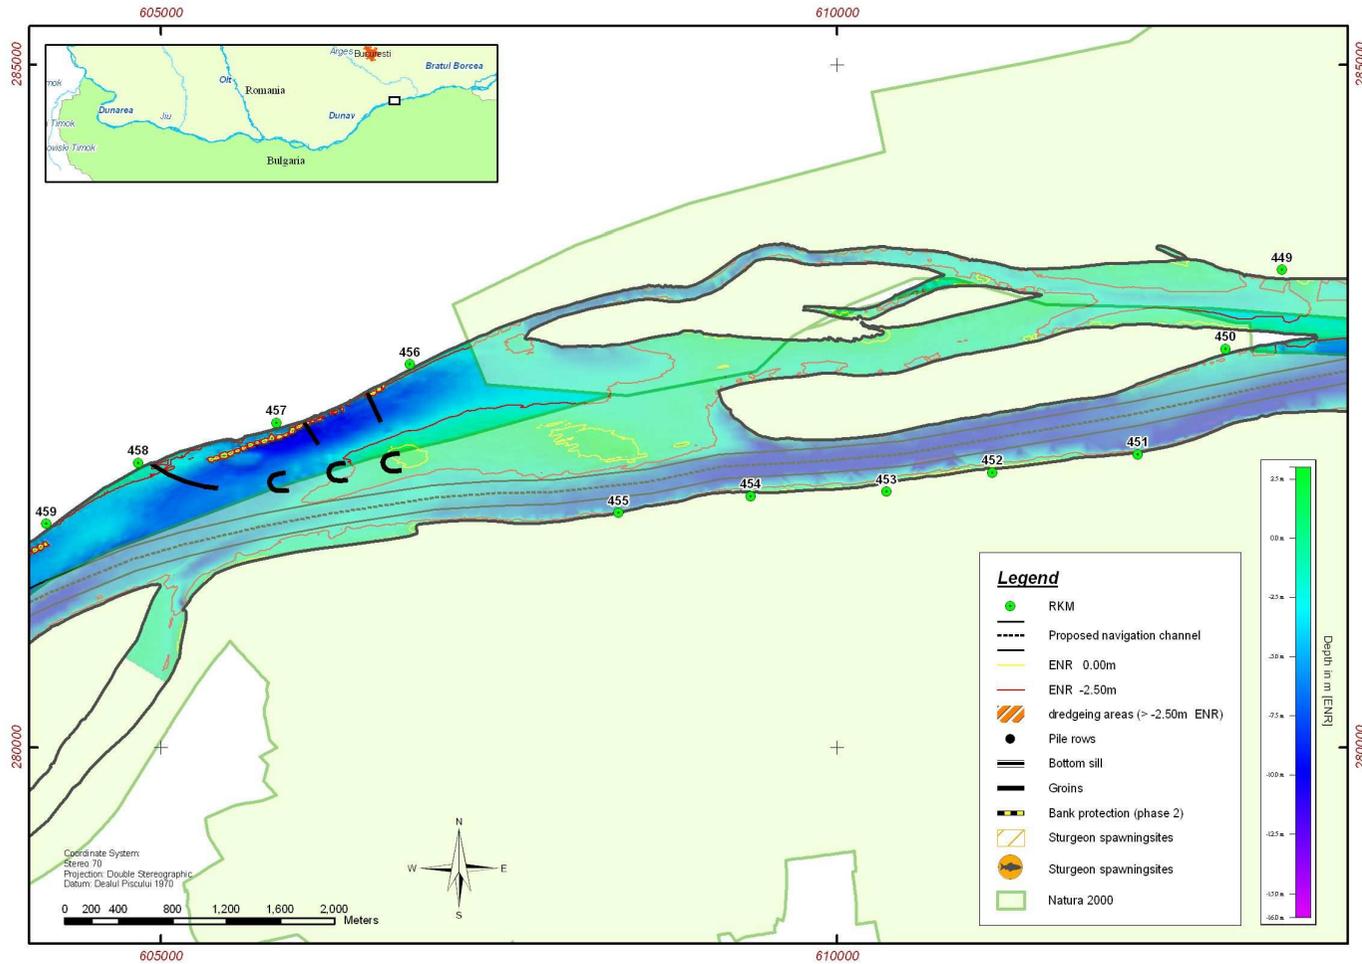
Figure 72: Mishka Island Alternative Development Strategy B

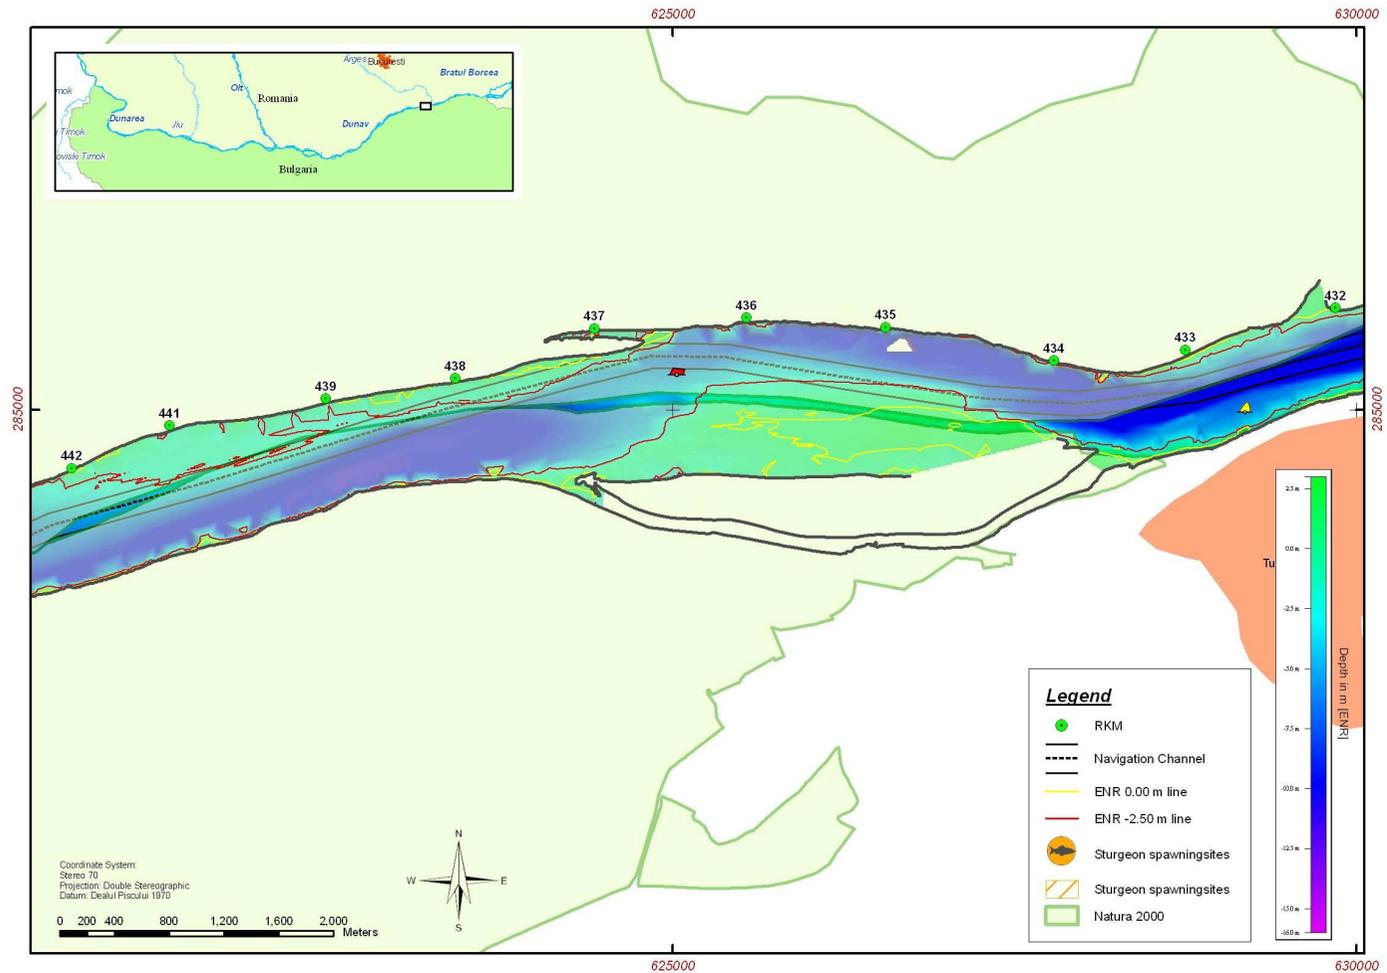
Last update of this sheet:	18/09/08
	Critical Sector Number:	27
Location:		
Radetzki Island		
Position:	Danube sector:	
rKm 441-435	Common Romanian – Bulgarian sector rKm 610 - 845.5	
Sector for detail measurements:		
Critical point reported by:		
<ul style="list-style-type: none"> • APPD Ruse 		
Description of the present situation:		
There are no problems for navigation at present.		
Proposed works:		
Harris (1999):		
Alternative Development Strategies (Technum et al., 2008):		
A realignment of the navigation channel would be enough to improve this sector. No other measures are proposed in this area.		
Selected solutions JV Technum, Trapec, Tractebel, CNR, Safege (2008)

Figure 73: Radetzki Island Present Conditions

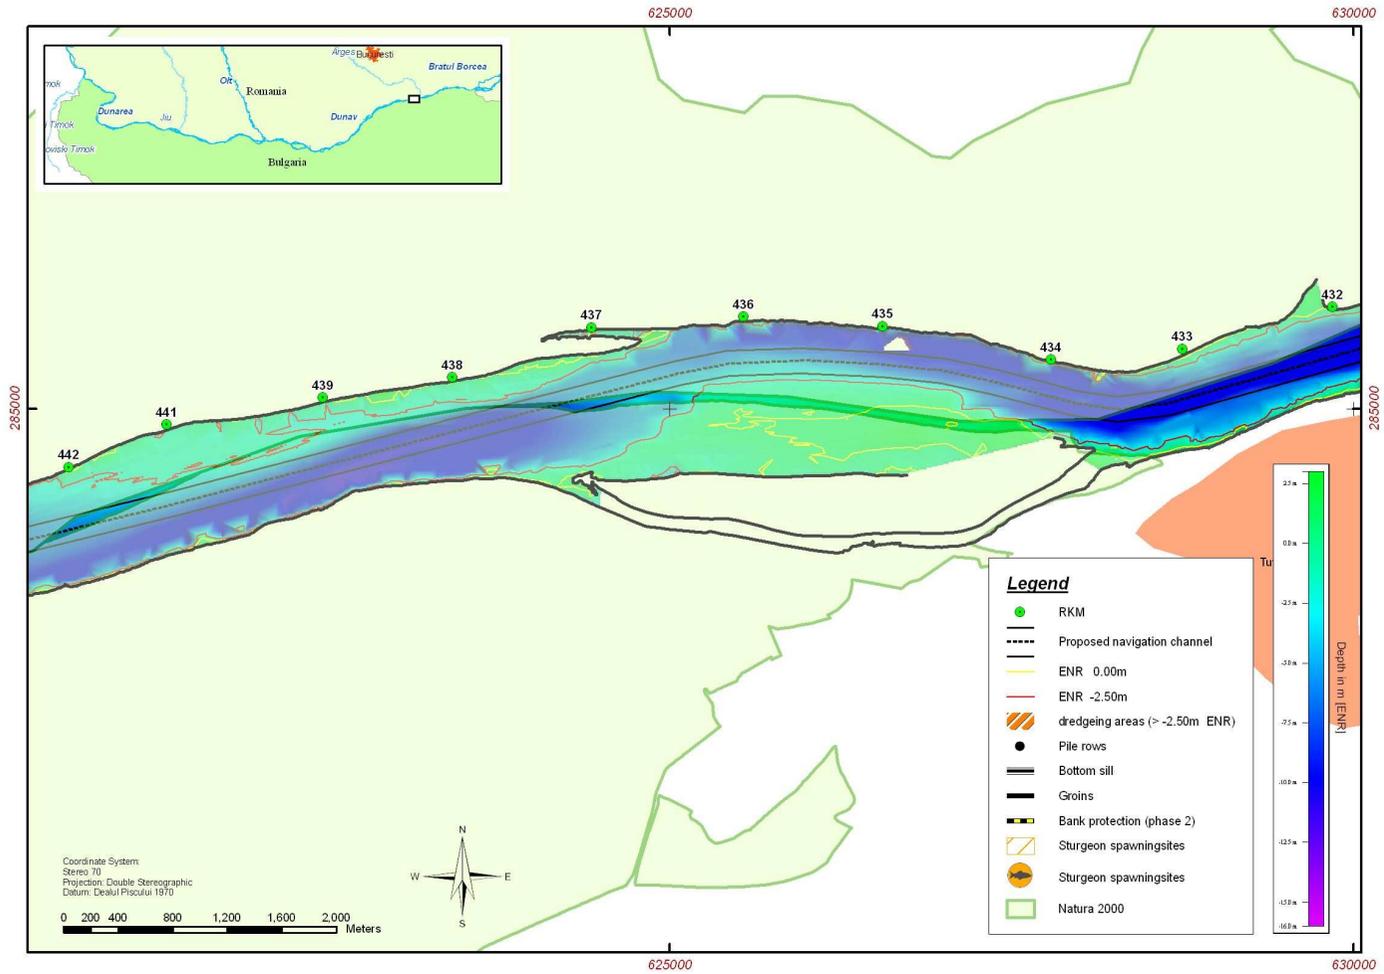
Figure 74: Radetzki Island Alternative Development Strategy

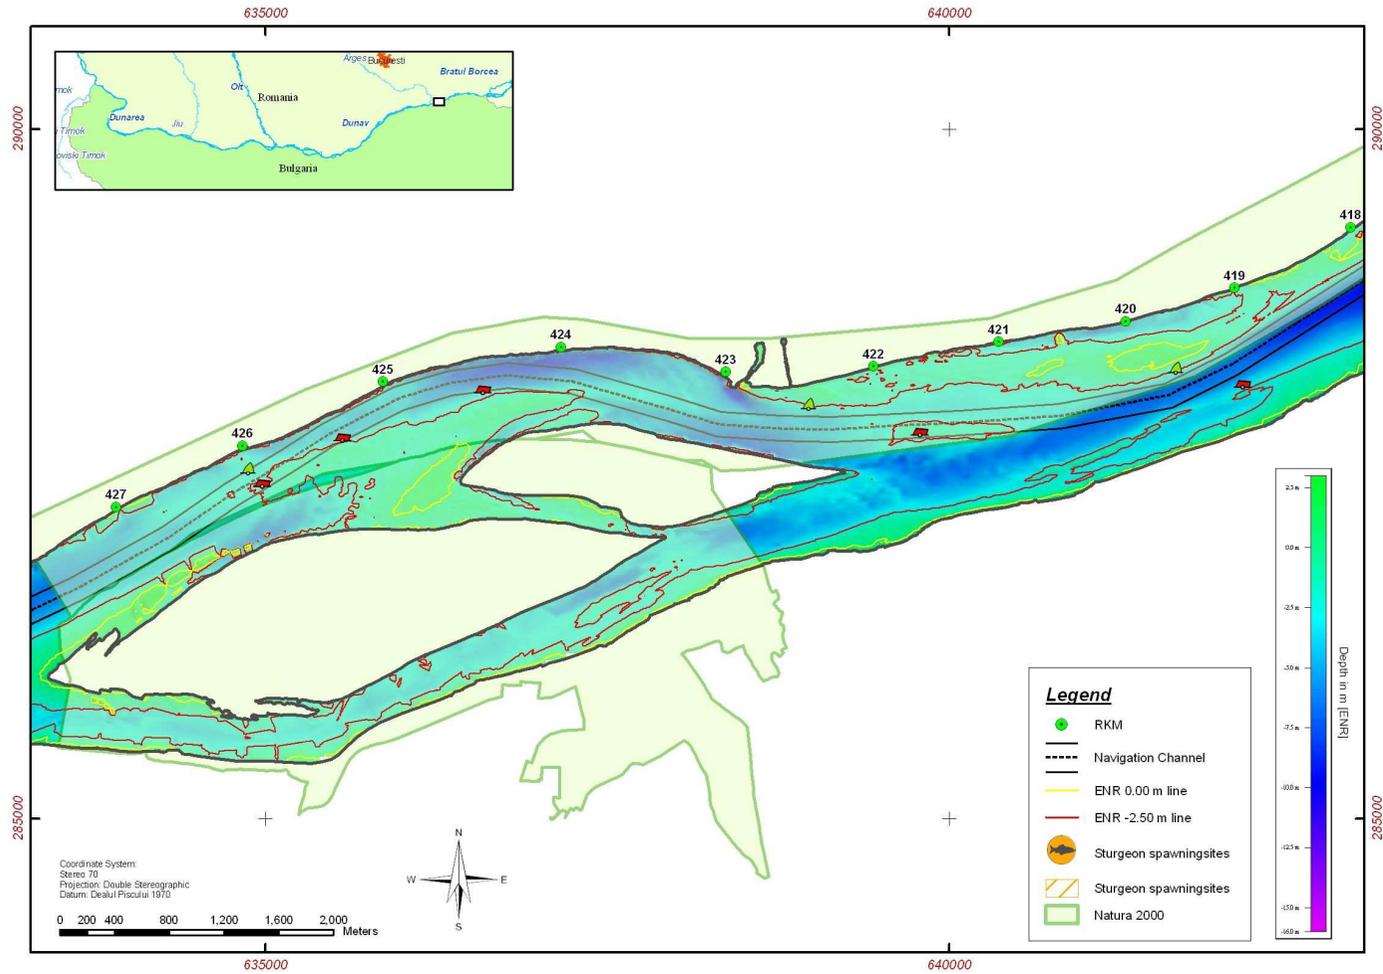
Figure 75: Kosui Present Conditions

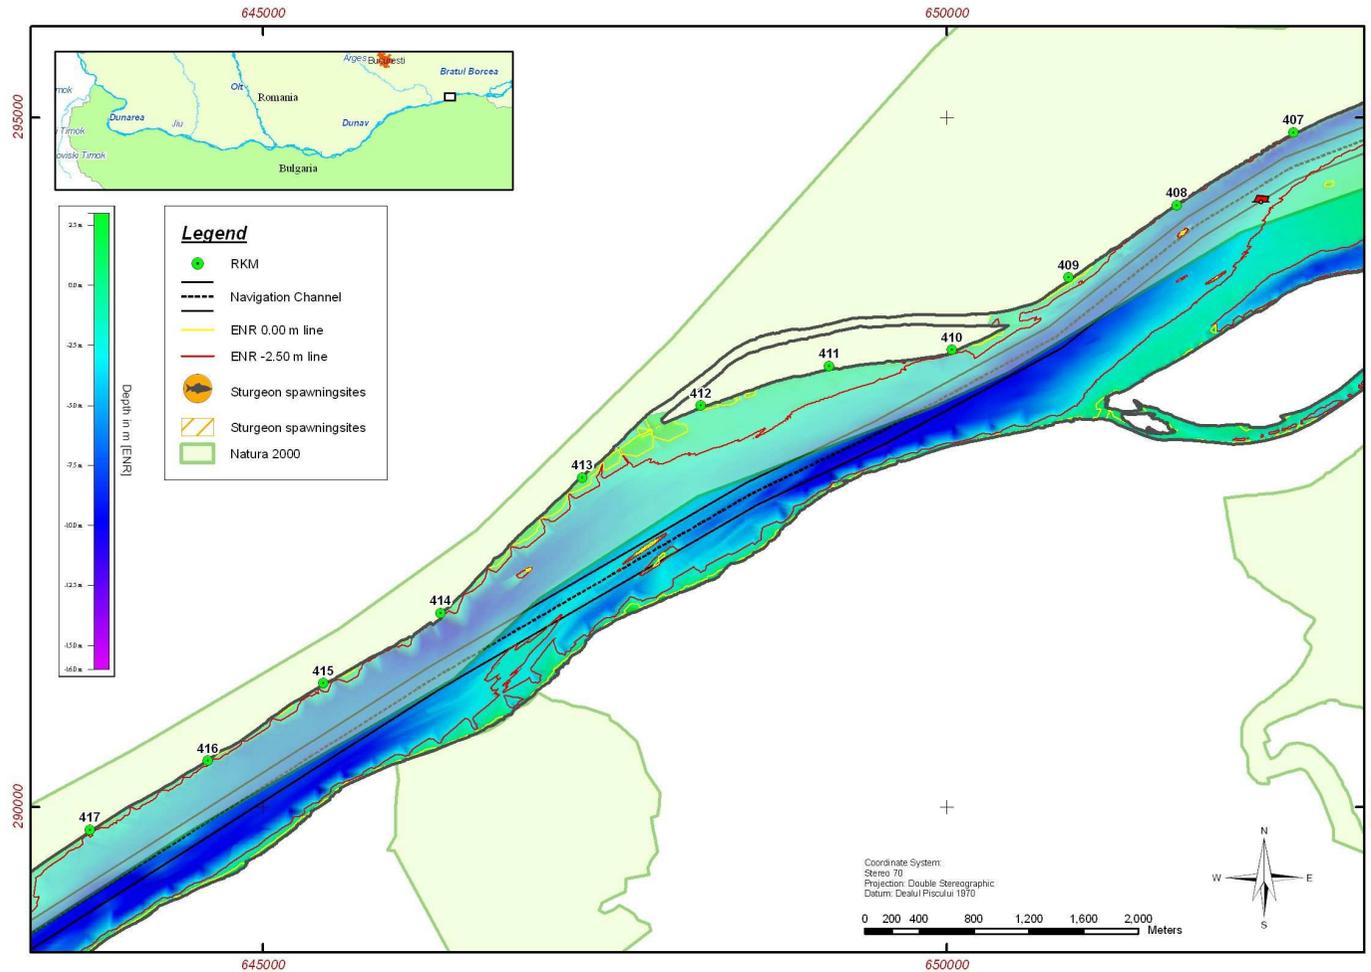
Last update of this sheet:	18/09/08
	Critical Sector Number:	29
Location:		
Albina		
Position:	Danube sector:	
rKm 415-410	Common Romanian – Bulgarian sector rKm 610 - 845.5	
Sector for detail measurements:		
Critical point reported by:		
<ul style="list-style-type: none"> • APPD Ruse 		
Description of the present situation:		
There are no problems for navigation at present.		
Proposed works:		
Alternative Development Strategies (Technum et al., 2008):		
<p>A realignment of the navigation channel would be enough to improve this sector. However, because the river increases its cross section width at rkm414-413, the TWS includes three groins on the left bank. No training works are proposed in the MS and EES.</p> <p>Other important aspects for the EES and GES, and in general for construction:</p> <ul style="list-style-type: none"> • Phasing of dredging to take into account fish spawning/migration; • Phasing of training works; • Keep impact on deep areas as low as possible (spawning sites); • Useful application of dredged material; • Open groins at the river bank; • Smaller number of groins with L-shape.

Figure 77: Albina Present Conditions

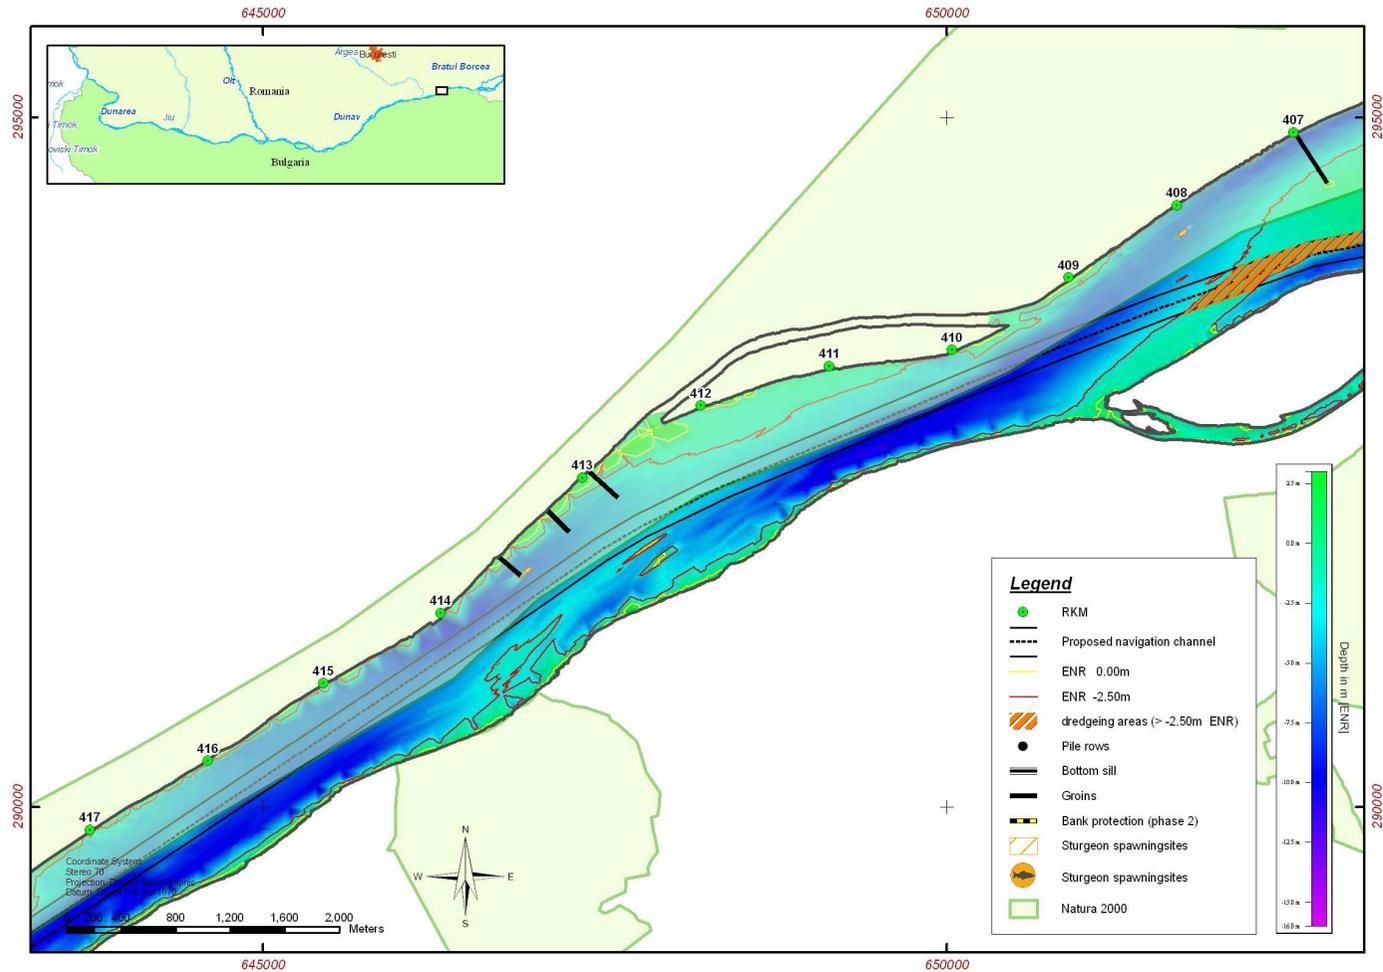
Figure 78: Albina Alternative Development Strategy

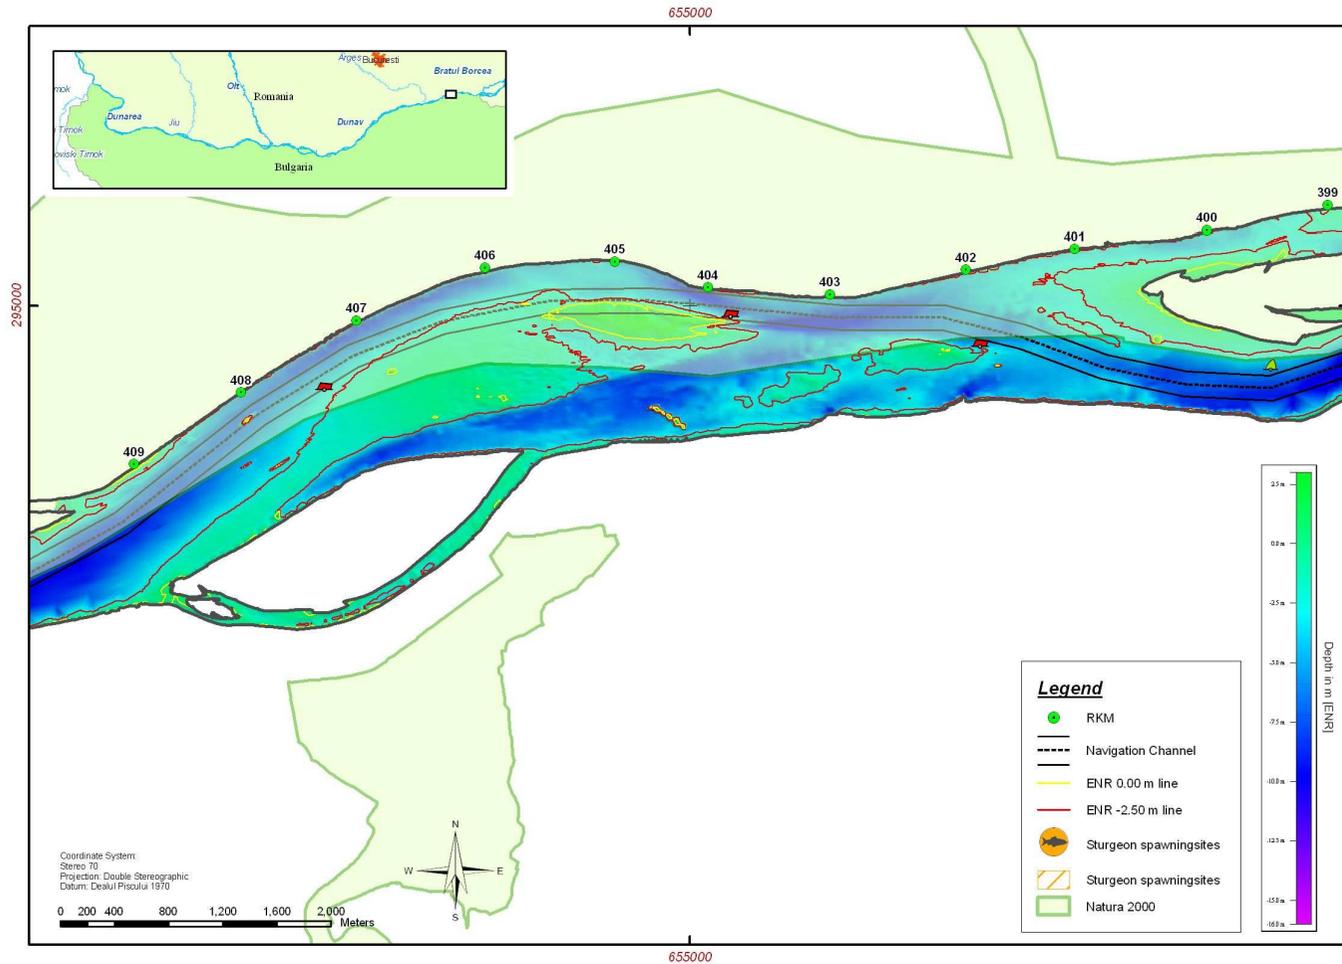
Last update of this sheet:	18/09/08
	Critical Sector Number:	30
Location:		
Popina		
Position:	Danube sector:	
rKm 409-400	Common Romanian – Bulgarian sector rKm 610 - 845.5	
Sector for detail measurements:		
Critical point reported by:		
<ul style="list-style-type: none"> • Harris (1999) • Navigation Directorate • APPD Ruse 		
Description of the present situation:		
<p>Small islands and sand banks occur, distributing river flow among the several branches. This results in low flow velocities in the main channel during low flow conditions and the navigation channel depth and width cannot be kept naturally. There are no problems for navigation at present.</p>		
Proposed works:		
<p>Harris (1999): The proposed solution includes groins, bank protection and a bottom sill in Valasti (rkm 400).</p>		
Alternative Development Strategies (Technum et al., 2008):		
<p>The navigation channel is moved towards the right bank. Because the river increases its cross section width at rkm407-405, the TWS includes three groins on the left bank. No training works are proposed in the MS and EES. Other important aspects for the EES and GES, and in general for construction:</p> <ul style="list-style-type: none"> • Phasing of dredging to take into account fish spawning/migration; • Phasing of training works; • Keep impact on deep areas as low as possible (spawning sites); • Useful application of dredged material; • Open groins at the river bank; • Smaller number of groins with L-shape.

Figure 79: Popina Present conditions

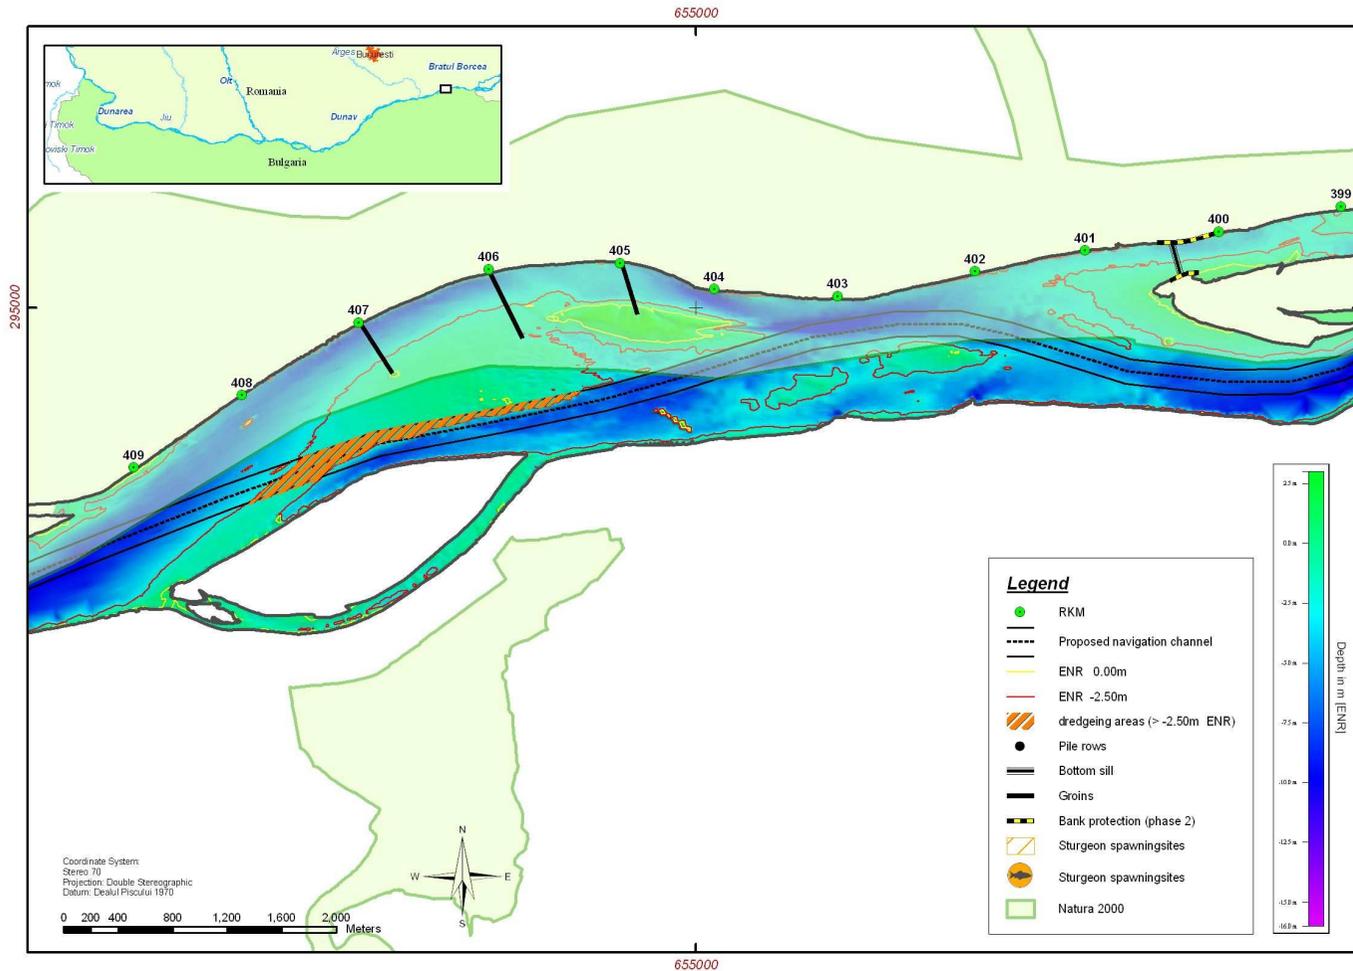
Figure 80: Popina Alternative Development Strategy

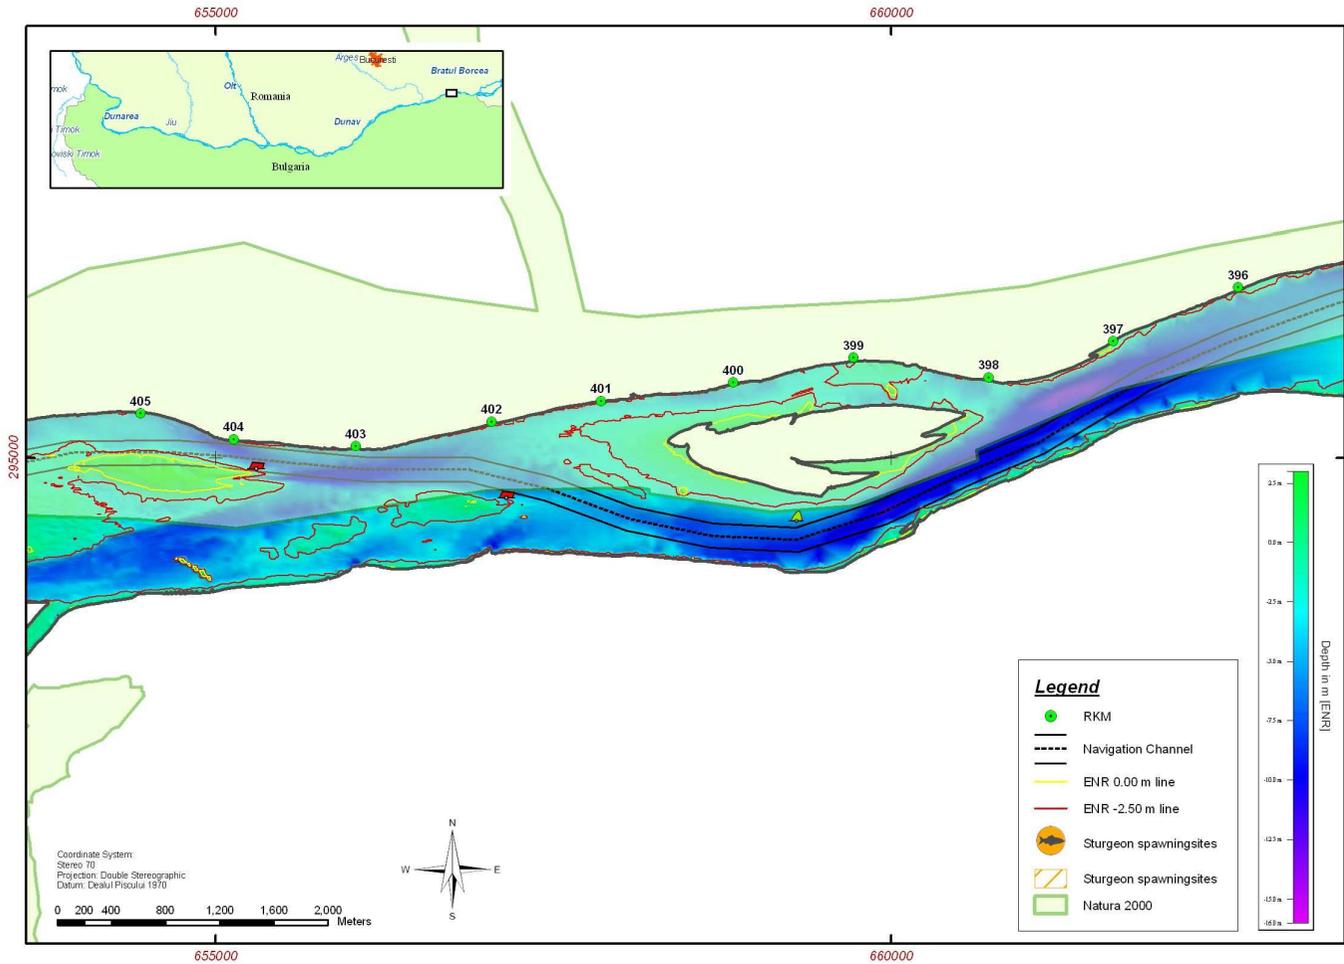
Last update of this sheet:	18/09/08
	Critical Sector Number:	31
Location:		
Varasti Island		
Position:	Danube sector:	
rKm 400-399	Common Romanian – Bulgarian sector rKm 610 - 845.5	
Sector for detail measurements:		
Critical point reported by:		
Description of the present situation:		
The width of the navigation channel does not comply the recommendations of the Danube Committee for the Danube maritime fairway between rkm 400-399.		
Proposed works:		
Harris (1999): The proposed structures are a bottom sill at Varasti and at Vetren.		
Alternative Development Strategies (Technum et al., 2008):		
<p>The navigation channel is slightly modified on the right branch (rkm400) and a bottom sill in the secondary branch is proposed in the TWS. No training works are proposed in the MS and EES. Other important aspects for the EES and GES, and in general for construction:</p> <ul style="list-style-type: none"> • Phasing of dredging to take into account fish spawning/migration; • Phasing of training works; • Keep impact on deep areas as low as possible (spawning sites); • Useful application of dredged material; • Two open bottom sills instead of one.

Figure 81: Varasti Island Present Conditions
