TECHNICAL MEMOIR FOR ENVIRONMENT PERMIT ISSUANCE

The ISPA EUROPEAID/122137/D/SV/RO - "Technical assistance for improvement of conditions for navigation on the Common Romanian - Bulgarian Danube sector and further studies".

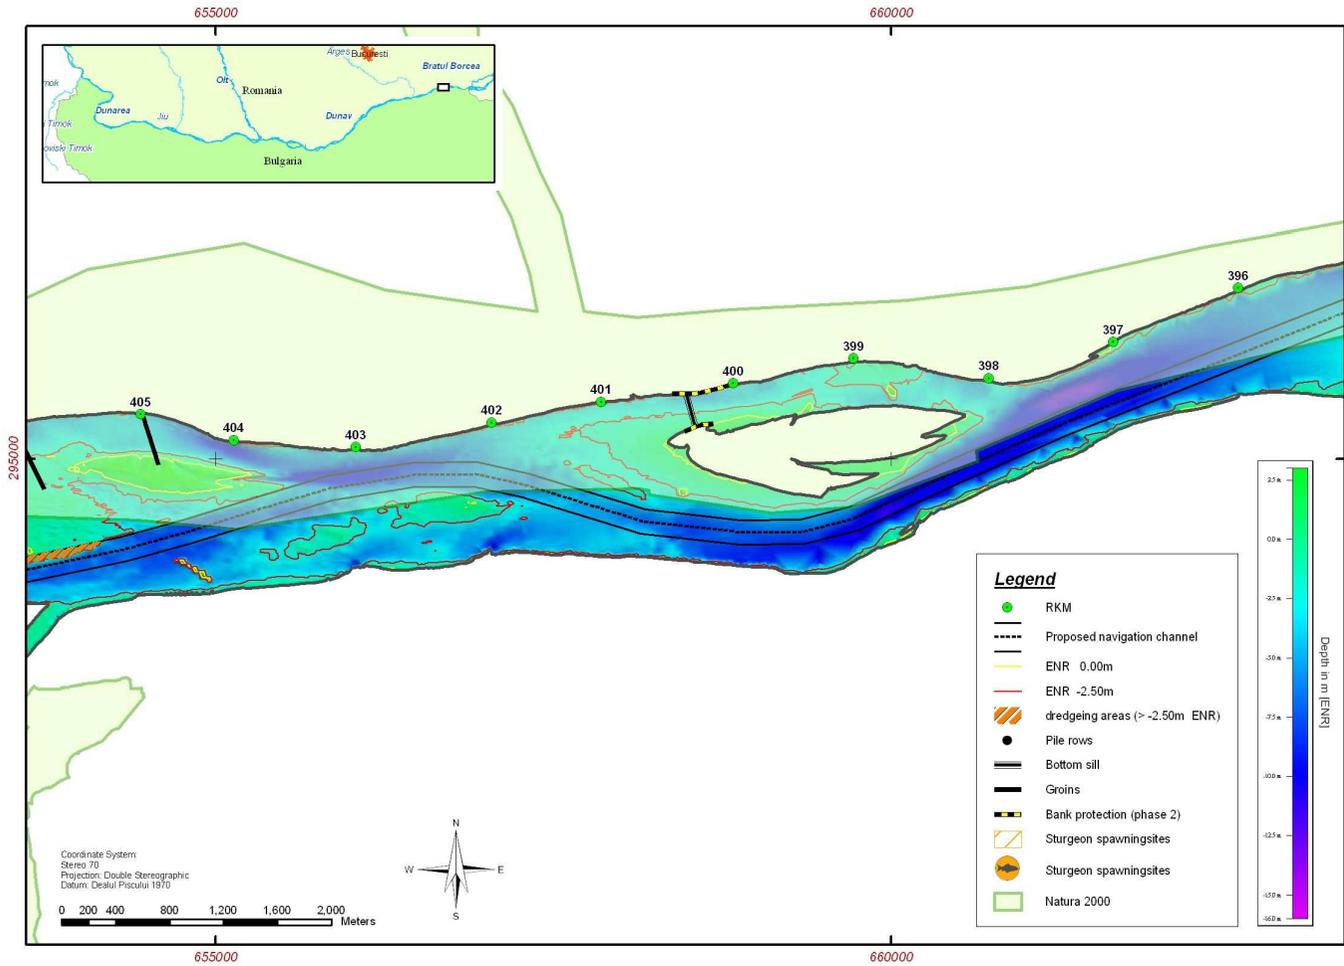
Figure 82: Varasti Island Alternative Development Strategy

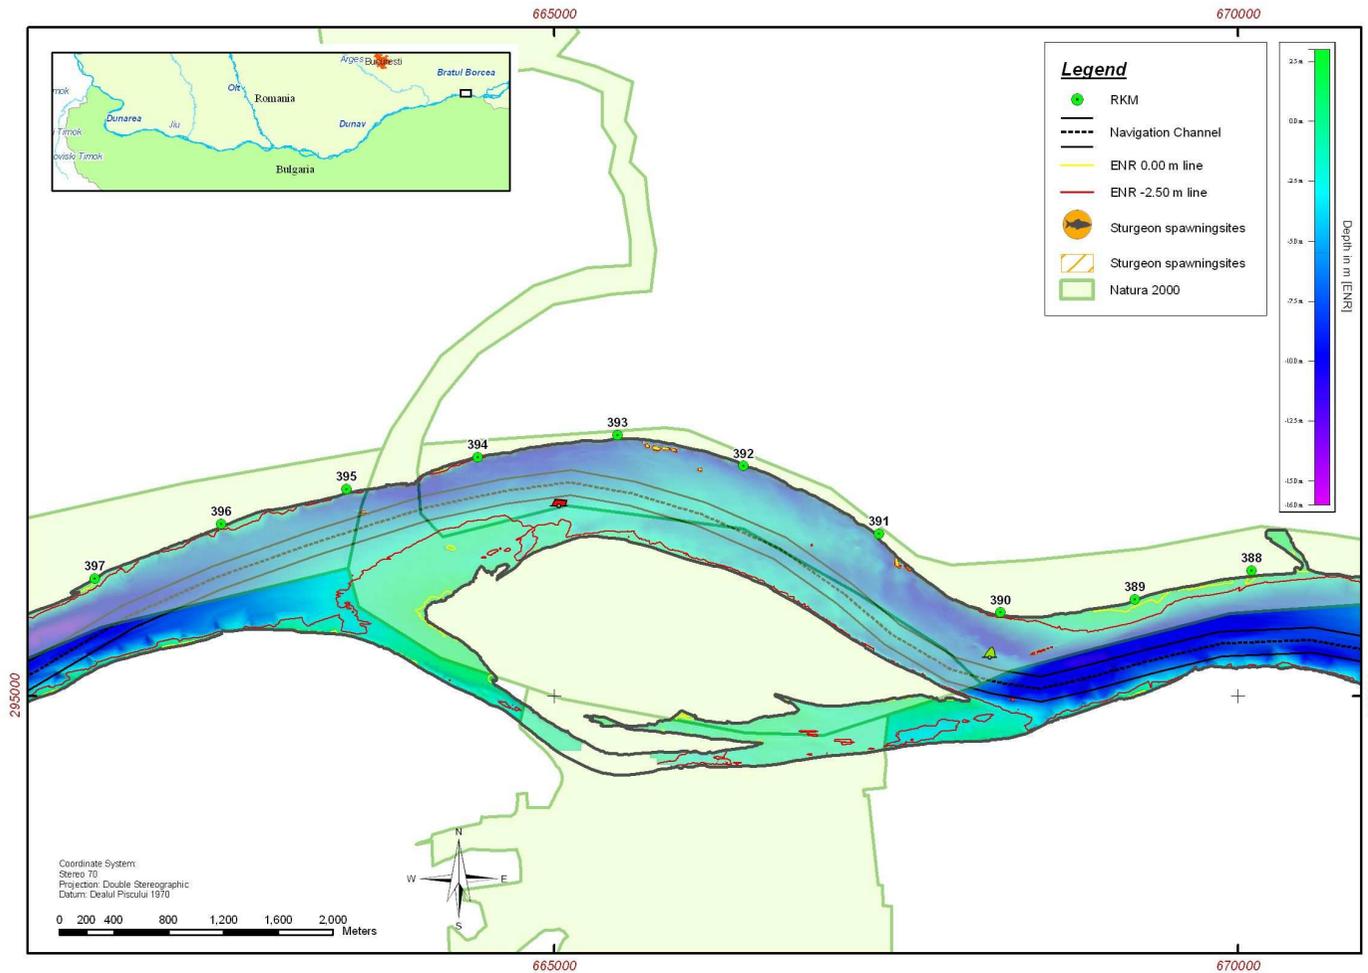
Last update of this sheet:	18/09/08
	Critical Sector Number:	32
Location:		
Vetren		
Position:	Danube sector:	
rKm 395-390	Common Romanian – Bulgarian sector rKm 610 - 845.5	
Sector for detail measurements:		
Critical point reported by:		
<ul style="list-style-type: none"> • Harris (1999) • Navigation Directorate • APPD Ruse 		
Description of the present situation:		
There are no problems for navigation at present.		
Proposed works:		
Harris (1999): The proposed structures are a bottom sill at Varasti and at Vetren.		
Alternative Development Strategies (Technum et al., 2008):		
No measures are proposed in this area.		
Selected solutions JV Technum, Trapec, Tractebel, CNR, Safege (2008)

Figure 83: Vetren Present Conditions

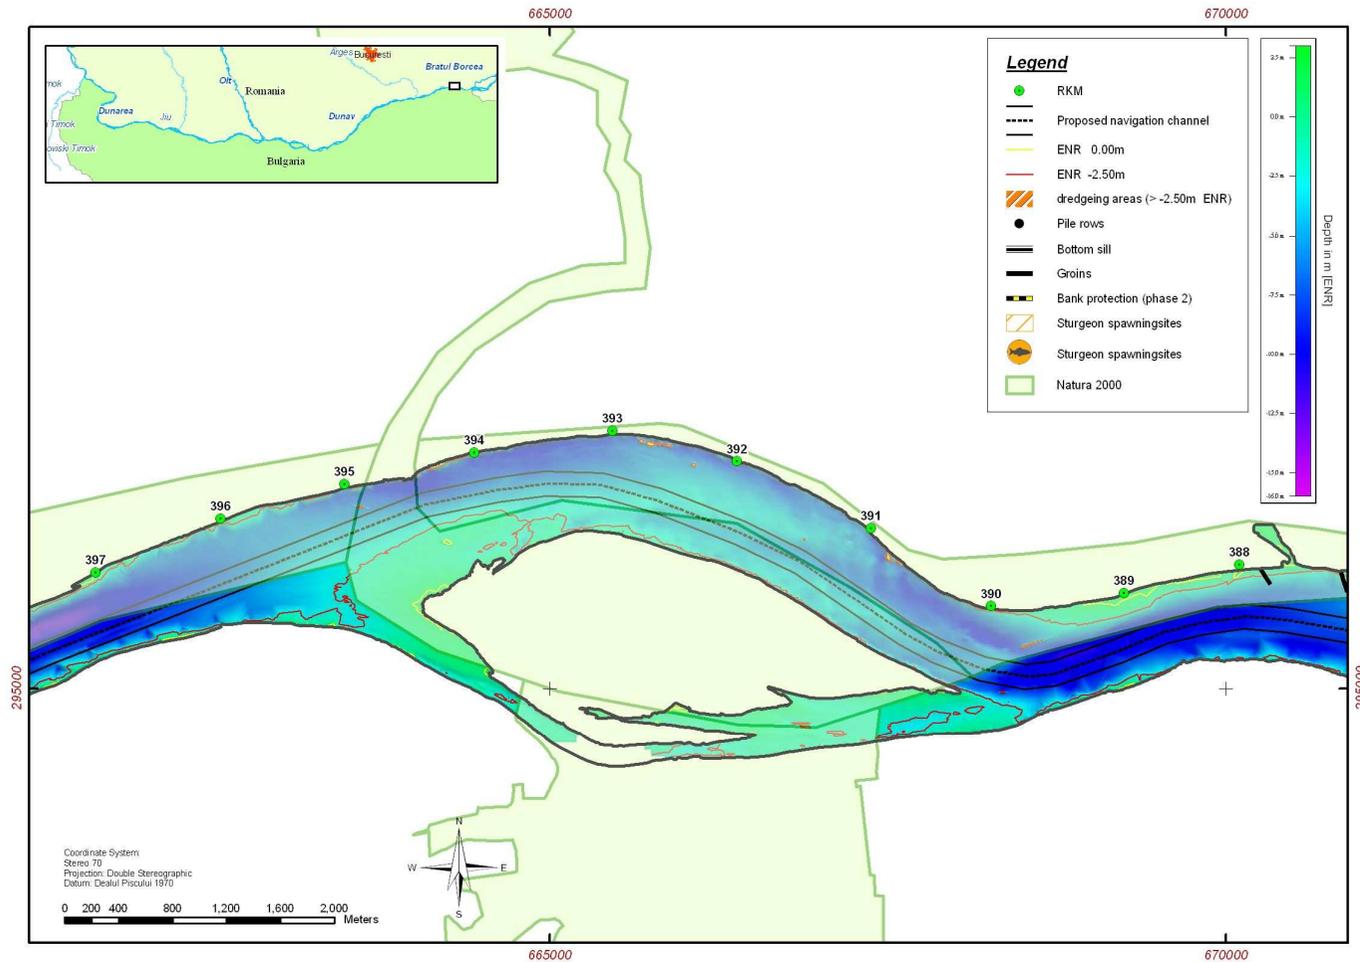
Figure 84: Vetren Alternative Development Strategy

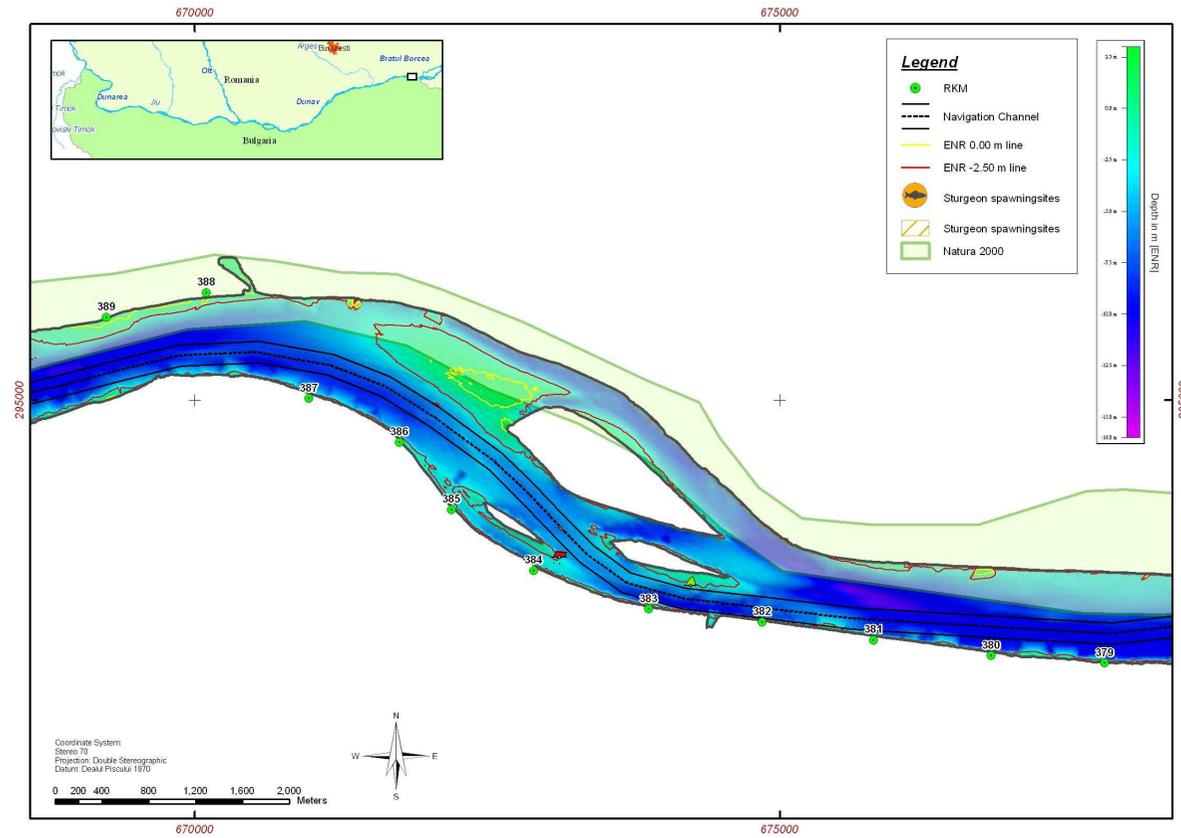
Last update of this sheet:	18/09/08
	Critical Sector Number:	33
Location:		
Chayka Island		
Position:	Danube sector:	
rKm 386-382	Common Romanian – Bulgarian sector rKm 610 - 845.5	
Sector for detail measurements:		
Critical point reported by:		
<ul style="list-style-type: none"> • APPD Ruse 		
Description of the present situation:		
There are no problems for navigation at present.		
Proposed works:		
Harris (1999):		
Alternative Development Strategies (Technum et al., 2008):		
<p>A realignment of the navigation channel and a small dredging volume would be enough to improve this sector. However, because the river increases its cross section width at rkm388-386, the TWS includes three groins on the left bank. No training works are proposed in the MS and EES.</p> <p>Other important aspects for the EES and GES, and in general for construction:</p> <ul style="list-style-type: none"> • Phasing of dredging to take into account fish spawning/migration; • Phasing of training works; • Keep impact on deep areas as low as possible (spawning sites); • Useful application of dredged material; • Open groins at the river bank; • Smaller number of groins with L-shape.

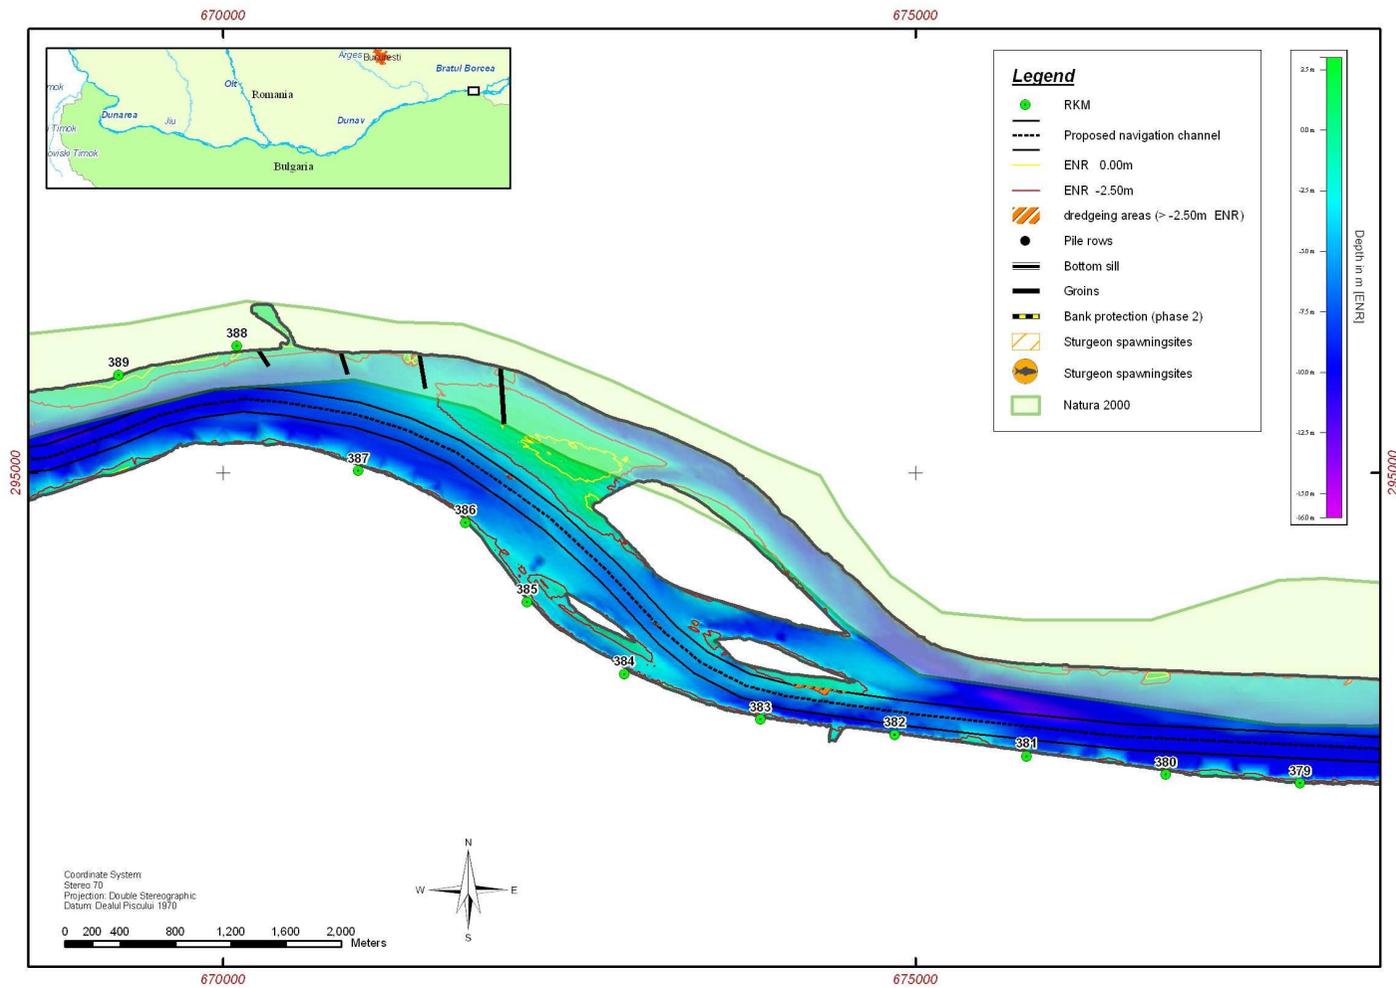
Figure 86: Chayka Island Alternative Development Strategy
